# MARINE ACCIDENT INVESTIGATION REPORT

October 3, 2017

| <b>Accident type</b> | Grounding |
| <b>Summary of the Accident</b> | An oil tanker, SAGAN, with 18 crews, including the master, became unable to start and drifted due to failures in the main engine while heading northeast off the western coast of the Noma Peninsula, Satsuma-shi, Kagoshima. She grounded on the southwest coast of the Suwanosejima Island, Toshima-mura, Kagoshima.<br>SAGAN was completely destroyed with cracks, etc. on the bottom shell, but there were no casualties. |

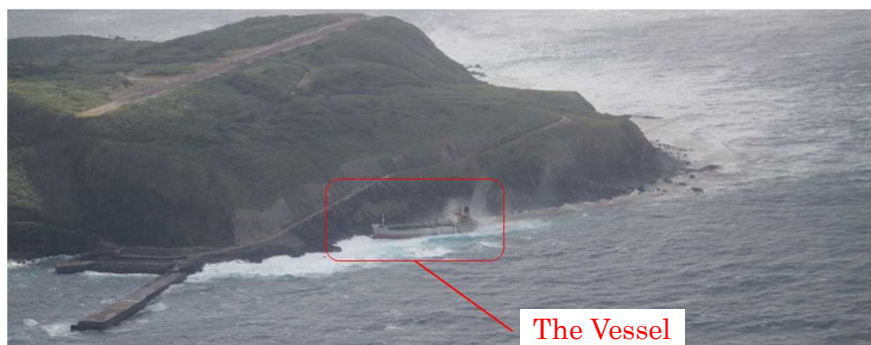
Figure 1 Place of grounding on the southwest coast of the

Suwanosejima Island  
(Photo provided by the 10th Regional Coast Guard  
Headquarters)

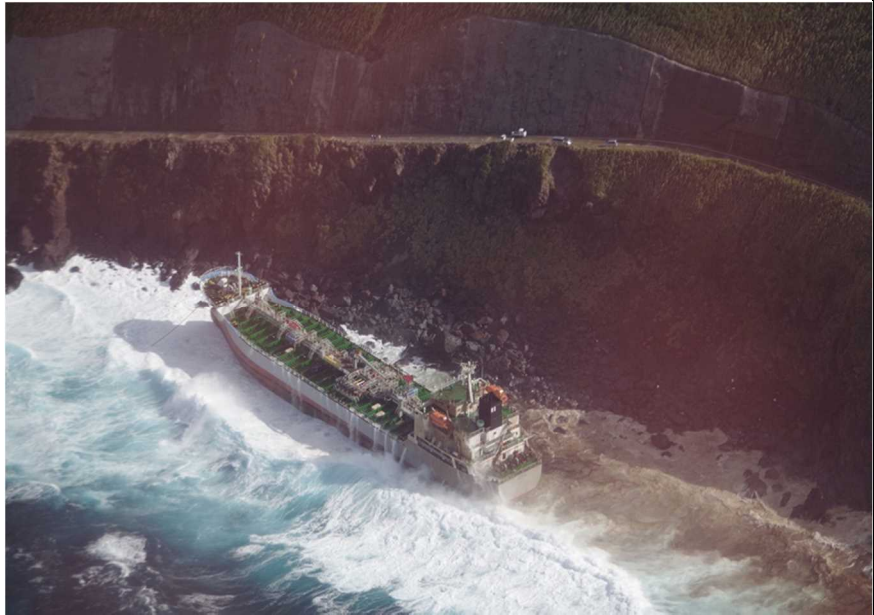
Figure 2 Conditions of grounding on the southwest coast of the  
Suwanosejima Island  
(Photo provided by the 10th Regional Coast Guard  
Headquarters)
