MA2018-8

**MARINE ACCIDENT
INVESTIGATION REPORT**

Vessel type and name: Cargo ship ASIAN BEAUTY

Vessel type and name: Liquefied gas bulk carrier ZEUS

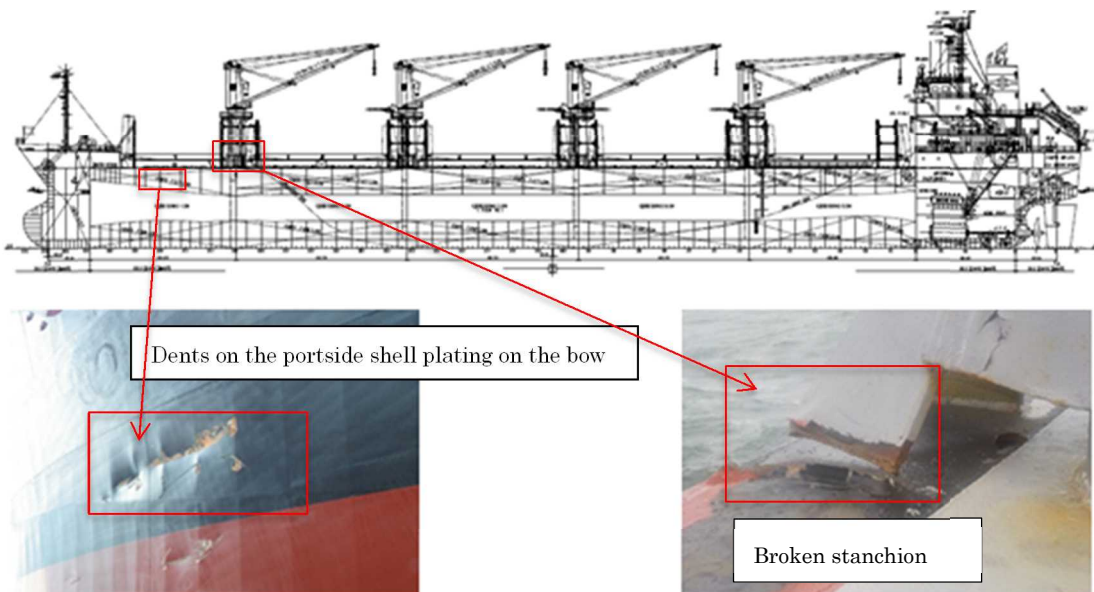
Figure 2 Damage to Vessel A

- (1) Vessel A suffered a dent on the portside shell plating on her bow, and the stanchion was broken. (See Photo 2)

- (1) Vessel A's portside front collided with Vessel B's starboardside bow. Vessel A suffered a dent on her portside front shell plating and broken portside front stanchion.
- (2) Vessel B suffered dents on its starboardside bow and starboardside center shell plating, and the starboardside bridge was destroyed.

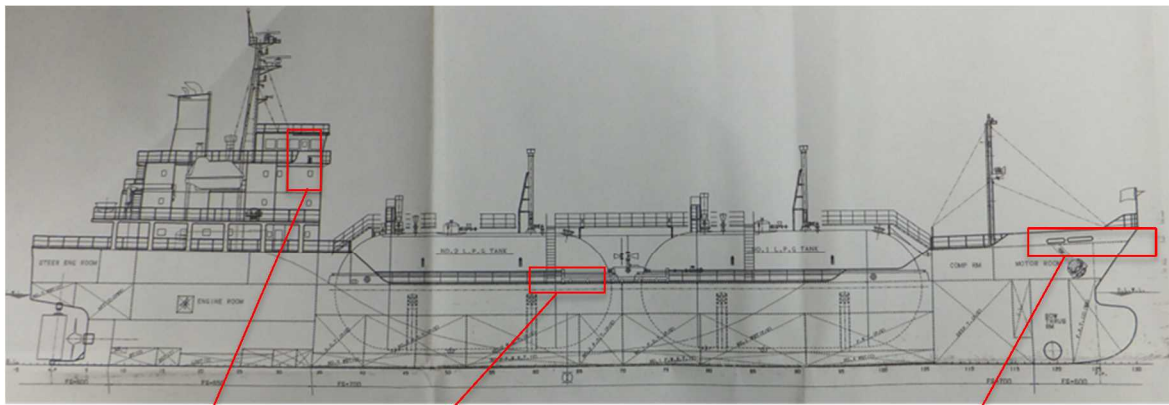
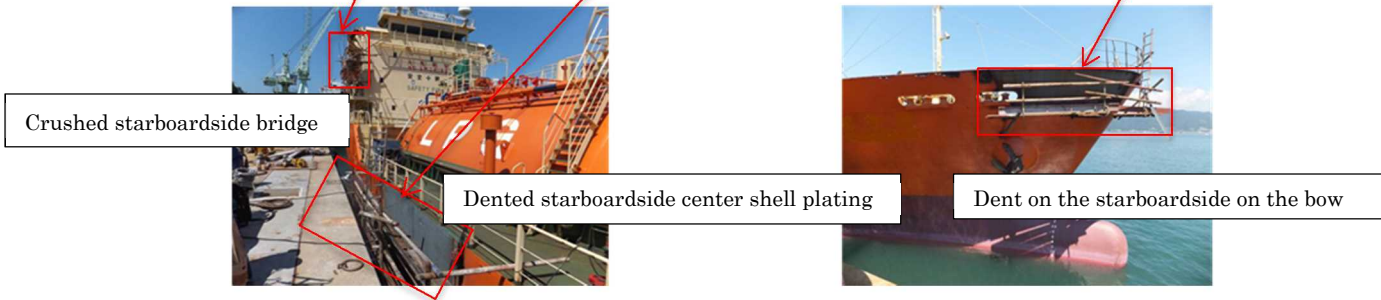
Figure 3 Damage to Vessel B

- (2) Vessel B suffered dents on her starboardside of the bow and starboardside center shell plating, and the starboardside bridge was crushed. (See Figure. 3)
