**MARINE ACCIDENT
INVESTIGATION REPORT**

Vessel type and name: Cargo ship ERNA OLDENDORFF

Accident type: Collision (Bridge)

Location: Oshima Bridge which spans Obatake Seto, Yamaguchi Prefecture

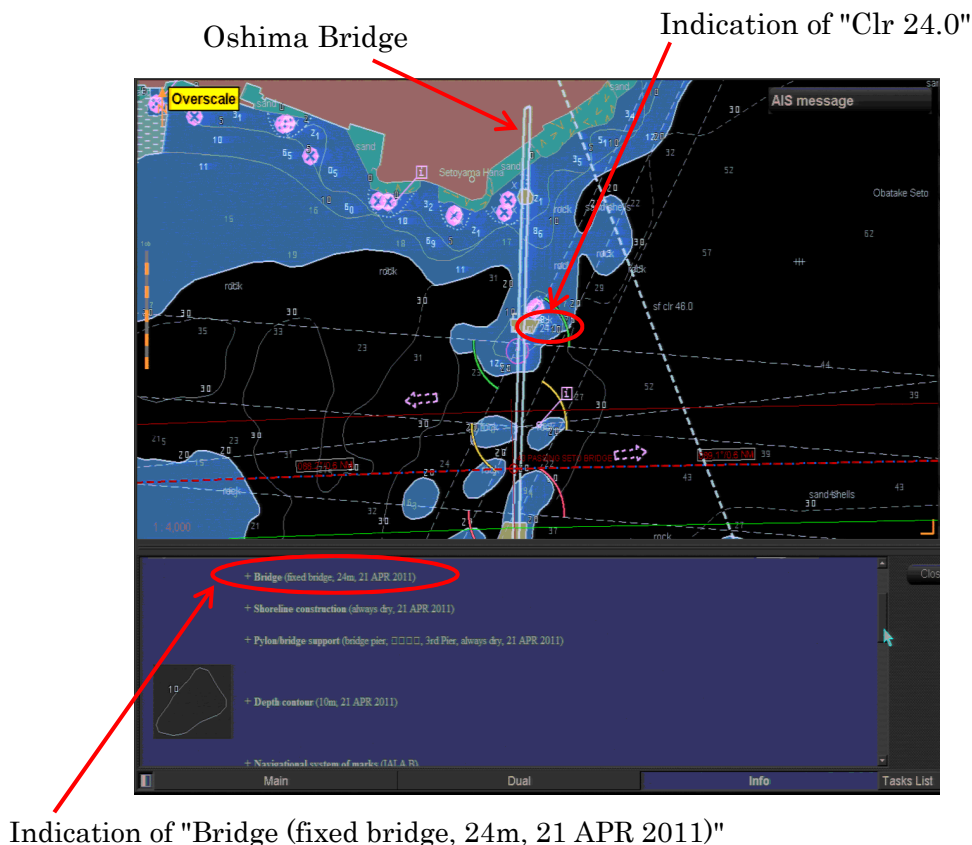
Figure 1 Image of the ECDIS screen (around 00:09:24)

In the Vessel's VDR, the state of the ECDIS screen installed on the Vessel was recorded as a still image every 15 seconds. From around 00:00 to 00:09 October 22, images in which the Vessel was navigating near Kasasa Shima, Suo-Oshima Town, Yamaguchi Prefecture were recorded and then at around 00:09:24 an image which was zoomed in the area near Oshima Bridge was recorded in the VDR.

According to the replies to the questionnaire by Navigation Officer A₁, he operated the ECDIS and zoomed Oshima Bridge on the screen at that time, but he did not carefully check the information displayed on the screen of the ECDIS because he panicked a little bit and focused on searching the information of the bridge's height using sailing directions issued by the United Kingdom Hydrographic Office (ADMIRALTY Sailing Directions Japan Pilot Volume 3, 11th Edition 2016; hereinafter referred to as "the Sailing Directions").

According to the replies to the questionnaire by Master A, he did not check the information displayed on the ECDIS himself because he focused on maneuvering of the Vessel to pass through a narrow channel and thought that the Vessel could pass under the bridge at that time.

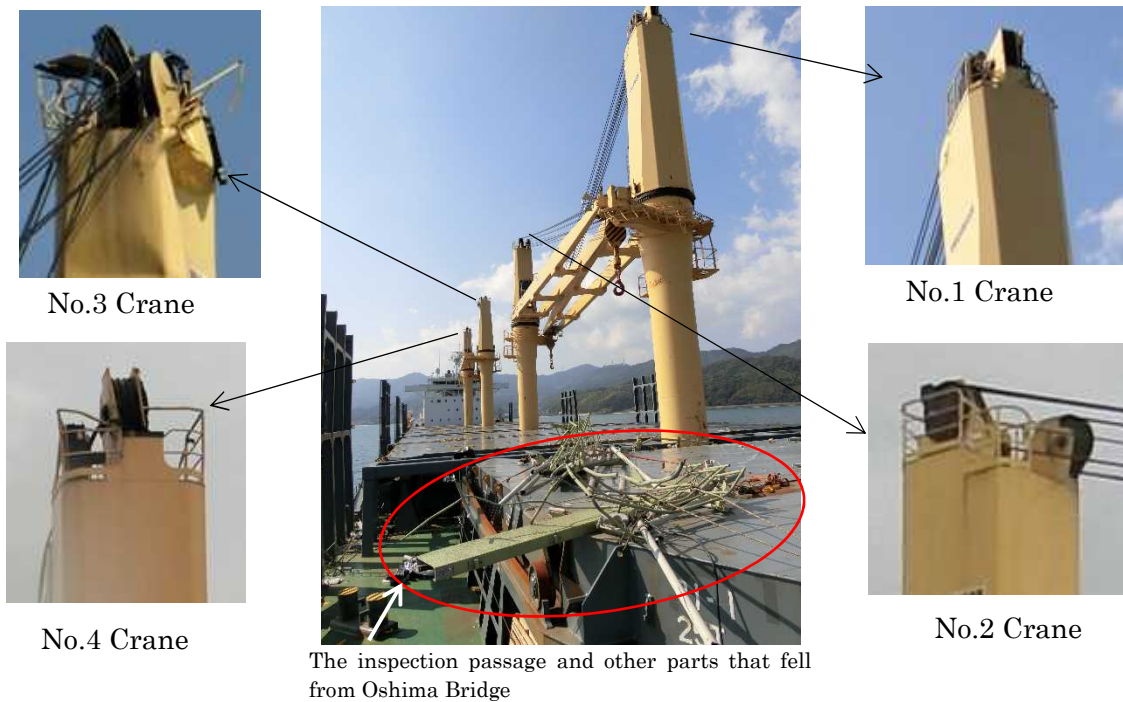
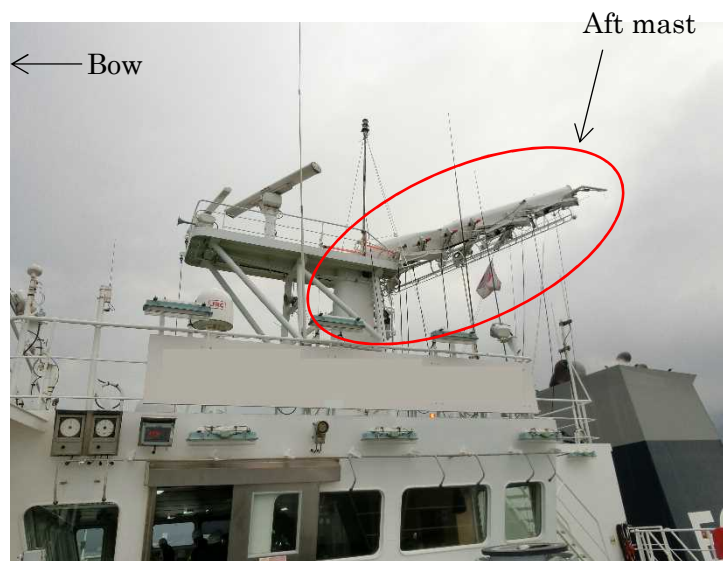
Figure 2 Damage to the Vessel

According to on-site investigation and the reply to the questionnaire by Company A, the Vessel suffered dents and other damage to No.1 crane, No.3 crane and No.4 crane of her four cargo cranes installed on the deck (referred to as No. 1 crane to No. 4 crane in order from the bow), and a bent damage to her aft mast installed on the bridge. (See Figure 2)

- (1) It is certain that the Vessel suffered dents and other damage to her No.1 crane, No.3 crane and No.4 crane, and a bent damage to aft mast.
- (2) It is probable that Oshima Bridge suffered cracks, dents, and other damage to its girders; an inspection passage that was installed under the girders was broken and fell, and a water pipe, power cables, telecommunication cables, etc. were severed; causing a water outage damaging 9,046 house and 14,590 people and regional industries, lasted for approximately forty days almost all

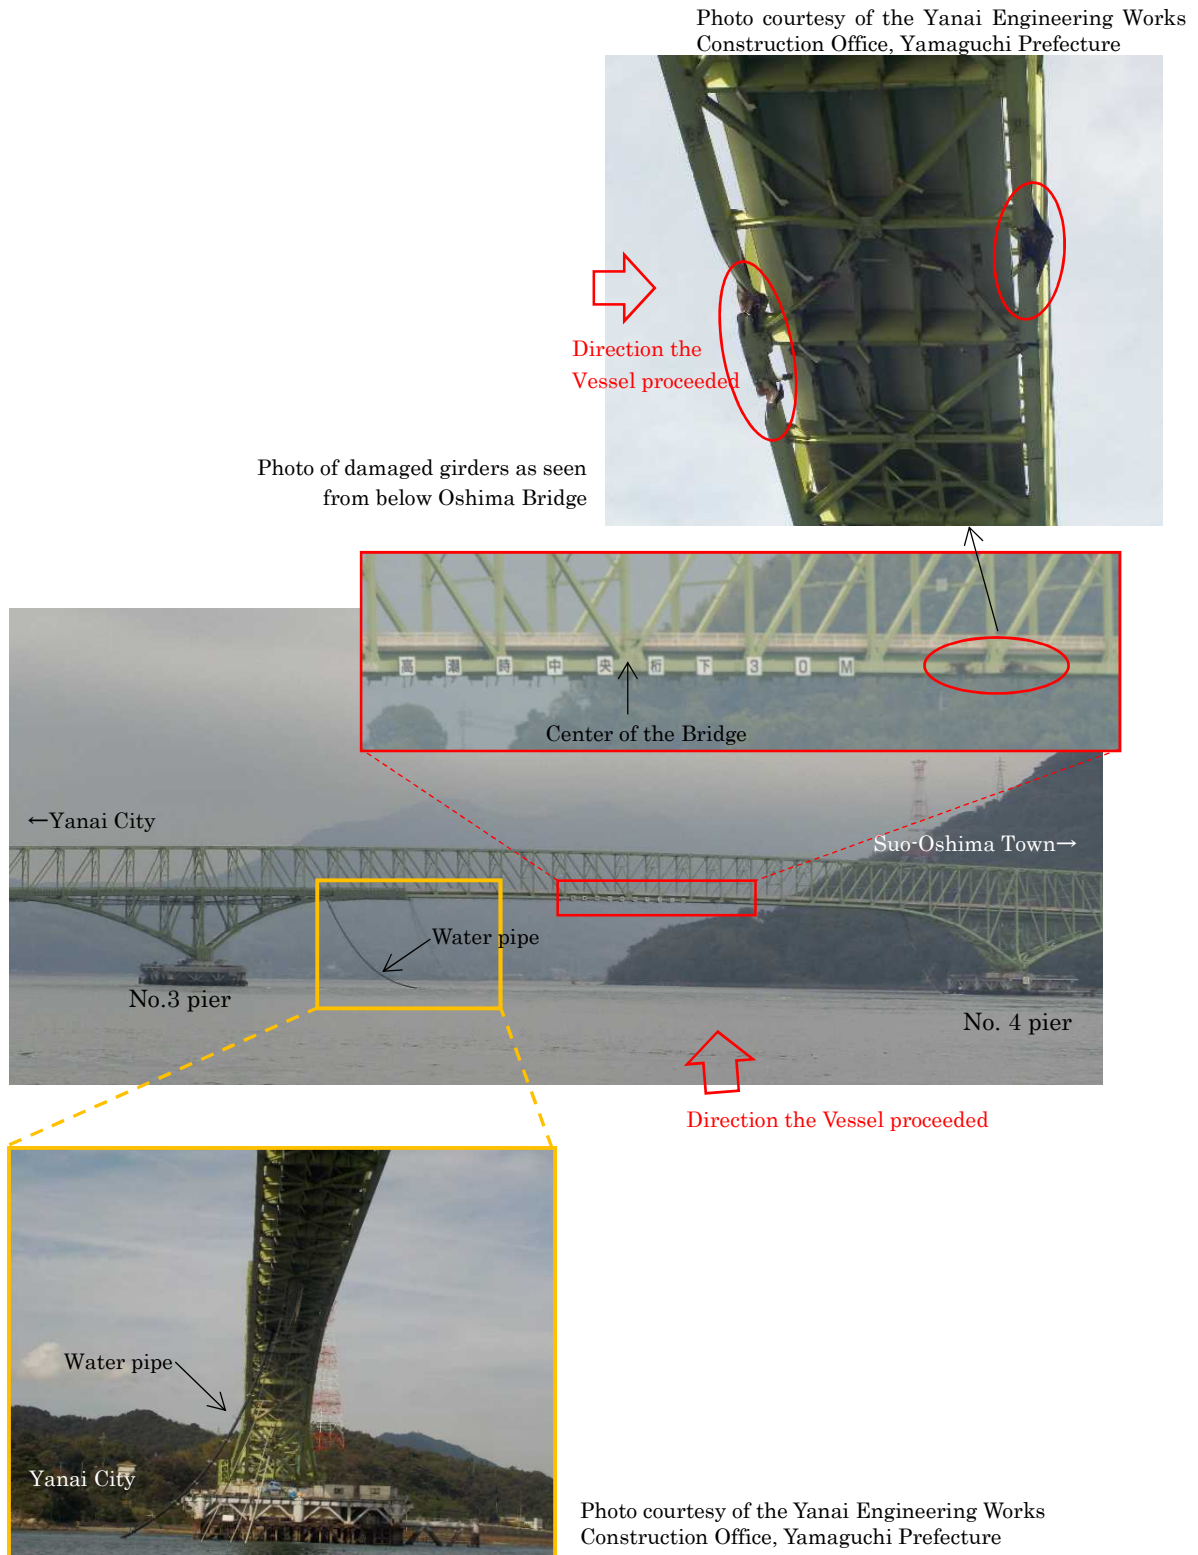
Figure 3 Damage to Oshima Bridge

Oshima Bridge suffered cracks, dents, and other damage to its girders; an inspection passage that was installed under the girders was broken and fell, and a water pipe, power cables, telecommunication cables, etc. were severed; causing a

water outage damaging 9,046 houses, 14,590 people and regional industries that lasted for approximately forty days in almost all area of Suo-Oshima Town; causing a temporary power outage, communication failures of the Internet and mobile phones etc., in some part of Suo-Oshima Town. (See Figure 3)

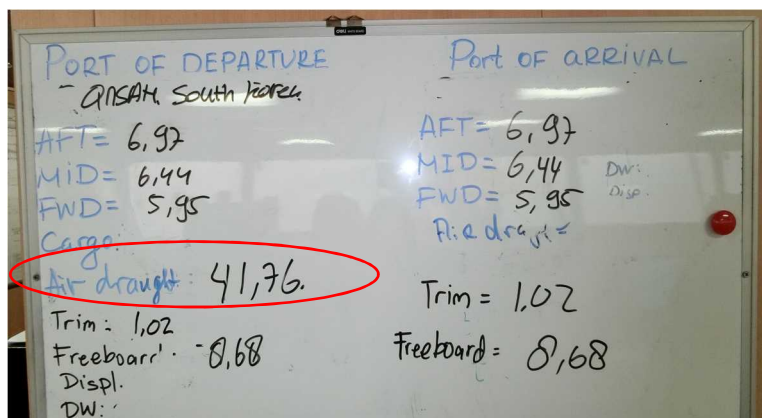
Photo 2 Air-draught, etc. displayed in the Vessel's bridge

According to on-site investigation, on the whiteboard in the Vessel’s bridge, the Vessel’s draught, air-draught etc. at the time of departure of Port of Onsan were displayed. (See Photo 2)

According to the statement of Master A and Navigation Officer A₁, they were aware of the Vessel's air-draught.

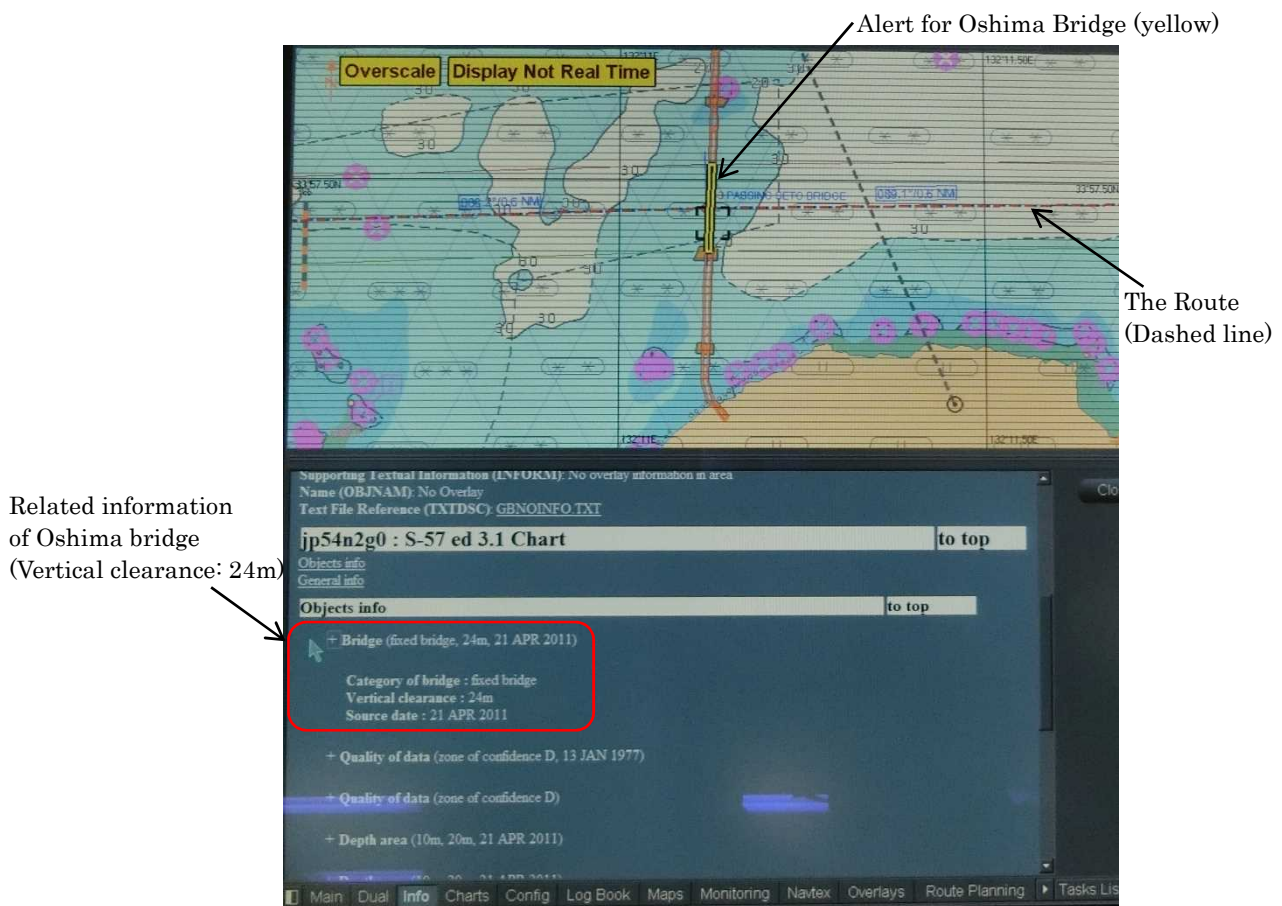
Figure 8 Alert by the route check function

When the route check function was executed for the data, the alert was displayed for Oshima Bridge including 24m of the bridge's height as the related information. (See Figure 8)

- (2) Crewmembers should thoroughly review alerts generated by the route check function of ECDIS as well as check the route visually on ENCs not to overlook navigational hazards when preparing voyage plans by ECDIS.
