MA2020-5

**MARINE ACCIDENT
INVESTIGATION REPORT**

MARINE ACCIDENT INVESTIGATION REPORT

Accident type	Fatality of a worker
Date and time	Around 03:39 on January 17, 2019
Location	Quay adjacent to Sumitomo Chemical Co., Ltd., Niihama Port, Niihama City, Ehime Prefecture Vicinity of T.B'g 059°/668 m from Niihama Port East Breakwater Lighthouse (Approximately 33°59.0' N 133°16.3' E)
Summary of the accident	While the cargo ship "ISHIZUCHI" was unloading cargo at Niihama Port, a worker was hit by a bulldozer in the hold and died at around 03:39 on January 17, 2019.
Process and progress of the investigation	(1) Set up of investigation The Japan Transport Safety Board appointed a chief investigator-in charge and two other investigators to investigate this accident on February 5, 2019. (2) Collection of evidence February 24, 2019: On-site investigation; February 5, 6, 12, 20, 22, 23 and July 30, 2019: Interview; February 13, 21, March 6, 7, 2019, and January 20, 2020: Collection of questionnaire (3) Comments from parties relevant to the cause Comments on the draft report were invited from parties relevant to the cause of accident. (4) Comments from the Flag State Comments on the draft re

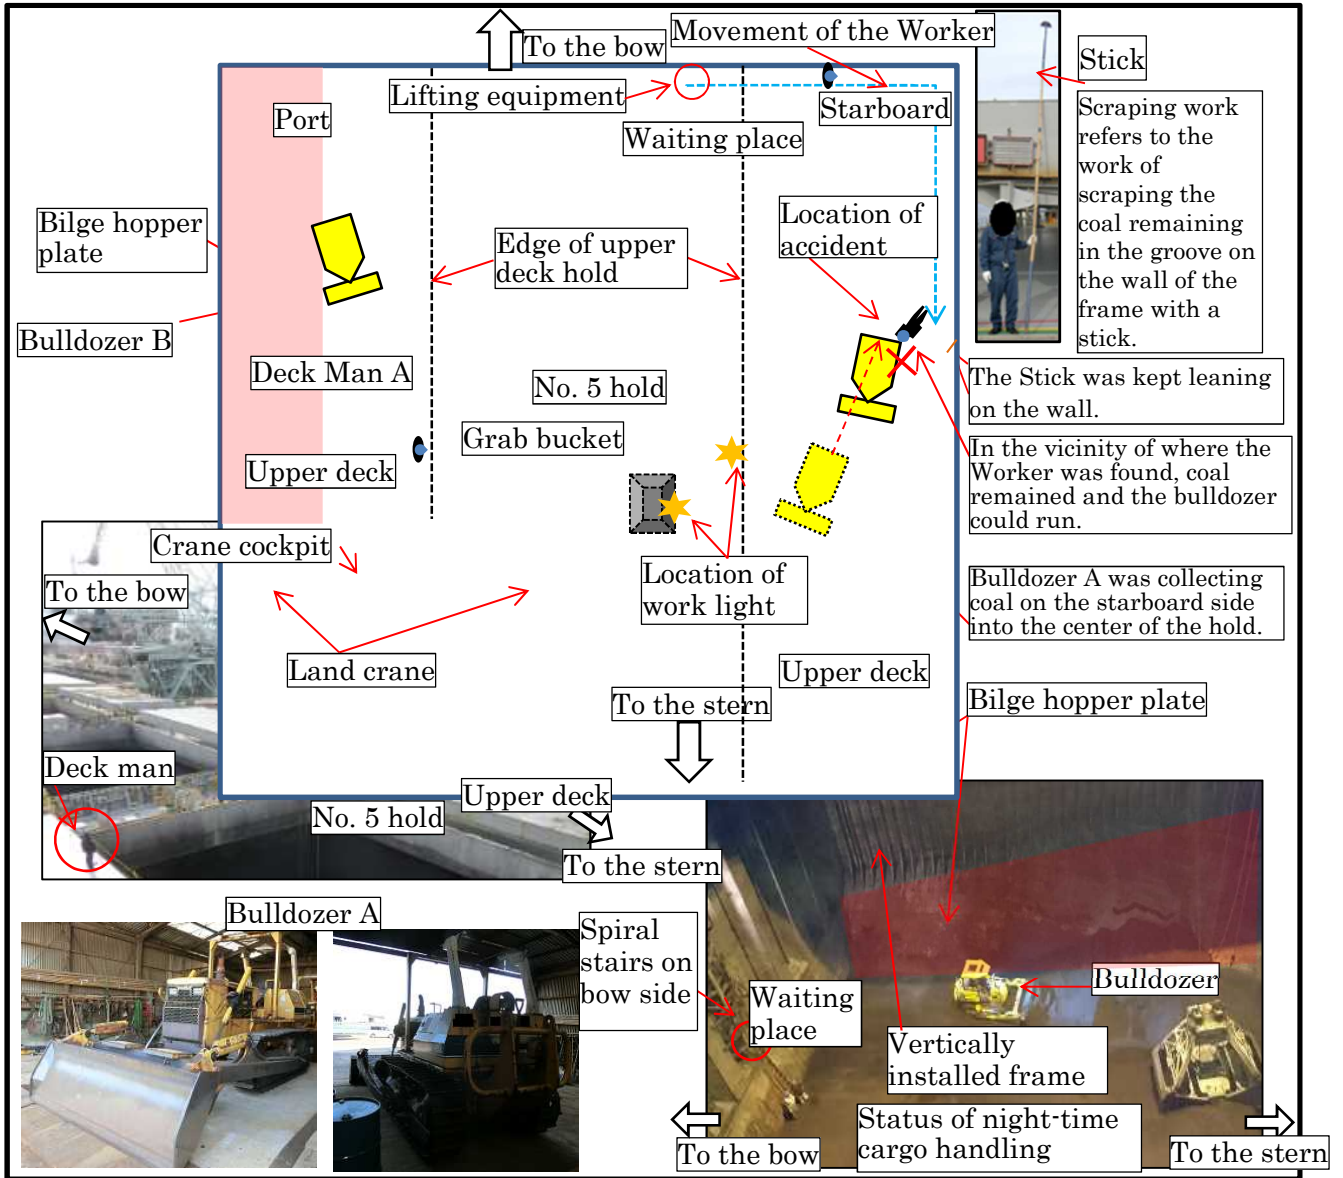
Figure 3 Situation of the accident occurrence (image)

It is highly probable that the Worker of Company A, while unloading coal in No. 5 hold at Niihama Port where the Vessel moored, was run over by Bulldozer A to death, when it was moving backward.

Although the Worker was instructed by Company A to keep out of the moving range of the bulldozer, it is highly probable that he moved from the waiting place to the center of the wall on the starboard side with a stick and was staying in the backward moving range of Bulldozer A.

When this accident occurred, the Worker was found with his head facing the interior of the hold and there remained the traces of him being run over, ranging from his helmet to the lower part of his body. Therefore, it is somewhat likely that he fell down and was hit during his work. However, since there were no witnesses, the situation could not be determined.

Although Operator A was instructed to carry out the work while checking the position of the Scraper, he did not acknowledge the signals from the Worker and Deck Man A at the time of this accident. And under the circumstances, it was probable that only the Scraper and two bulldozers were working in the hold, as a result of which he thought that the Worker was still in the waiting place and nobody was behind Bulldozer A, and the operator continued to move the Bulldozer backward in the vicinity of the wall on the starboard side without turning his face backward.

It is probable that Operator A did not notice the Worker in the rear.

<p>Safety actions</p>	<p>1. Measures taken by Company A after this fatal accident</p> <p>Company A has put together safety work procedures for the cargo-hold-work and has made the signals and actions of the Scraper and heavy equipment operators in the hold thoroughly well-known as well as it has taken measures for keeping the Scraper out of places where a danger of contact may arise between the Scraper and vehicle-type construction machinery in operation.</p> <p>(1) The Scraper must carry a whistle, and when moving in the hold, he must give a signal to the operator of bulldozer with the whistle to stop the bulldozer and thereafter move to the required position.</p> <p>(2) The operator of bulldozer, when acknowledging the signal of the Scraper, must stop the bulldozer and confirm the position of the Scraper.</p> <p>(3) While a bulldozer works in an area where two bulldozers can stay side by side (about 2.7 m x 2), the Scraper must not enter the space between the side wall and heavy equipment in operation.</p> <p>(4) The Scraper must wear a light-emitting vest so that the deck man and bulldozer operator can find his whereabouts easily.</p> <p>2. Accordingly, the implementation of the following measures would help to prevent recurrence of a similar accident, etc.:</p> <ul style="list-style-type: none"> • The deck man, as the chief of cargo handling officer onboard, must grasp the positional relationship between the Scraper and the bulldozer, and determine the method of work for preventing the Scraper from entering the moving range of the bulldozer, and make a command of the work directly. • Company A is required to conduct internal safety education on a regular basis, and make it well known that the Scraper must not enter the moving range of the bulldozer. • Every time the bulldozer moves backward, its operator is required to point at the position of the Scraper, and the bulldozer must not move backward before the position of the Scraper is confirmed. • If Company A finds it difficult for one deck man to monitor the cargo-hold-work, it is desirable to deploy another person in charge of monitoring the work or guiding the bulldozer. • It is desirable for Company A to have each worker carry a radio so that the deck man can quickly and easily contact the

<p>Scraper and the operator of bulldozer.</p> <ul style="list-style-type: none">• It is desirable for Company A to repair the defective part of bulldozer, and to equip the bulldozer with the facilities for checking the surroundings and for issuing an alarm when the Scraper approaches the bulldozer.
--	---

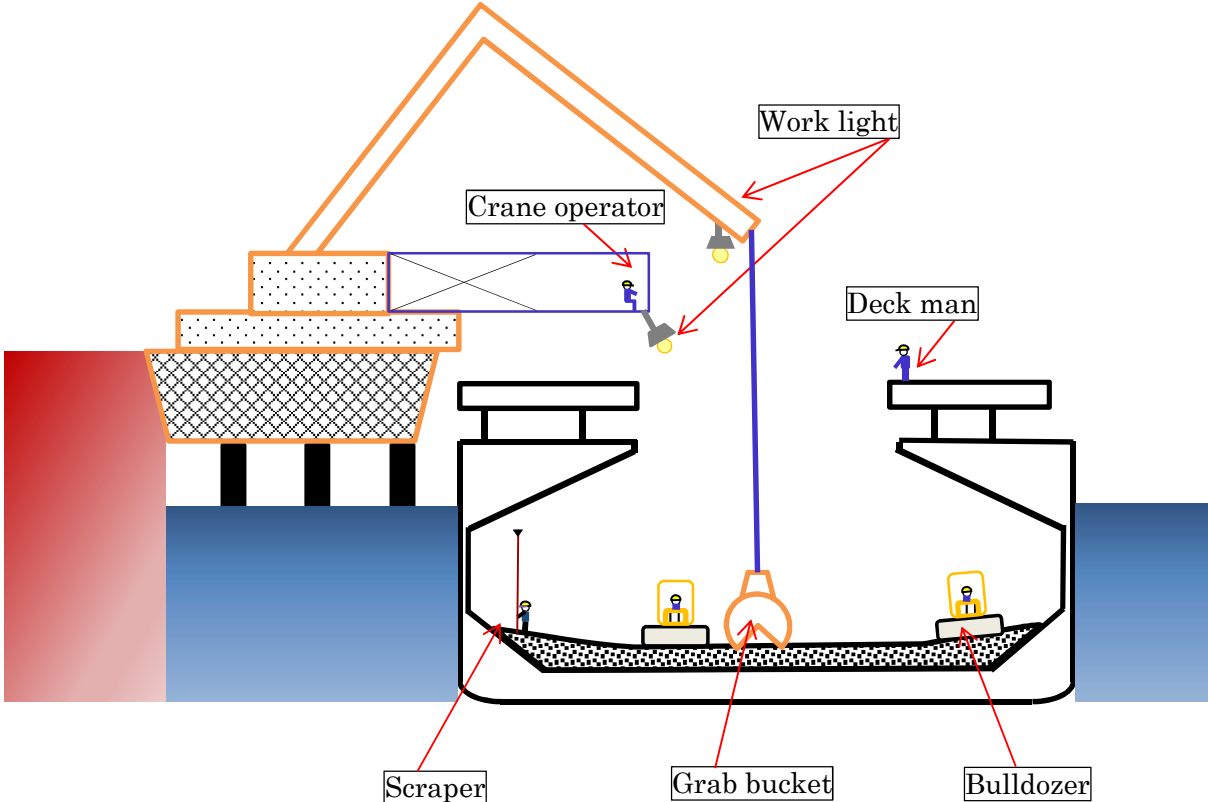
Figure 5 State of the cargo-hold-work (as seen from bow side)

<p>with a bulldozer in the hold.</p> <p>(2) Situation of the accident occurrence, etc.</p> <p>No one witnessed this accident.</p> <p>The Worker was wearing work clothes, a helmet, safety shoes, a dust-proof mask and a reflective vest as designated by Company A.</p> <p>With regard to the cargo-hold-work, Deck Man A heard from other workers about a contact accident occurring during work between a bulldozer and a grab bucket in another company, and so he was paying attention to contact between Bulldozer A and the grab bucket when this accident occurred.</p> <p>In Operator A's experience, when performing the cargo-hold-work with this Worker, he never failed to appear in a position which was easily visible from the bulldozer and he always gave a signal. Never did he work in dangerous situations, such as moving within the operating range of a bulldozer.</p> <p>While Operator A was working near the side wall, he never expected the Worker to move nearer to the wall concerned. He did not even notice that the Worker had been hit by Bulldozer A.</p> <p>After this accident occurred, there remained traces of being run over by the caterpillar of Bulldozer A upon the body of the Worker having fallen into the coal, ranging from his helmet to the lower part of his body, and the coal was also left on the bilge hopper plate.</p> <p>Inside the hold, brightness was sufficient for performing the cargo-hold-work with the work lights of the Vessel and the land crane.</p> <p>(Figure 1: Map of location of the accident, Figure 2: General arrangement, Figure 3: Situation of the accident occurrence (image), Figure 4: State of the land crane, Figure 5: State of the cargo-hold-work)</p>
