**MARINE ACCIDENT
INVESTIGATION REPORT**

Vessel type and name: Cargo ship CAPE VERDE

Vessel type and name: Fishing vessel MUNEYOSHI MARU

Accident type: Collision (Fishing gear)

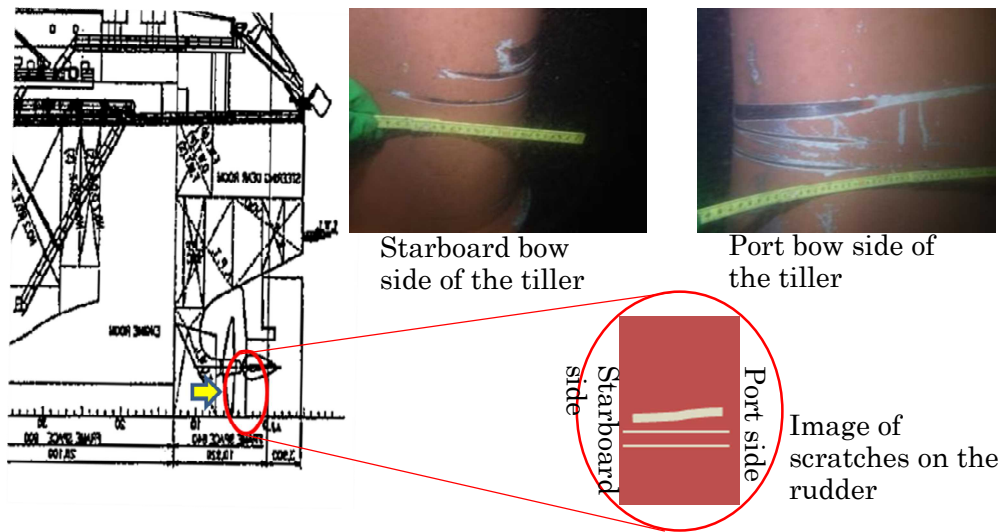
Figure 2.3-1 Scratches on the Rudder of Vessel A

- (1) Vessel A had scratches about 3 to 12 mm wide and about 6 cm long on the bow side of the rudder at a water depth of about 15.7 m.
- (2) On Vessel B, the fishing net tow rope on the starboard side broke and the main engine and other parts were damaged by sea water.

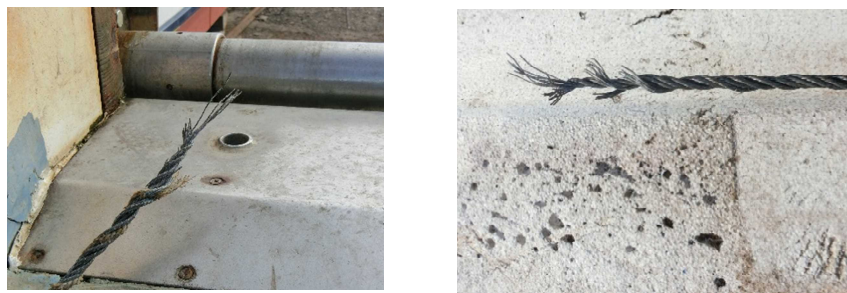
Photo 2.3-1 Broken Fishing Net Tow Rope of Vessel B

On Vessel B, the fishing net tow rope on the starboard side broke and the main engine and other parts were damaged by sea water. (See Figure 2.3-1 and Photo 2.3-1.)

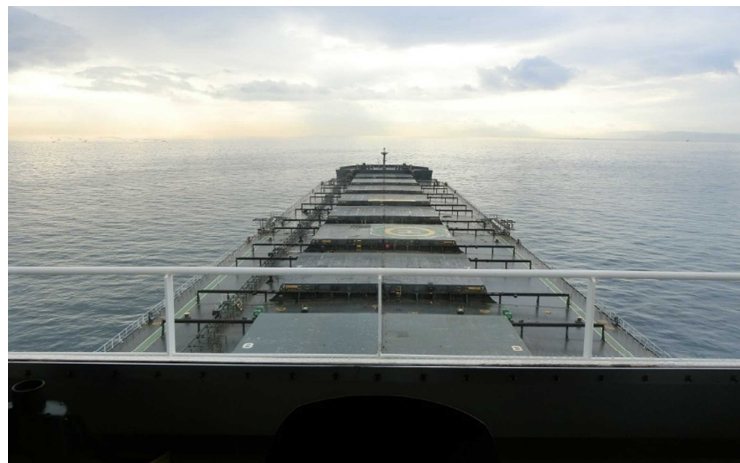
Photo 2.5-4 View from the Bridge of Vessel A

According to the visibility sketch of Vessel A, the tip of the bow to the sea surface, about 253 m ahead was blind in the draft at the time of the accident.

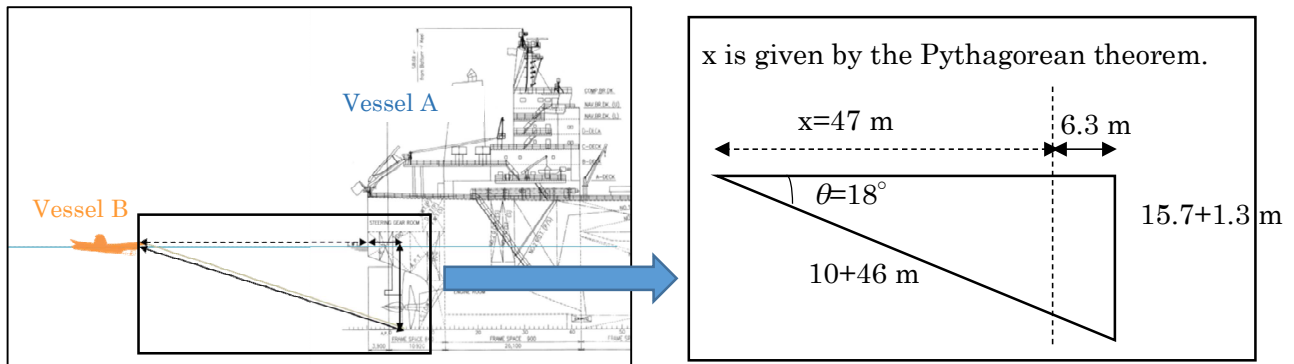
Figure 3.2 Analysis of Positional Relationship between Two Vessels at the Time of the Collision (Image)

[4] The rudder of Vessel A was installed at about 6.3 m from the stern end of Vessel A.

[5] The height from the sea level to the bulwark at the stern end of Vessel B was about 1.3 m.
