MA2021-4

**MARINE ACCIDENT
INVESTIGATION REPORT**

Vessel type and name: Cargo Ship AZUL CHALLENGE

Accident type: Grounding

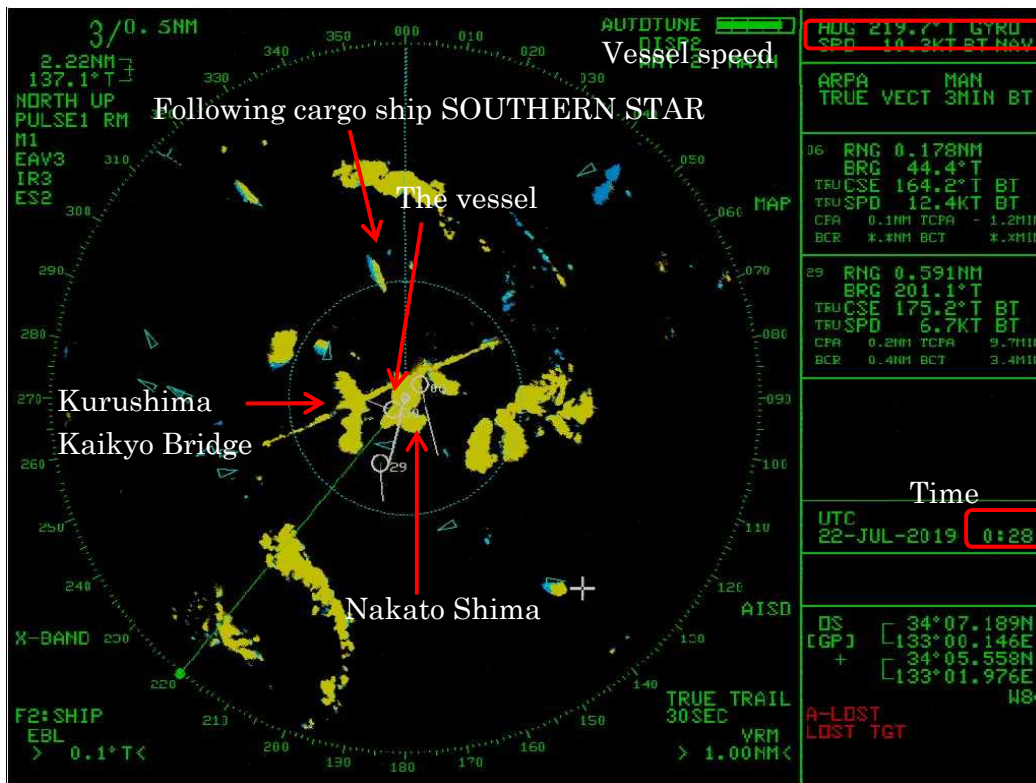
Figure 1 Radar Image (around 09:28)

Radar images are recorded as still images in the VDR every 15 seconds. Images of the following cargo ship SOUTHERN STAR (overall length of 199.9 m) navigating the Kurushima Kaikyo Traffic Route were recorded from around 09:21. (See Figure 1)

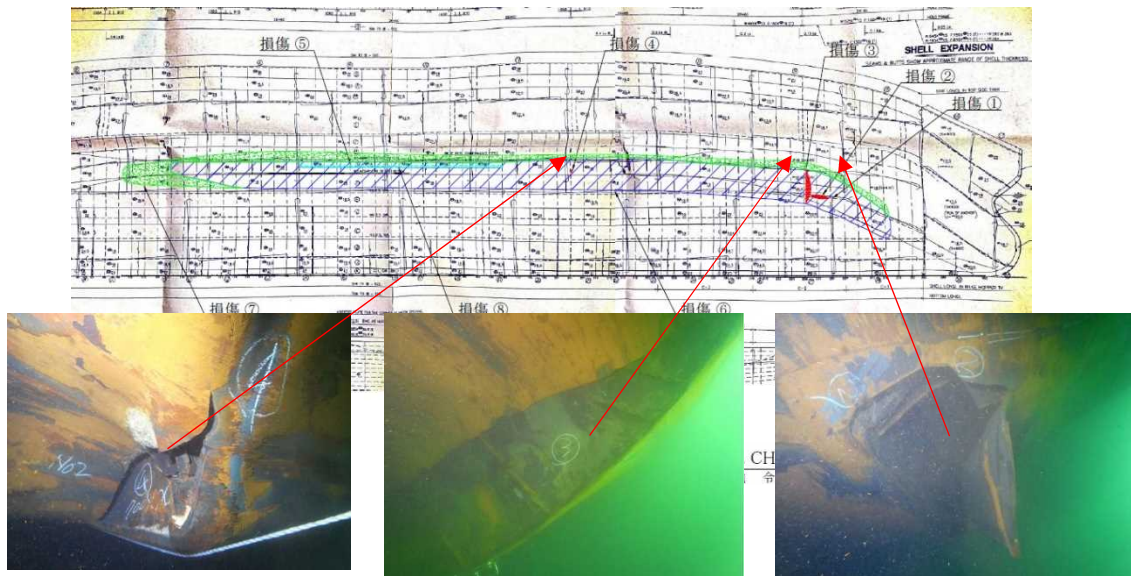
Figure 2 Underwater Investigation Report (Excerpt)

According to onsite investigations, the repair dock's damage plan, and reply to the questionnaire of Company A (underwater investigation report), the Vessel sustained dents to the port plating shell of ballast tanks No. 1 to 7, deformation of the port-side bilge keel, and holes to the ballast tanks' port plating shell in three places and consequently underwent plating shell replacement. (See Figure 2 and Figure 3)

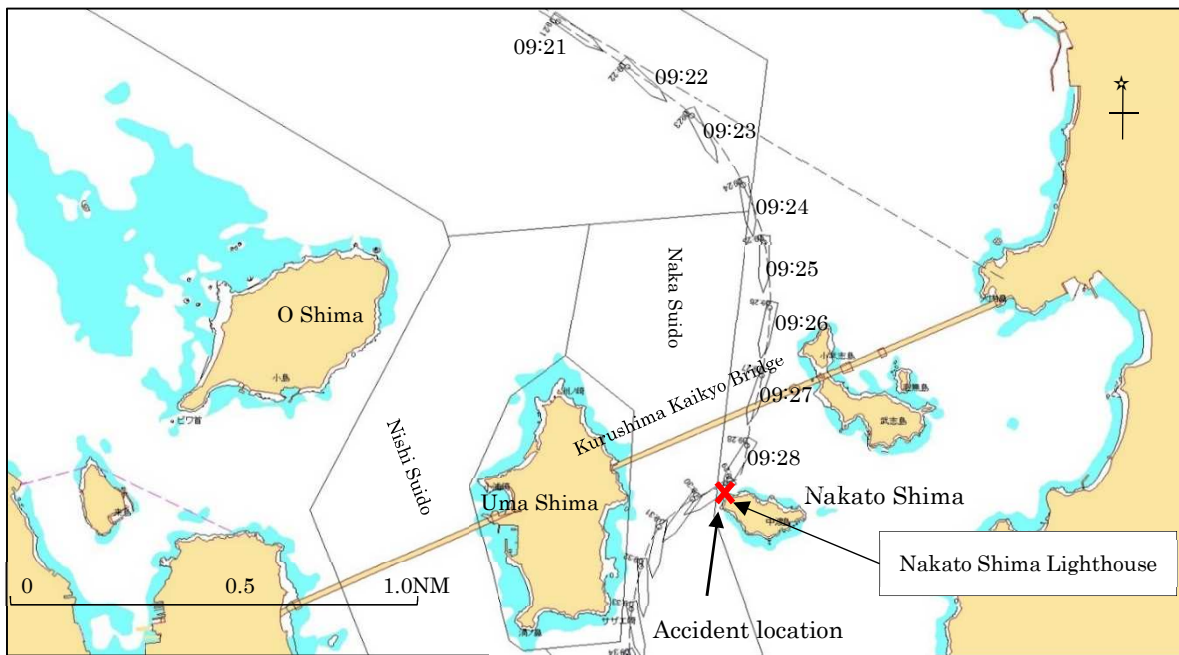
Attached Figure 2 Navigation Track (Around Kurushima Kaikyo)

Pilot A ordered the rudder set amidships and then hard to port to keep the Vessel's stern away from shallows to the west of Nakato Shima. However, immediately after Quartermaster A set the rudder hard to port, the Vessel's bottom ran aground on the west side of Nakato Island at around 09:28.

The date and time of occurrence of the accident was at around 09:28 on July 22, 2019, and the location was around 180 m at 017° true bearing from Nakato Shima Lighthouse.
