MA2022-06

**MARINE ACCIDENT
INVESTIGATION REPORT**

Vessel type and name: Container ship SITC BANGKOK

Vessel type and name: Container ship RESURGENCE

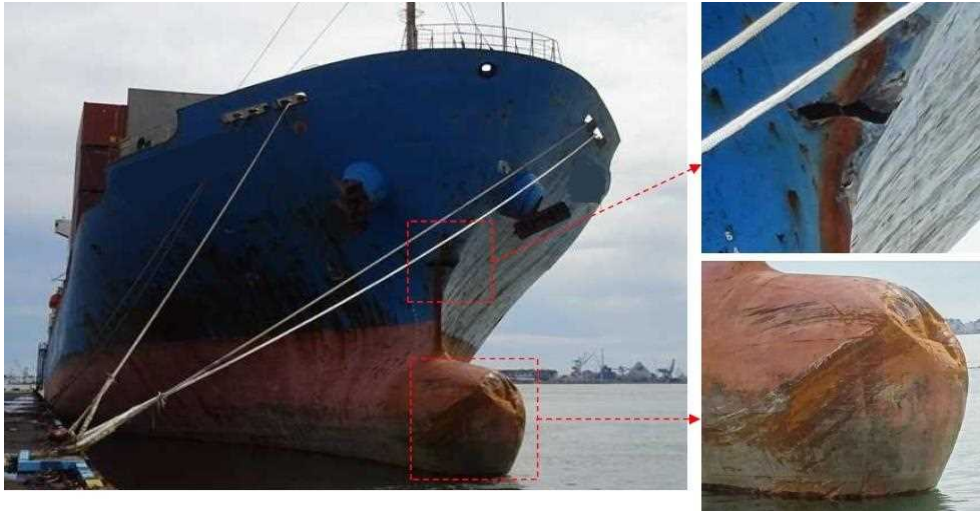
Photo 1 Status of Damage to Vessel A

SITC BANGKOK sustained a breach, etc. on the bow plating, and RESURGENCE sustained a dent on the starboard bow plating, but there were no casualties on either vessel.

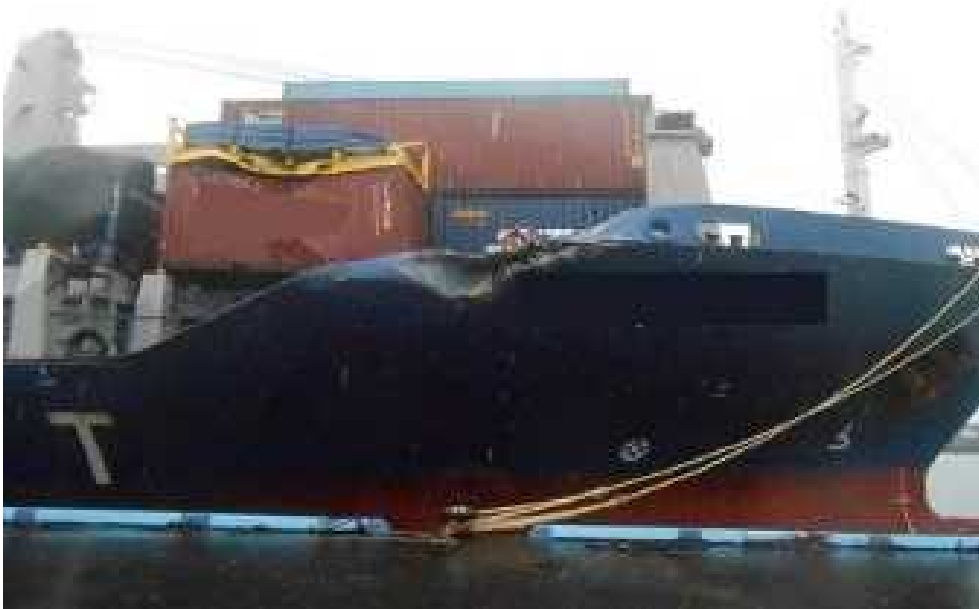
Photo 2 Status of Damage to Vessel B

(2) Vessel B sustained a dent on her starboard bow plating.
