MA2022-07

**MARINE ACCIDENT
INVESTIGATION REPORT**

| Summary of the Accident | The cargo vessel CHANG SHUN I adrift in the west channel of the Tsushima Strait with the main engine stopped. Since the main engine failed to start, the vessel was pushed by wind and waves and grounded on shallows on the north side of Mitsushima. The master of CHANG SHUN I was injured and the vessel sank after the hull was split into several blocks. |

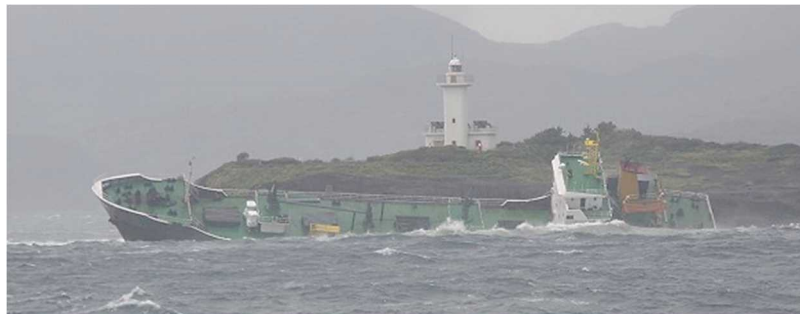
Photo 1: CHANG SHUN I (provided by the Japan Coast Guard)

At around 02:50, the vessel grounded on shallows on the north side of Mitsushima, Tsushima City, Nagasaki Prefecture. (See Photo 1)

After grounding, the vessel heeled to port side and the hull was split into several blocks and sank around 10:00 p.m. on September 14.

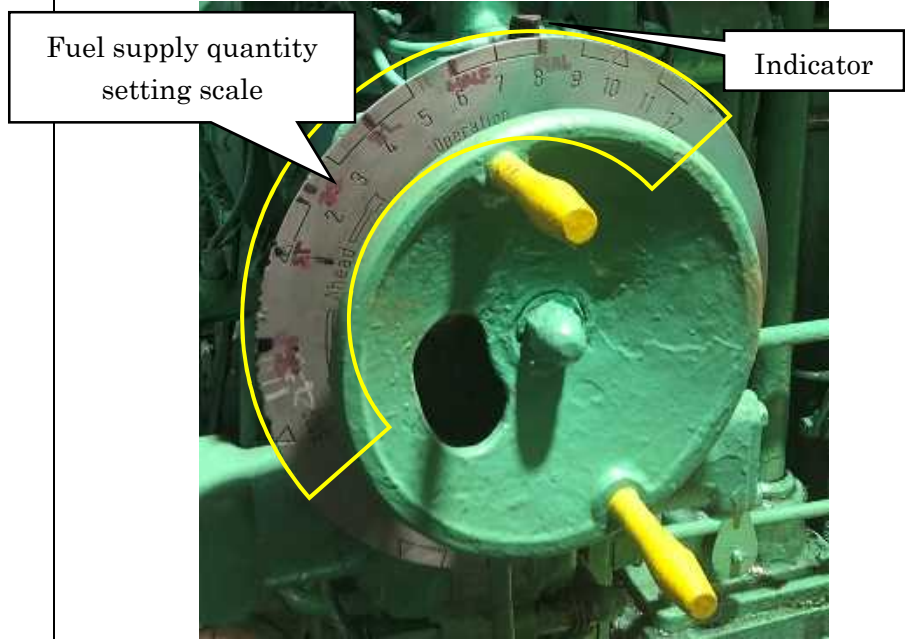
Photo 4: Governor

According to the statement of Chief Engineer, the main engine could not be started because the internal mechanism of the governor*¹ did not work in accordance with the fuel supply

quantity setting scale during the last attempt to restart the main engine before the accident, which caused a problem with the fuel supply.

| <p>Probable Causes</p> | <p>The cause of this accident is probable that the vessel with both anchors disabled, having left port at night for the purpose of avoiding the Typhoons, was unable to start the main engine while drifting in the west channel of the Tsushima Strait for the purpose of waiting to enter the Busan port, and was pushed southward by wind and waves, and then grounded on shallows on north side of Mitsushima.</p> <p>It is probable that the vessel left port with both anchors out of service because the vessel was unable to complete repairs to the starboard anchor chain and the port anchor brake due to the Typhoons approaching while having been moored at the Busan port.</p> <p>It is probable that the vessel's main engine did not start because the internal mechanism did not work according to the fuel supply volume setting scale of the governor.</p> |

| <p>Safety Actions</p> | <p>It is probable that the following measures will be useful in preventing the recurrence of similar accidents and reducing the damage:</p> <ul style="list-style-type: none"> (i) If the Master has no choice but to leave port with neither anchor in service in preparation for an approaching typhoon, etc., the Master should ensure that there is sufficient distance from islands and shallows when drifting in consideration of the fact that emergency anchoring to stop being pushed to the shore is not possible; (ii) When repairs of critical facilities essential for navigation, such as anchor equipment, of its managed vessel are carried out, it is necessary for Company A to obtain information on the typhoon well in advance and give instructions on whether to evacuate the vessel to the sea after recovery of critical facilities, or whether to provide other vessels for support or to dock the vessel; (iii) Company A should maintain a system to receive communications from the managed vessel at any time; and (iv) In the event that the main engine is unable to start and the vessel is pushed to shallows, the master should immediately notify the nearest SAR (Search and Rescue) organization of the occurrence to without delay. |

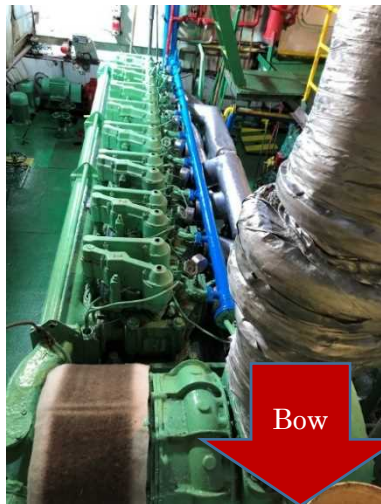
Photo 5: Main Engine(1)

At around 00:20 on September 12, the vessel's Chief Engineer and other members of the engine department attempted to start the main engine under the direction of the Master, but were unable to do so and the vessel began to be pushed southward by wind and waves.
