MA2024-7

# **MARINE ACCIDENT INVESTIGATION REPORT**

| <b>Accident Type</b> | Fatality of the Linesman |
| <b>Summary of Accident</b> | When the Container Ship DONGJIN FORTUNE with master and 16 crew members on board were during an operation of berthing on the Akaishi-10m berth with starboard side, a linesman who was working at the berth to connect the ship's mooring line to the bollard (hereinafter referred to as "mooring lines work") was seriously injured when he was hit by a mooring line bouncing up, and he had subsequently died. |

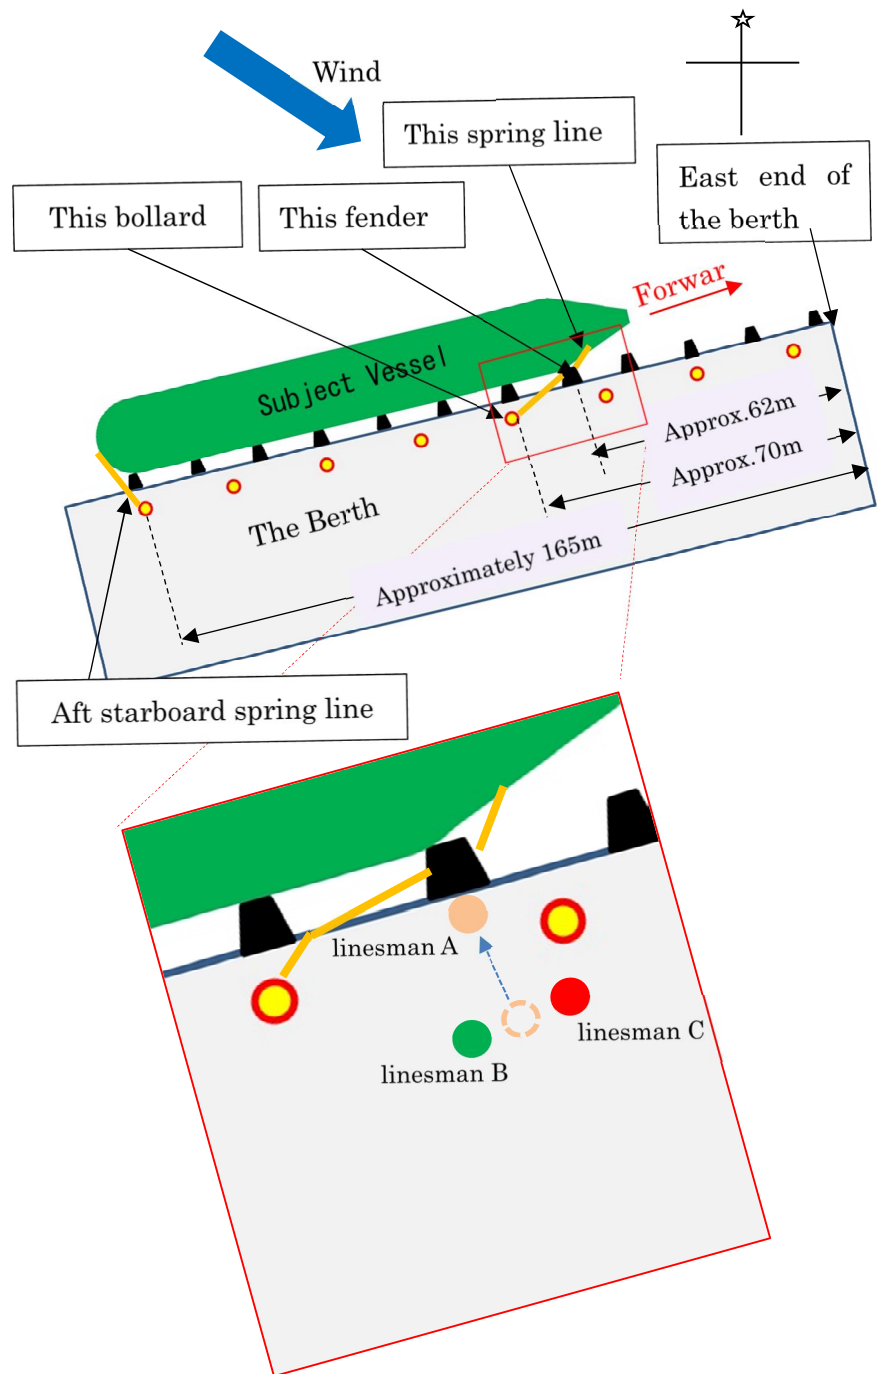
Figure 4 Situation of the berth of subject vessel

spring line, and the 3 linesmen of stern side connected the eye (ring) part at the end of the aft starboard spring line to the 8th bollard located from approximately 165 meters west of the east end of the berth. After that, starboard side of the vessel was arrived ashore parallelly to the berth by using the bow thruster and one tugboat. At that time, since the vessel arrived ashore before keeping tension of this spring line, this spring line was kept slack, and it passed through below the fifth rubber fender (hereinafter referred to as "this fender") from the east end of the berth. The starboard shell plate of the subject vessel was contacted with this fender, and this spring line passed through below the contacted part. (See Figure 4.)

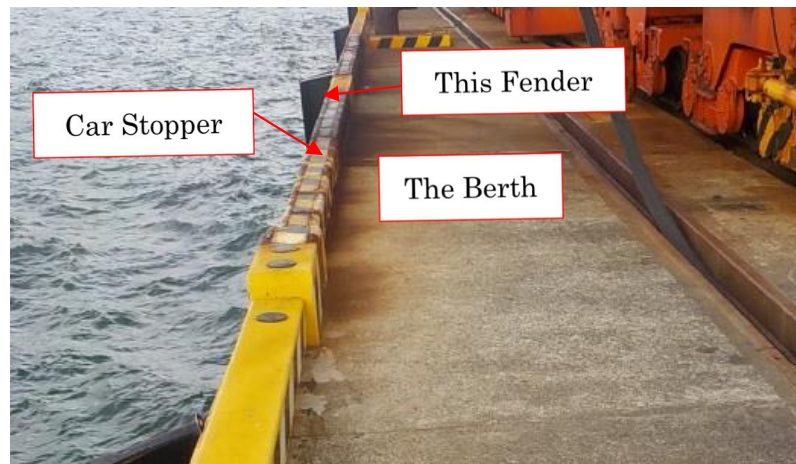
Picture 2 The dock and this fender

This fender was made a solid rubber<sup>\*7</sup>, and it was V-shape. The vertical length of the fender which was attached to the berth was approximately 1.3m, and the height from the mounting bottom which was fitted to the berth to the protruding part toward the sea was approximately 0.6 m. The upper and lower end portions that were contacted to the upper edge of the berth were tapered<sup>\*8</sup> with respect to the contact surface that contacts the shell plate of the vessel, and it was trapezoidal when viewed from the side.

The 12 fenders were installed at approximately 15.5m intervals at the berth. This fender was installed approximately 62 meters away from the east end of the berth, and it was 5th fender from the west. (See Figure 6 and Picture 2)

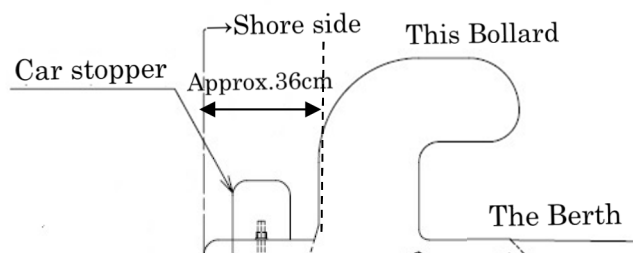
Figure 7 This Bollard

This bollard was cylindrical type made by steel which was the diameter of approximately 32 cm, end of this bollard was bent approximately 90 degrees toward the shore, and the maximum allowable load was approximately 500 kN.

This bollard was located approximately 36 cm on the shore side from the edge of the berth which the car stopper approximately 20 cm wide and 20 cm high was fitted. (See Figure 7.)

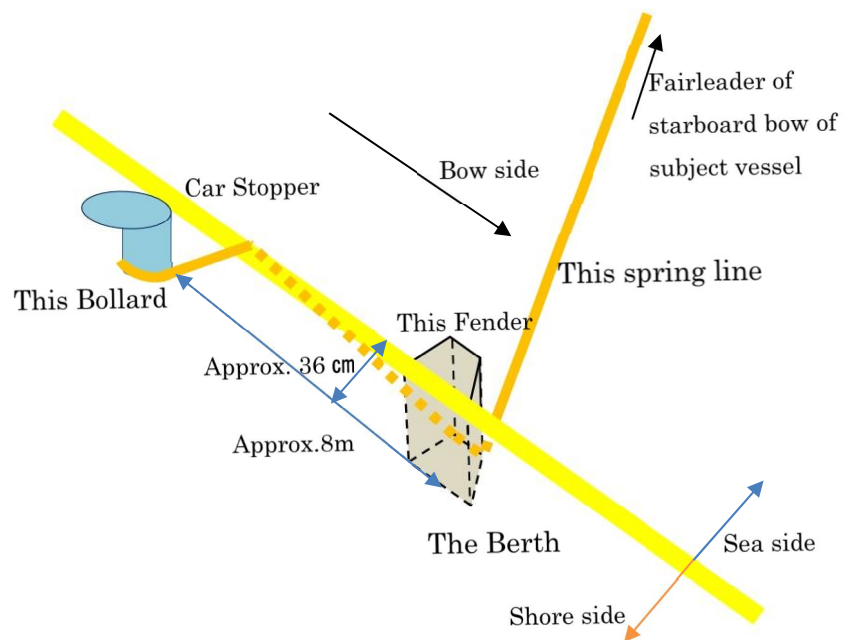
Figure 8 The status of this spring line before this accident  
(Image)

This spring line was connected with this bollard, and then, the starboard of subject vessel was berthed to the berth before this spring line was received the tension. Since starboard shell plate contacted with this fender, it is probably that this spring line passed below lower end of this fender which was located approximately 1.3 m below the upper edge of the berth located upper end of this fender.

This spring line caught on the underside of this fender and it was pulled to downward direction. Furthermore, since this bollard was also located approximately 36cm shore side from end of the berth, it is probably that this spring line was bent towards the shore side by the car stopper which was approximately 20cm width and approximately 20cm height.(See Figure 8)

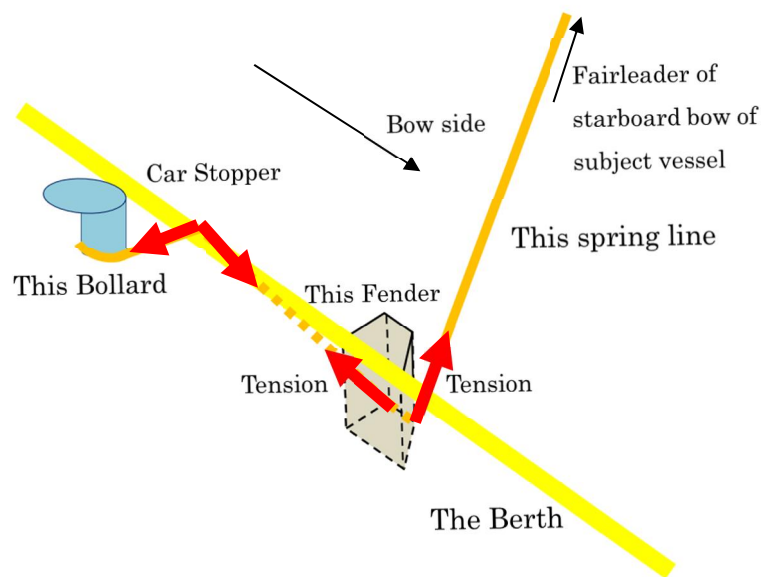
Figure 9 The energy was stored to this spring line before accident  
(Image)

Since subject vessel was moved forward in order to adjust the position of the berthing, this spring line made by synthetic fiber was pulled to bow side and increased tension slowly. After that, this spring line caught on the underside of this fender which was located approximately 1.3 m below the upper edge of the berth located upper end of this fender, and it was more increased the tension. It is probably that energy was stored which was attributed to the elasticity of the synthetic fiber of this spring line, because the strong tension was applied to both direction of subject vessel side and the berth side. (See Figure 9)

This spring line came off from below of this fender when this spring line receiving the tension was applied to both direction of fairleader side of starboard bow of subject vessel and the berth side by point of origin from bottom of this fender. Therefore, it is probably that stored energy was released immediately and this spring line was bounced up.

Although this fender was contacted with starboard shell plate of subject vessel, this section of the starboard shell plate was water cutting section and the starboard of subject vessel which had angle and inclination was contacted with this fender. Therefore, when subject vessel was moved forward, the starboard shell plate of subject vessel got away from this fender and created a gap between the starboard shell plate and this fender. In this regard, it is probably that this spring line was

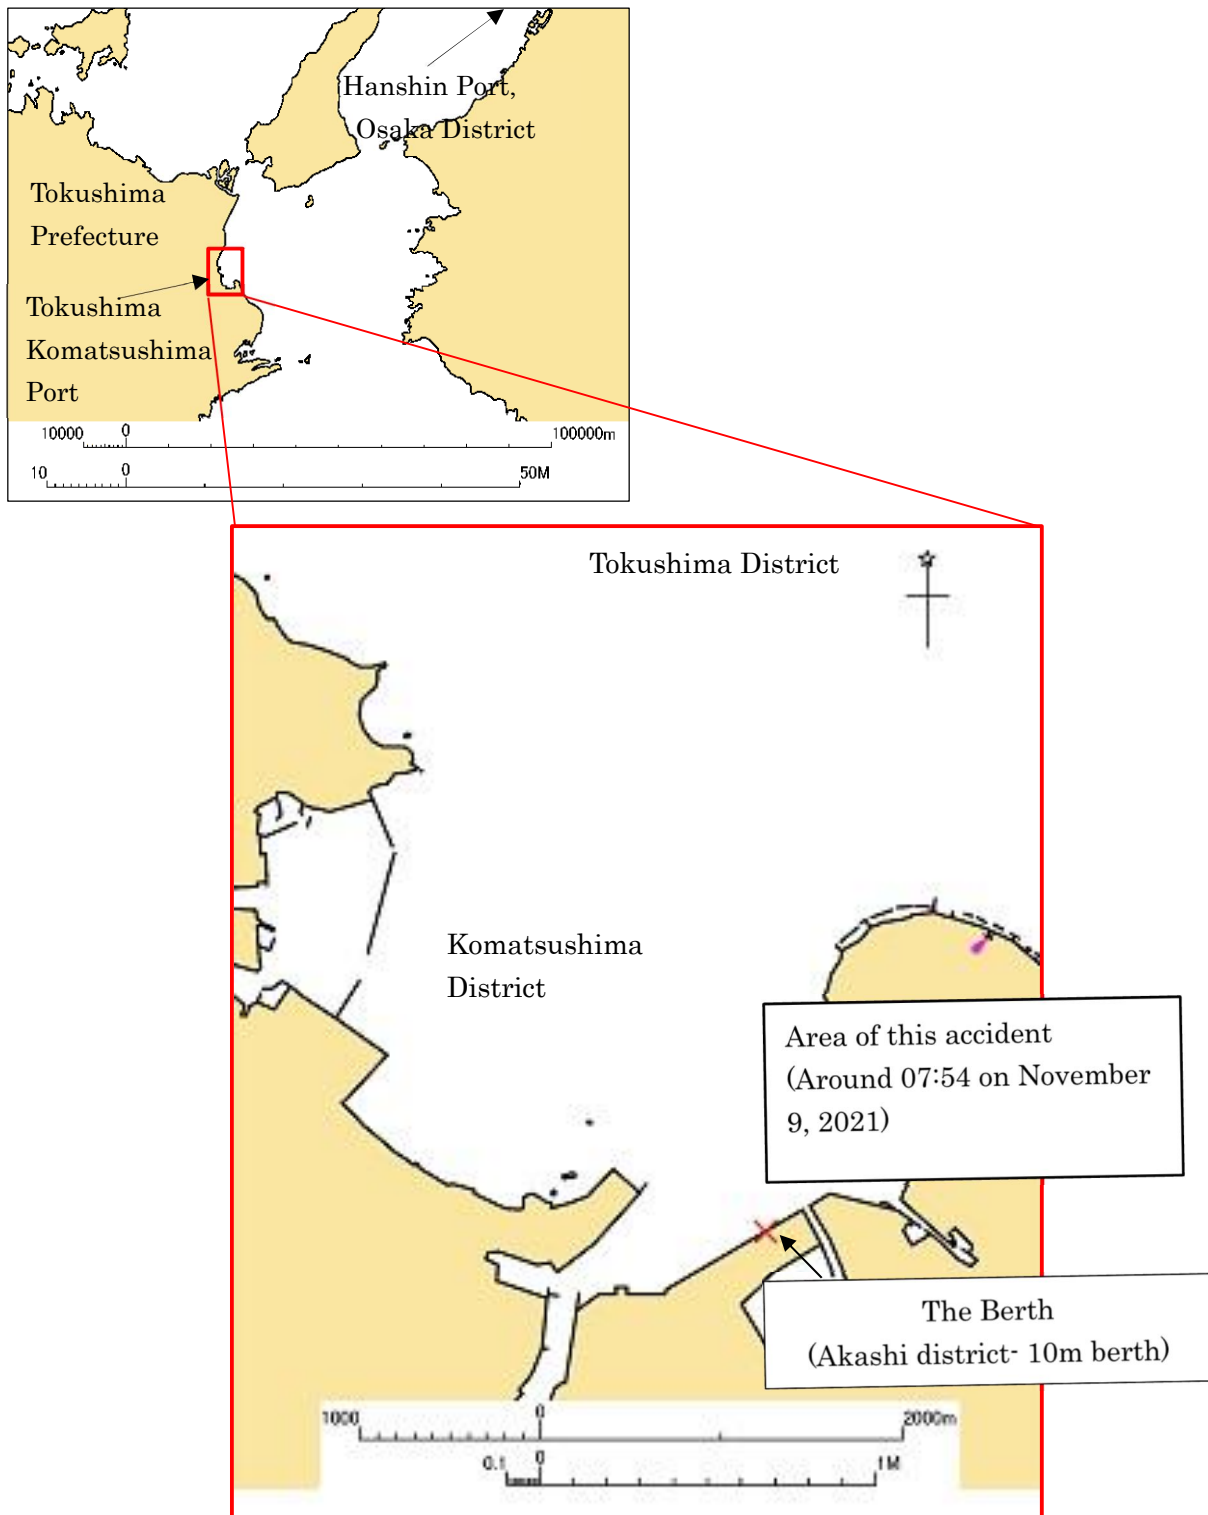
## Appendix 1 Schematic view of accident location

| | <p>At around 07:52, under the situation where the starboard shell plate of subject vessel was pressed against each fender due to the wind coming from the west-north-west, and the vessel used main engine and moved to forward (east) side in order to meet the location of the cargo handling equipment on shore side. At that time, the starboard shell plate of subject vessel was pressed against each fender strongly, and shell plate was friction to the fenders, and it was caused to rise smoke when the ship was moved.</p> <p>The linesman A, linesman B and linesman C were waiting for the next mooring line to be sent near this fender after connecting this spring line to this bollard. The tension of this spring line was increasing when the vessel was moving (to the east), and the tension of this spring line was more increasing due to catch on the underside of this fender.</p> <p>When this spring line was receiving tension, linesman A saw obliquely downward from near the upper edge of the berth where the fenders were installed. At that moment, this spring line which were receiving the tension came off from underside of this fender, and it bounced up and hit to linesman A's head.</p> <p>The linesman A was carried to the hospital in the Komatsushima city. Although he was hospitalization and he was serious condition of unconscious and continued to treat, he died at around 18:11 on 12 November, 2021. The cause of death was determined as cervical spinal cord injury, diffuse brain injury and fractures of the skull, facial bones and rib. (Appendix 1 Schematic view of accident location, Table 1 AIS Record (excerpt))</p> |
