MA2024-03

**MARINE ACCIDENT  
INVESTIGATION REPORT**

<b>Accident type</b>	Grounding
<b>Date and time</b>	Around 09:20 on January 24, 2023
<b>Location</b>	Off the northwest of Taketomi Island, Taketomi Town, Okinawa Prefecture Around 268° true bearing, 3.8 nautical miles (M) from Ryukyu Kannonzaki Lighthouse (Approx. 24°21.8'N 124°02.6'E)
<b>Summary of the Accident</b>	The cargo ship XIN HAI ZHOU 2 was drifting for the purpose of time adjustment off the west of Ishigaki Island, Ishigaki City, Okinawa Prefecture, when she was pushed by the wind and waves. She therefore started her main engine and navigation; however, she continued to be pushed without gaining sufficient propulsion or rudder effect and ran aground on a shallow reef off the northwest of Taketomi Island. XIN HAI ZHOU 2's hull subsequently broke in two at her center section.
<b>Process and Progress of the Investigation</b>	The Japan Transport Safety Board appointed an investigator-in-charge and two other marine accident investigators to investigate this accident on January 24, 2023. January 26 and 27, 2023: Interviews January 28, 2023: On-site investigation February 1, 7 to 9, 14, and 15; March 3 and 31; April 19 and 2

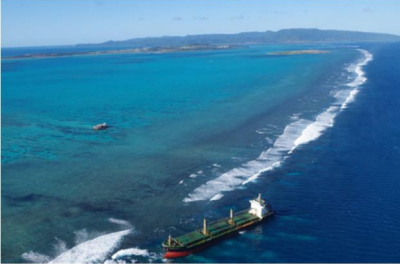
<p>Courtesy of the salvage company</p> <p>Photo 2</p> <p>The Situation After the Vessel's Grounding (January 26, 2023)</p> </div> <div data-bbox="1051 1048 1406 1317">

The Vessel remained grounded at the accident location with her heading east-southeast. With a portion of her cargo leaking out from a hole in her port-side shell plating, the salvage company began work to remove her hull and cargo and to recover her leaked cargo, etc., on July 13. However, the Vessel's hull broke into two at her No. 3 hold when Typhoon No. 6 (Khanun) approached the accident location on August 4.

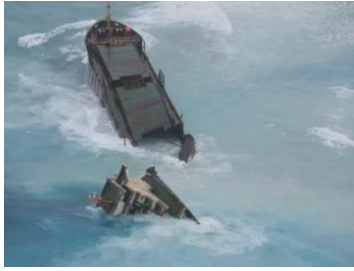
<p>Courtesy of Japan Coast Guard</p> <p>Photo 3</p> <p>The Situation After the Vessel's Grounding (August 4, 2023)</p> </div> </div>

The Vessel's entire cargo leaked into the ocean as a result of the breakage of her hull. The hull's rear portion collapsed with an inclination of approximately 65° to port.

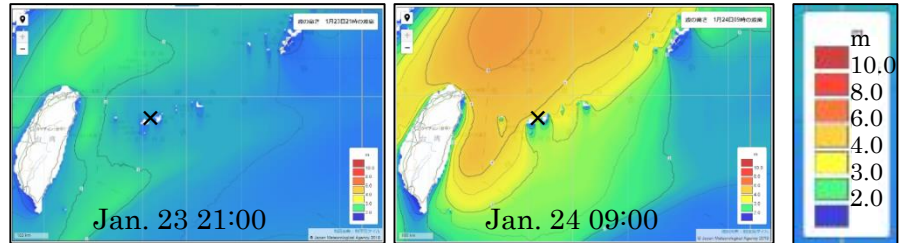
Figure 2 Coastal Wave Analysis Chart

(4) According to the coastal wave analysis chart, significant wave heights in the sea area near the location of the accident were under 2 meters at 21:00 on January 23 and between approximately 2 and 3 meters at 09:00 on January 24. (See Figure 2 and Annex Figure 2 Coastal Wave Analysis Chart)

\*The X indicates the vicinity of the accident location.

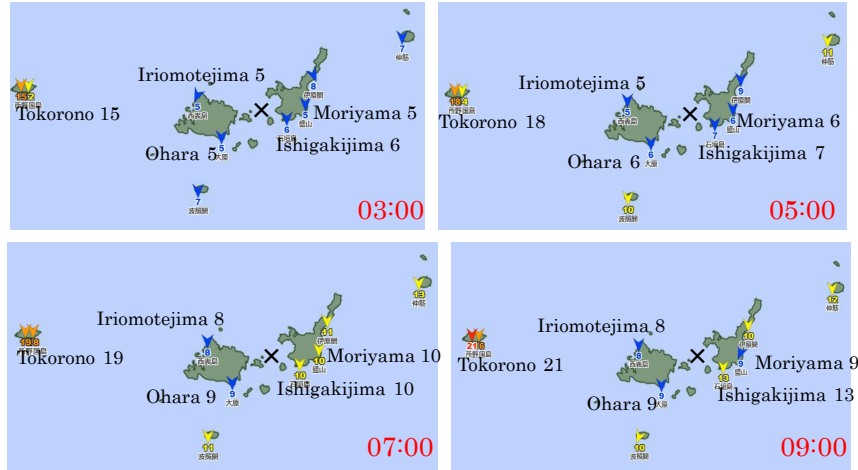
Figure 3 AMeDAS Analysis Charts  
(Wind Direction and Wind Speed)

At 00:00 on January 24, wind speeds at the observation points of Ishigaki Island, Iriomote Island, and Yonaguni Island were under 10 m/s. However, at 03:00, a northerly wind of 15 m/s was observed at the Tokorono Meteorological Observation Station on Yonaguni Island, located approximately 59 M west of the accident site. The

wind subsequently gained intensity at Iriomote Island and Ishigaki Island as well, and at 09:00, the wind speed was 13 m/s at Ishigakijima Meteorological Observation Station, located approximately 6.8 M east-southeast of the accident site. (See Figure 3 and Annex Figure 3 AMeDAS Observations)

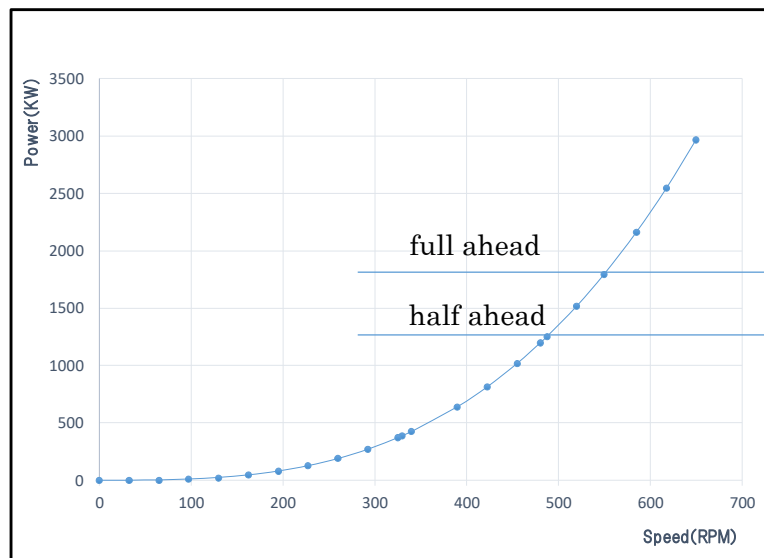
Figure 4 Speed-Power Curve of the Vessel’s Main Engine

The Vessel’s speed-power curve obtained from the maximum continuous output of the Vessel’s main engine (2,970 kW, 650 rpm; hereinafter referred to as “MCR”) and marine engine characteristics (diesel engine output proportional to the cube of revolutions) is as shown in Figure 4. According to the speed-power curve and the Vessel’s speed table, as shown in Table 2, at the time of the accident, the Vessel was operating at 480 rpm with her main engine set at half ahead and at approximately 40% of her output relative to the MCR.

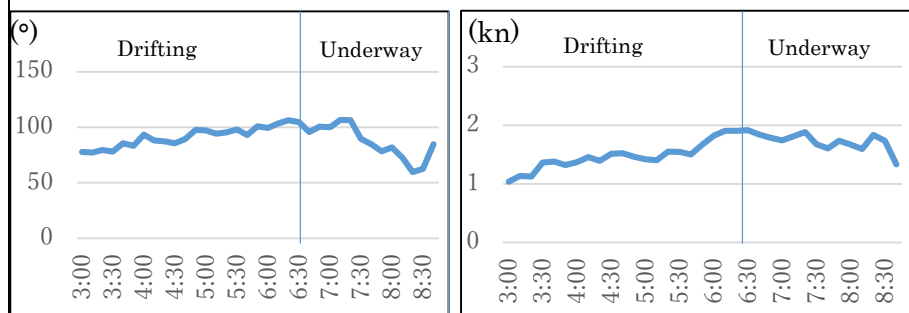
Figure 5 Angle of Pushing (to Starboard)

According to the Vessel's AIS record, the angle of pushing by the wind and waves (direction of course over the ground relative to heading) and speed over the ground from 03:00, when the Vessel was drifting with her main engine stopped, was as shown in Figure 5 and Figure 6. Even after the main engine was started after 06:30, the Vessel was being pushed in the direction of 60-100° to starboard at a speed of approximately 1 to 2 kn.

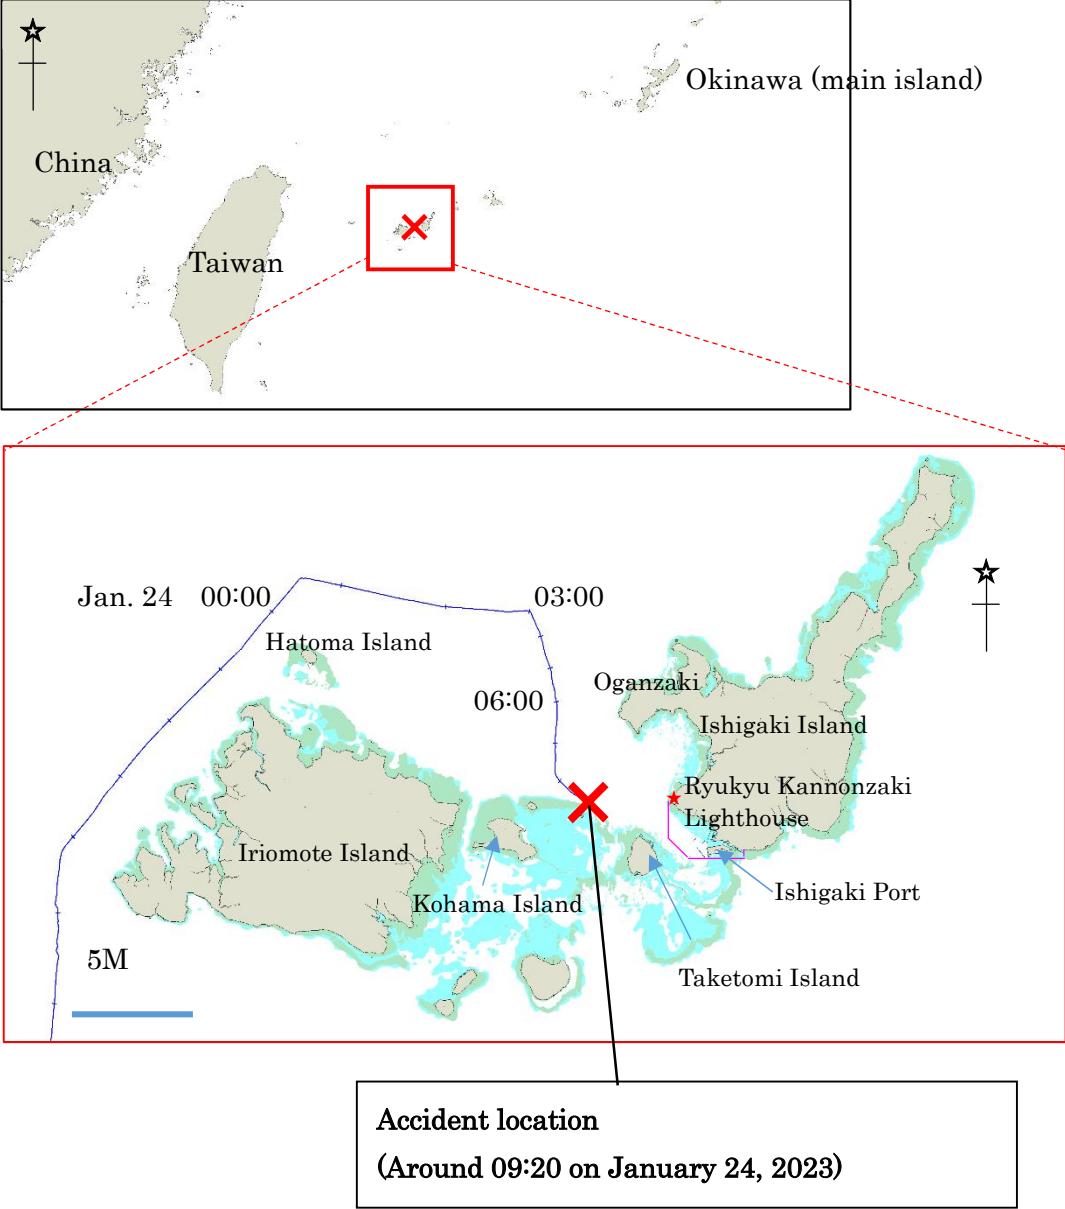
Annex Figure 4 Estimated Navigation Route

(approximately 8 M north of “shallow reef between Ishigaki Island and Iriomote Island” [hereinafter referred to as “the Shallow Reef”]) and began drifting with her heading to east-northeast. There were no other vessels in the Vessel’s vicinity from the time that she began drifting.

According to the Vessel’s AIS record, the Vessel’s heading was pointed east-northeast and she was being pushed south-southeast at a speed of approximately 1 to 2 kn from 03:00.

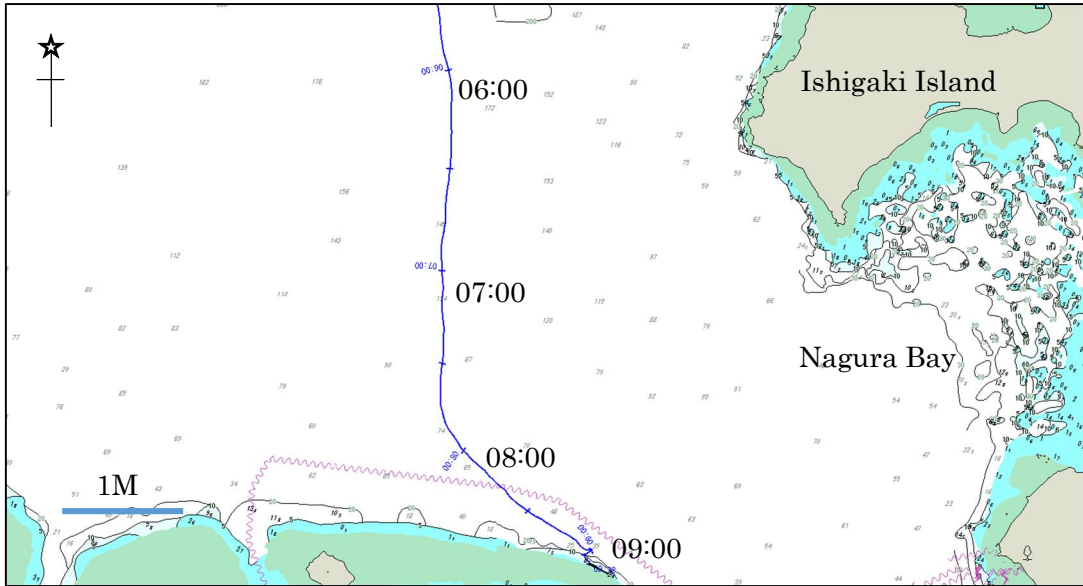
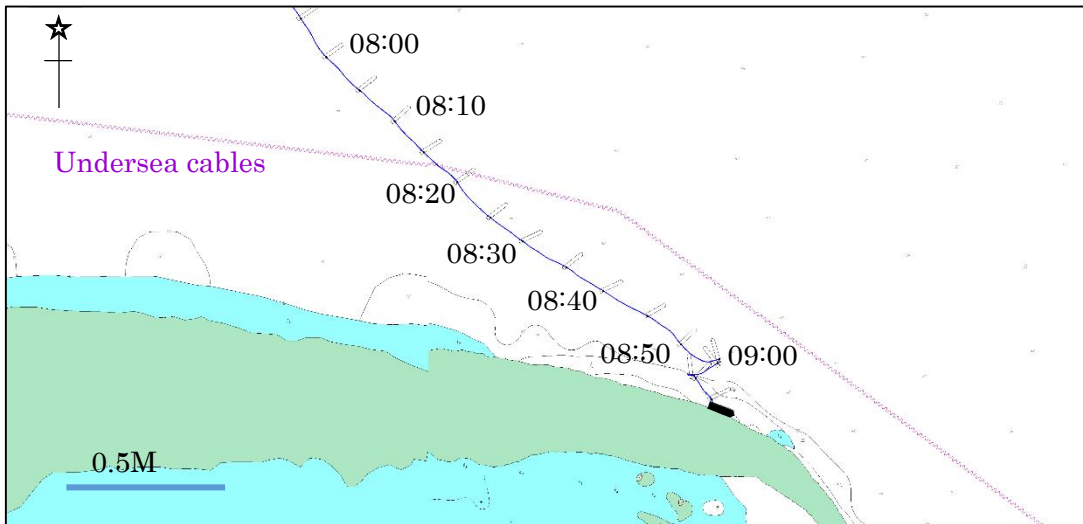
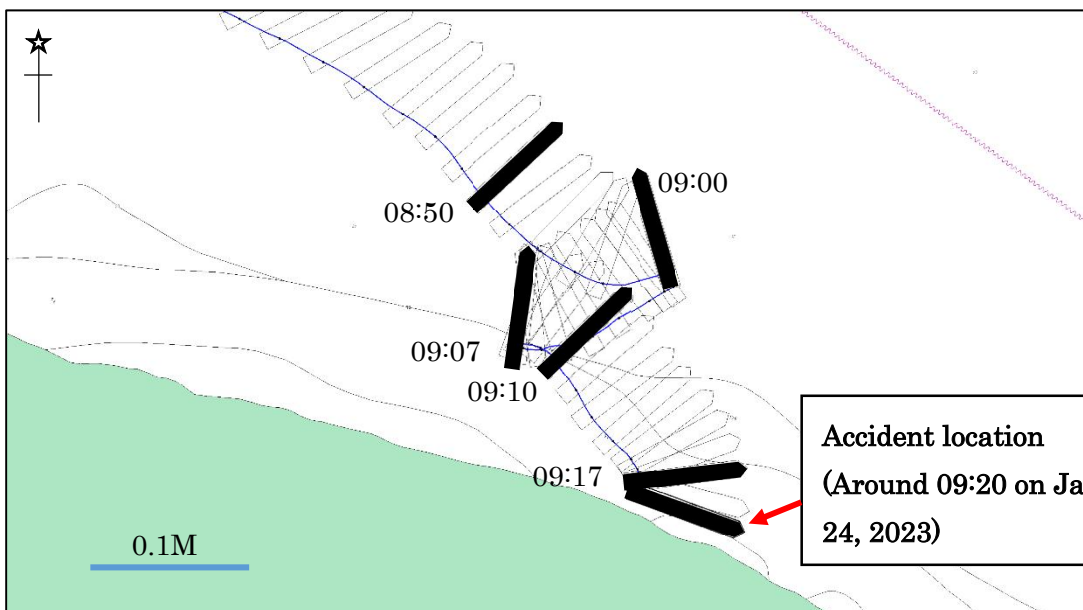
Annex Figure 5 Estimated Navigation Route (Enlarged)

Officer A observed that the wind and waves, whose effects on the Vessel were not particularly felt when he came to the bridge, were gradually gaining strength and that the Vessel’s distance to the Shallow Reef had become approximately 3 to 4 M. He therefore thought the main engine would be needed soon, and, at around 06:00, he ordered the engineer on engine room watch (hereinafter referred to as “Engineer A”) to start the main engine and asked the Master, who was resting in his cabin, to come to the bridge.
