MARINE ACCIDENT INVESTIGATION REPORT

Vessel Type and Name: Roll-on/roll-off cargo vessel Byakko

Vessel Type and Name: Chemical tanker ULSAN PIONEER

Accident Type: Collision

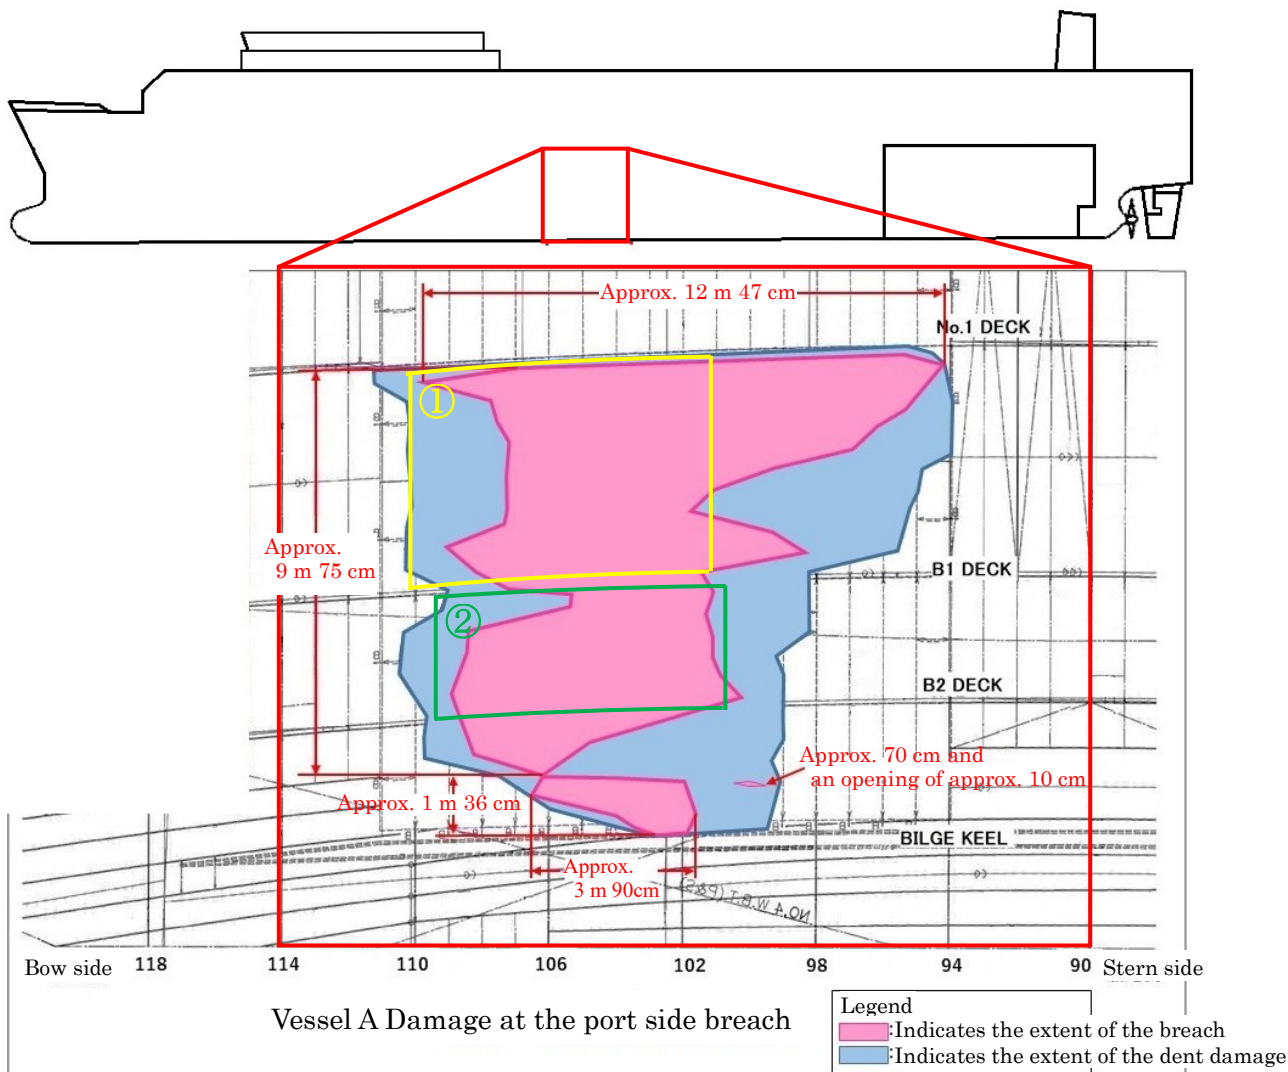
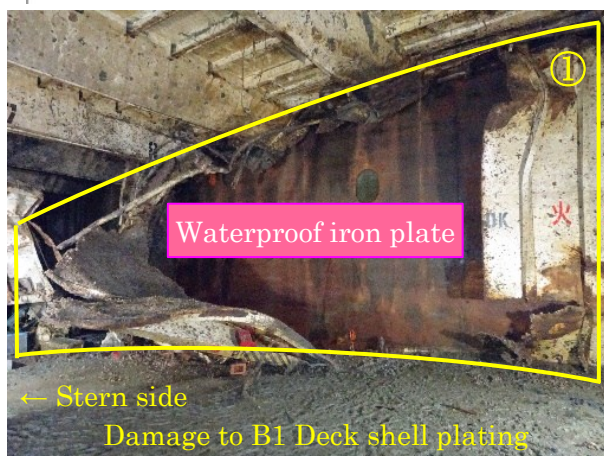
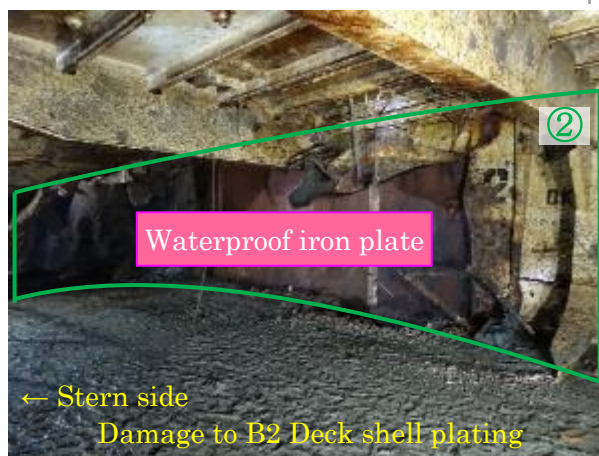
Figure 16 Damage to the deck shell plating of Vessel A

Byakko sustained a breach midship along its port side and subsequently foundered. The Master and two crew members lost their lives, and five others were injured. ULSAN PIONEER experienced damage, with its bow severely crushed and bulbous bow bent; however, no fatalities or injuries occurred on board.

Photograph shows the port side shell plating from the inside
(Waterproof plates are installed at the time of salvage construction)

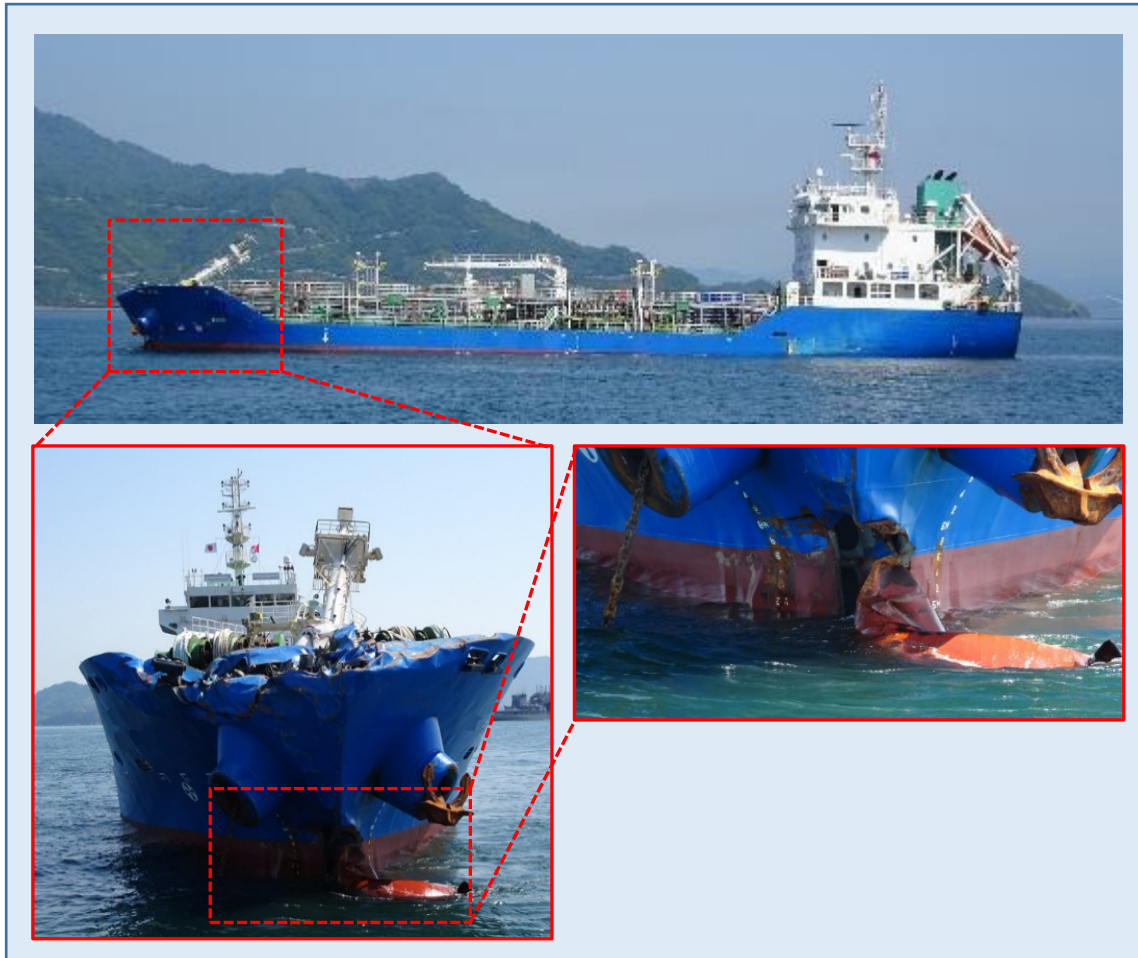
Photo 3 Damage to Vessel B

Vessel B sustained crushing damage to the bow (including the collapse of the fore mast and the light) and bending damage to the bulbous bow. (see Photo 3)

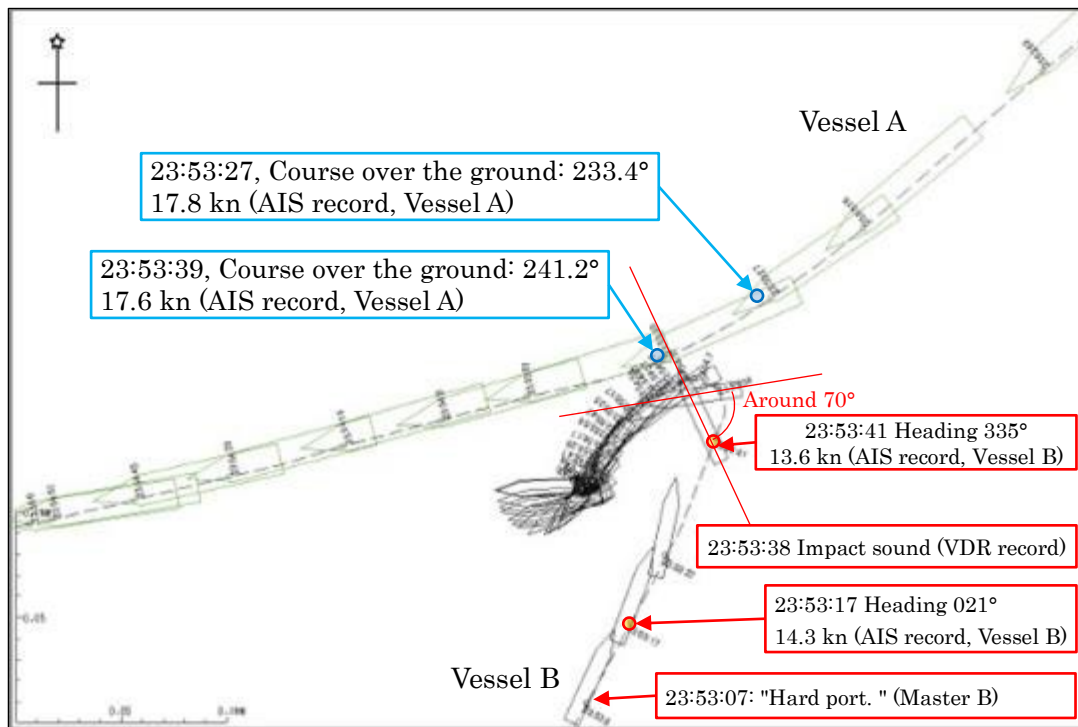
Figure 25 Collision situation of Vessel A and Vessel B

The JTSB concludes that, based on Sections 2.7, 3.1.1, and Figure 25, it is probable that Vessel A was navigating at approximately 17.6 kn and Vessel B at approximately 13.6 kn when the center of the port side of Vessel A collided with the bow of Vessel B.

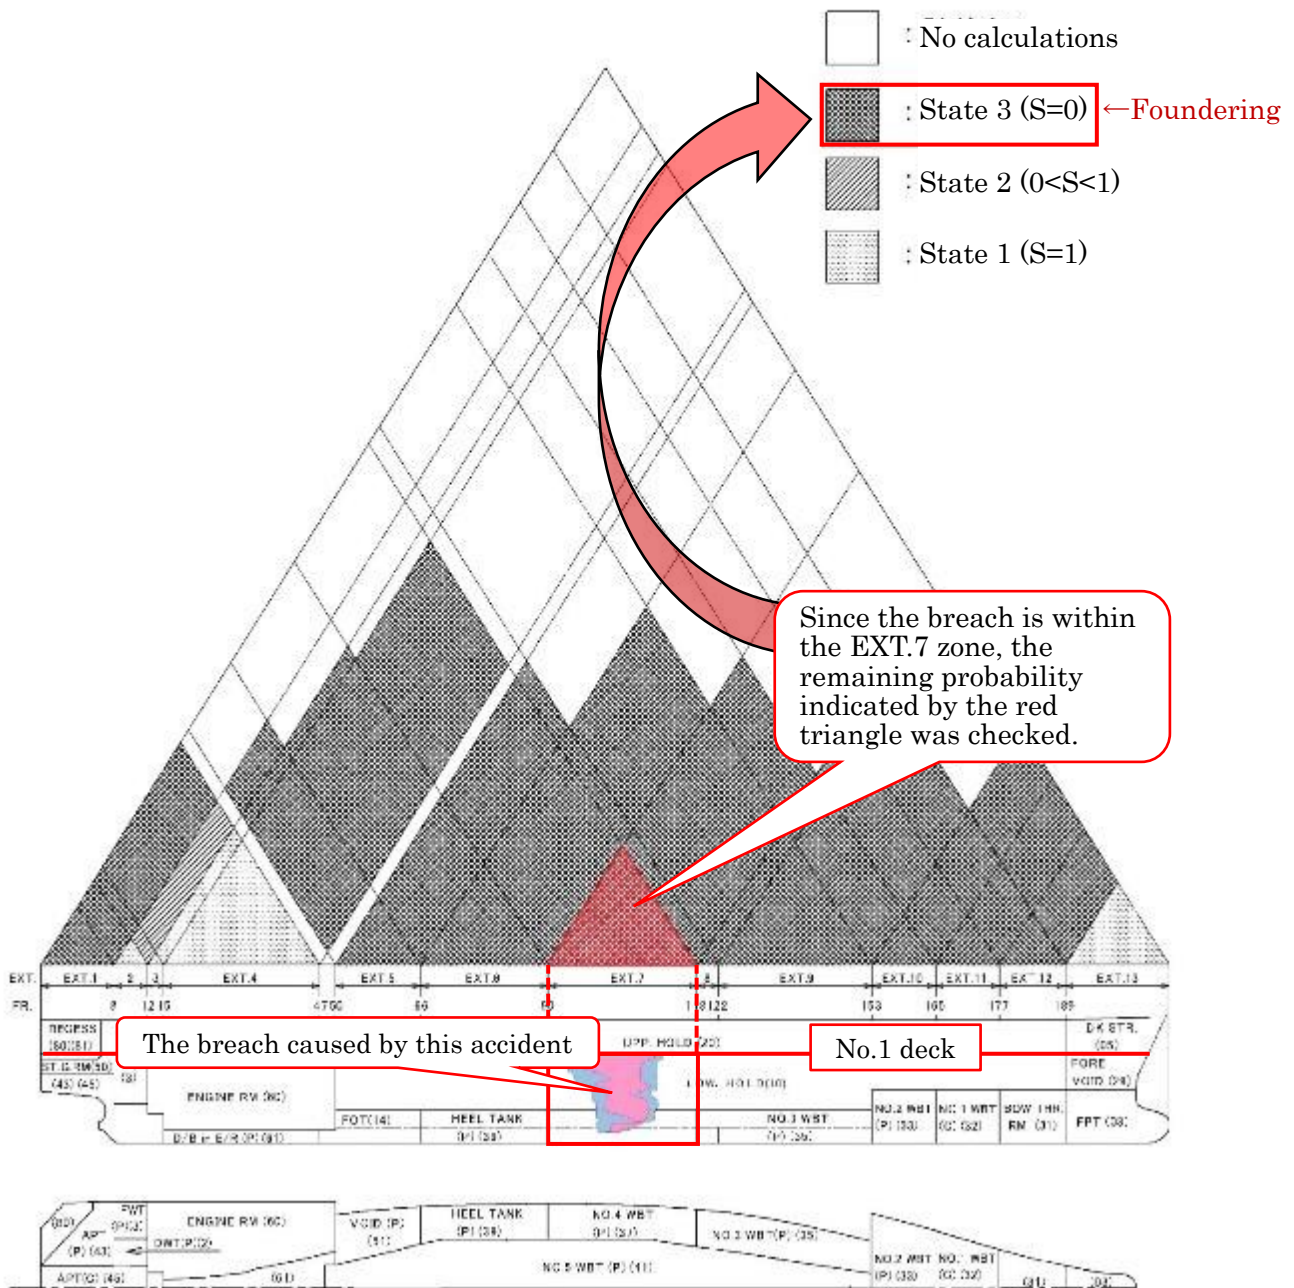
Figure 28 Calculated state of damage stability (close to the state at the time of the accident)

(Damage extent: vertical = No.1 deck, horizontal = C.L.)
