**MARINE ACCIDENT  
INVESTIGATION REPORT**

Vessel type and name: Container Vessel CONTSHIP UNO

Vessel type and name: Cargo vessel Izumi Maru

Accident type: Collision

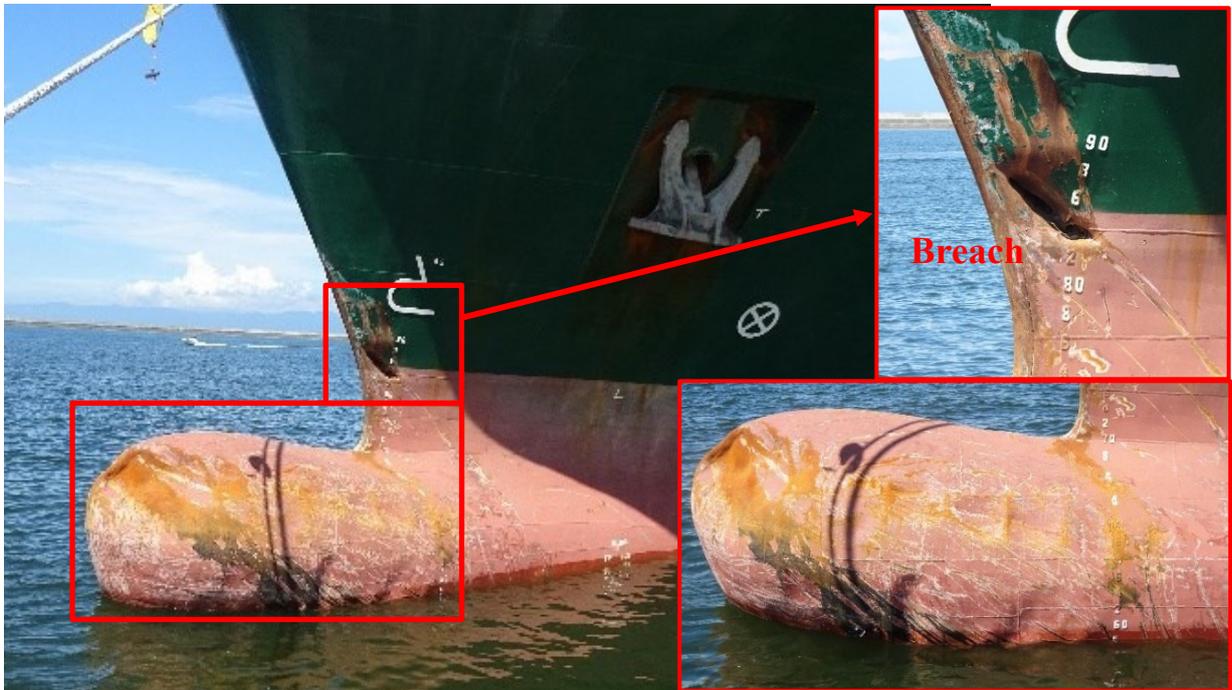
Figure 7: Damage to Vessel A

At the time of the accident, Vessel A's fore draft was approximately 5.8 meters, and the damage to the bow is estimated to have occurred at a height of about 2.5–3.2 meters above the waterline.

As described in Section 2.3, Vessel A sustained a breach in the bow, buckling and dents in the bulbous bow, and abrasions, while Vessel B suffered catastrophic damage to its mid-starboard section, capsized after the collision, and eventually sank at approximately 02:50 on August 26.

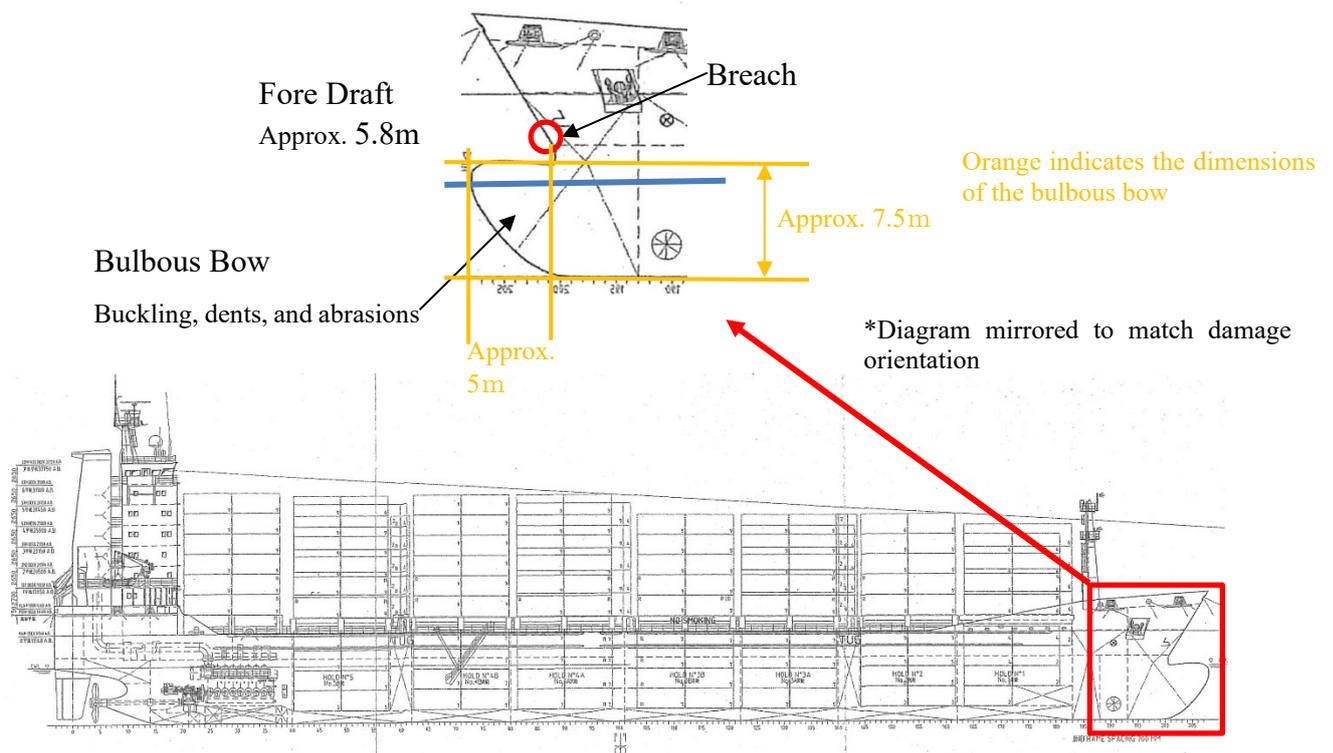
Figure 8: Schematic Diagram of Damage to Vessel A

According to the general arrangement plan, the dimensions of the bulbous bow were approximately 5 meters in length from the fore end to the base and about 7.5 meters in height.

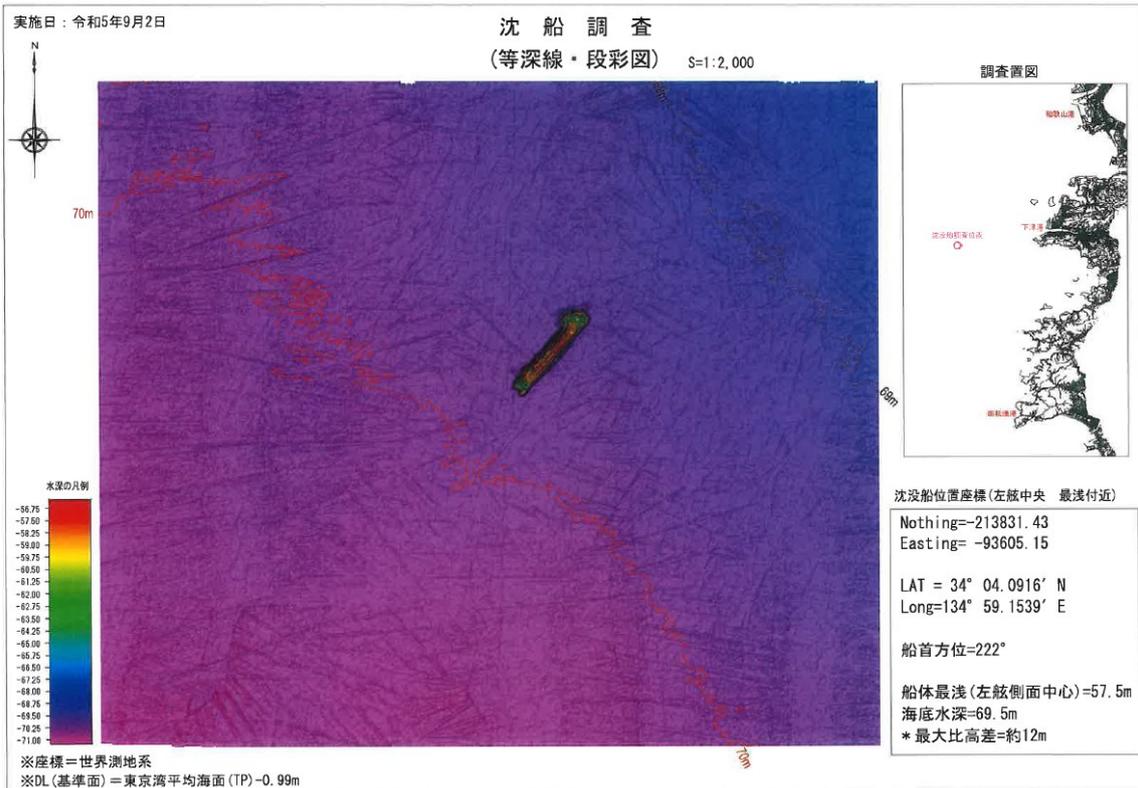
Figure 9: Vessel B's Sinking Status

*Vessel B is resting on the seafloor at a depth of approximately 70 meters, with its bow oriented at about 222° and tilted approximately 115° to the starboard side.*

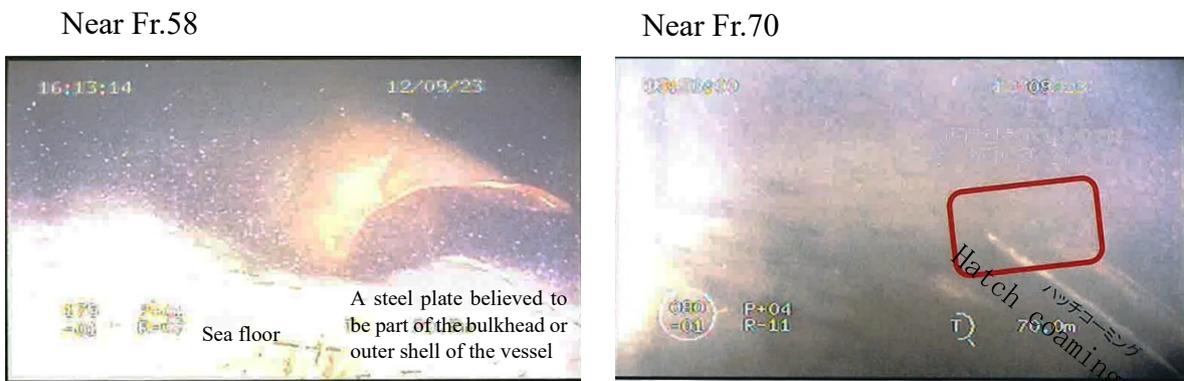
Figure 10: Damage to Vessel B (Photographed via Small ROV)

*The damage extends around Fr.50 to Fr.70 (a length of approximately 12 meters along the longitudinal axis of the ship). On the starboard cargo hold side, bulkheads and other structures appear to have collapsed inward toward the cargo hold, with sections peeled back. Additionally, other parts of the ship's structure are damaged and scattered. The damage is believed to be particularly severe near the midship section of the starboard side.*

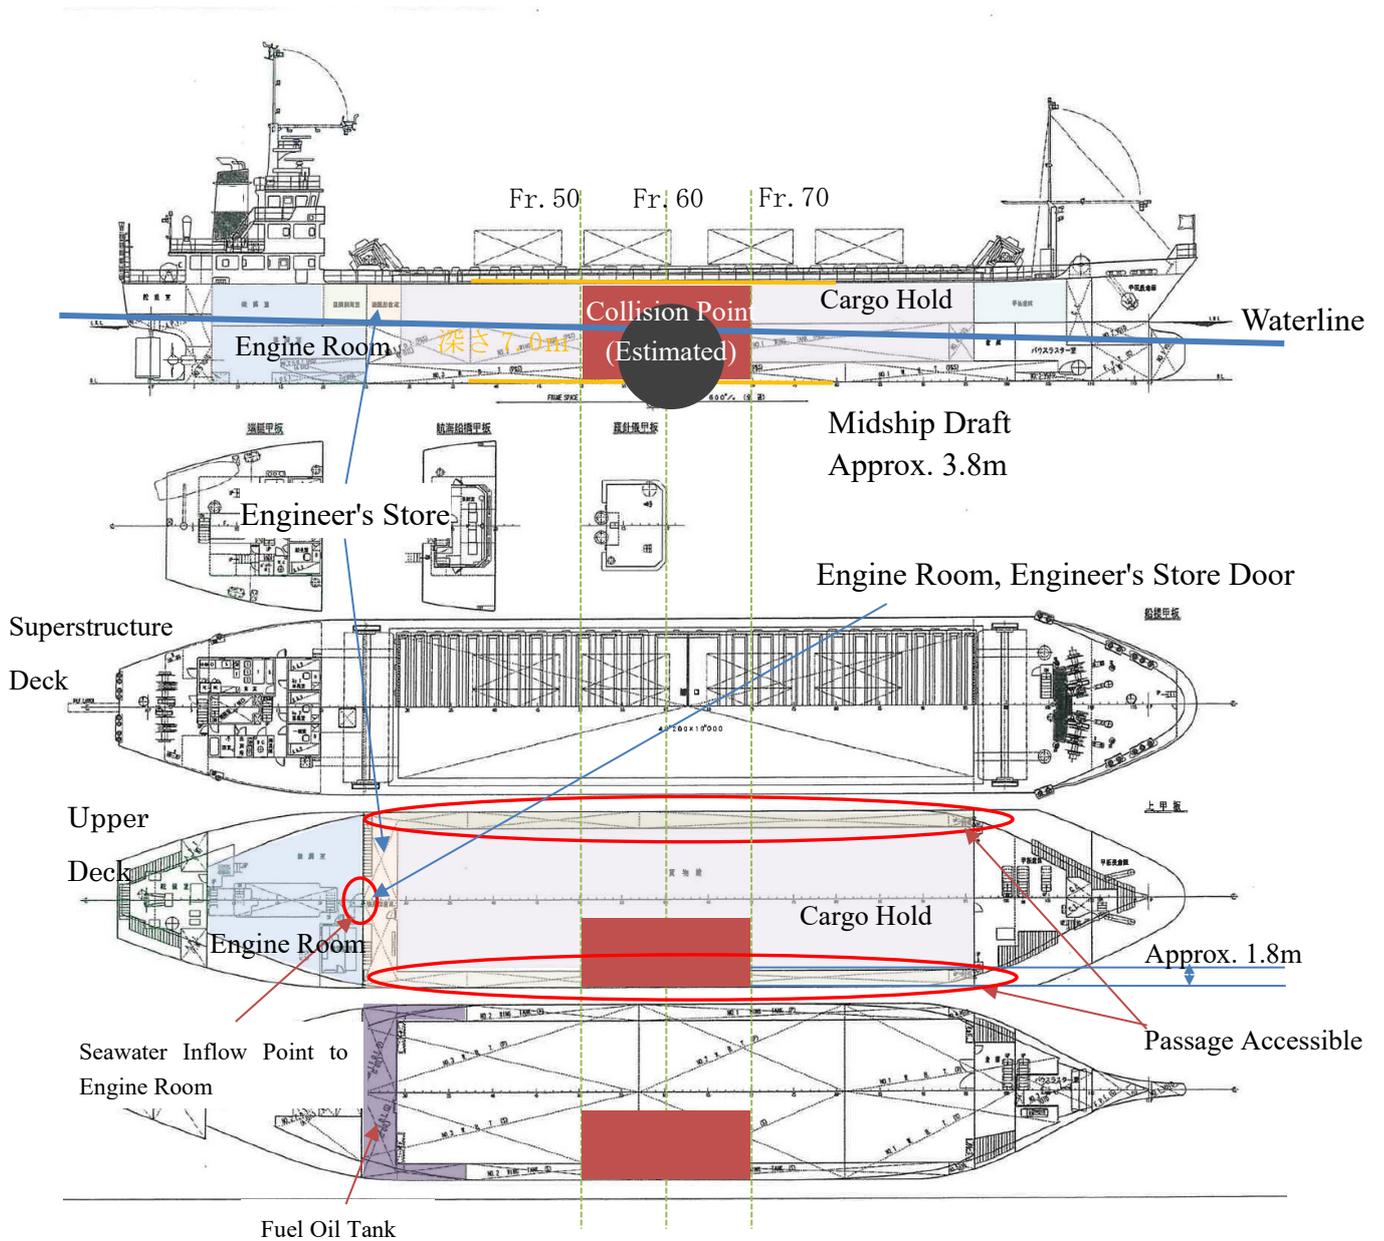
Figure 11: Schematic Diagram of Vessel B's Damaged Area

Vessel B, with a depth of 7.0 meters, had a draft at the time of the accident at approximately 3.2 meters at the fore and 4.5 meters at the aft, suggesting a midship draft at around 3.8 meters and estimated upper deck height above the waterline at approximately 3.2 meters.

Based on Vessel B's general arrangement plan, draft conditions, and the sinking status inspection report, as well as Vessel A's fore draft, dimensions of its bulbous bow, and damage details, the estimated collision point is illustrated in Figure 11.

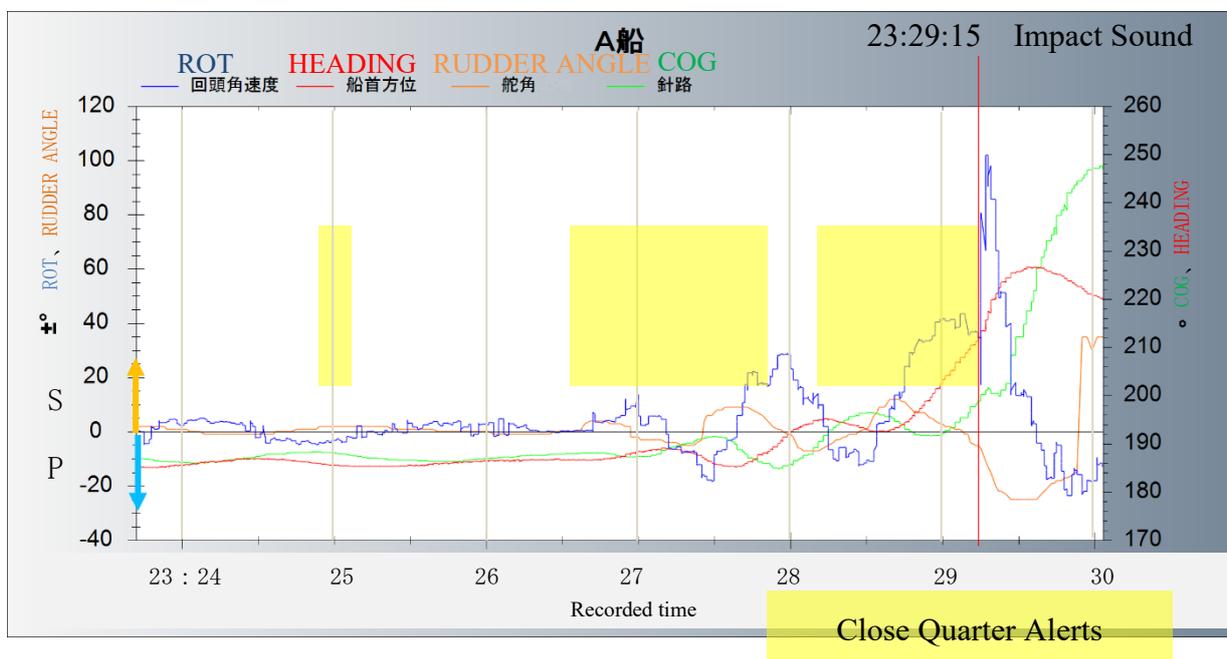
Figure 19: Transition of rate of turn, heading, rudder angle, course over ground, and radar proximity alarm display based on Vessel A VDR records

- ⑥ Around 23:25, after Vessel B was automatically plotted, a close quarter alert for Vessel B appeared on the starboard radar when the course shifted to the starboard side at 188°. However, the alert disappeared shortly thereafter as the course shifted to the port side. It is probable that, at this time, the course shifted to the starboard side had been caused by the autopilot's periodic oscillation, as the rudder angle at

- ⑨ Around 23:27:30, Officer A<sub>1</sub> uttered "shit," and a 9° starboard rudder was taken by Vessel A. This initiated a starboard turn from 23:27:41, though the course continued shifting to port until approximately 23:28. When the course reached around 185°, the close quarter alert for Vessel B briefly disappeared, but the course change to the starboard side triggered by the starboard rudder caused the alert to reappear.

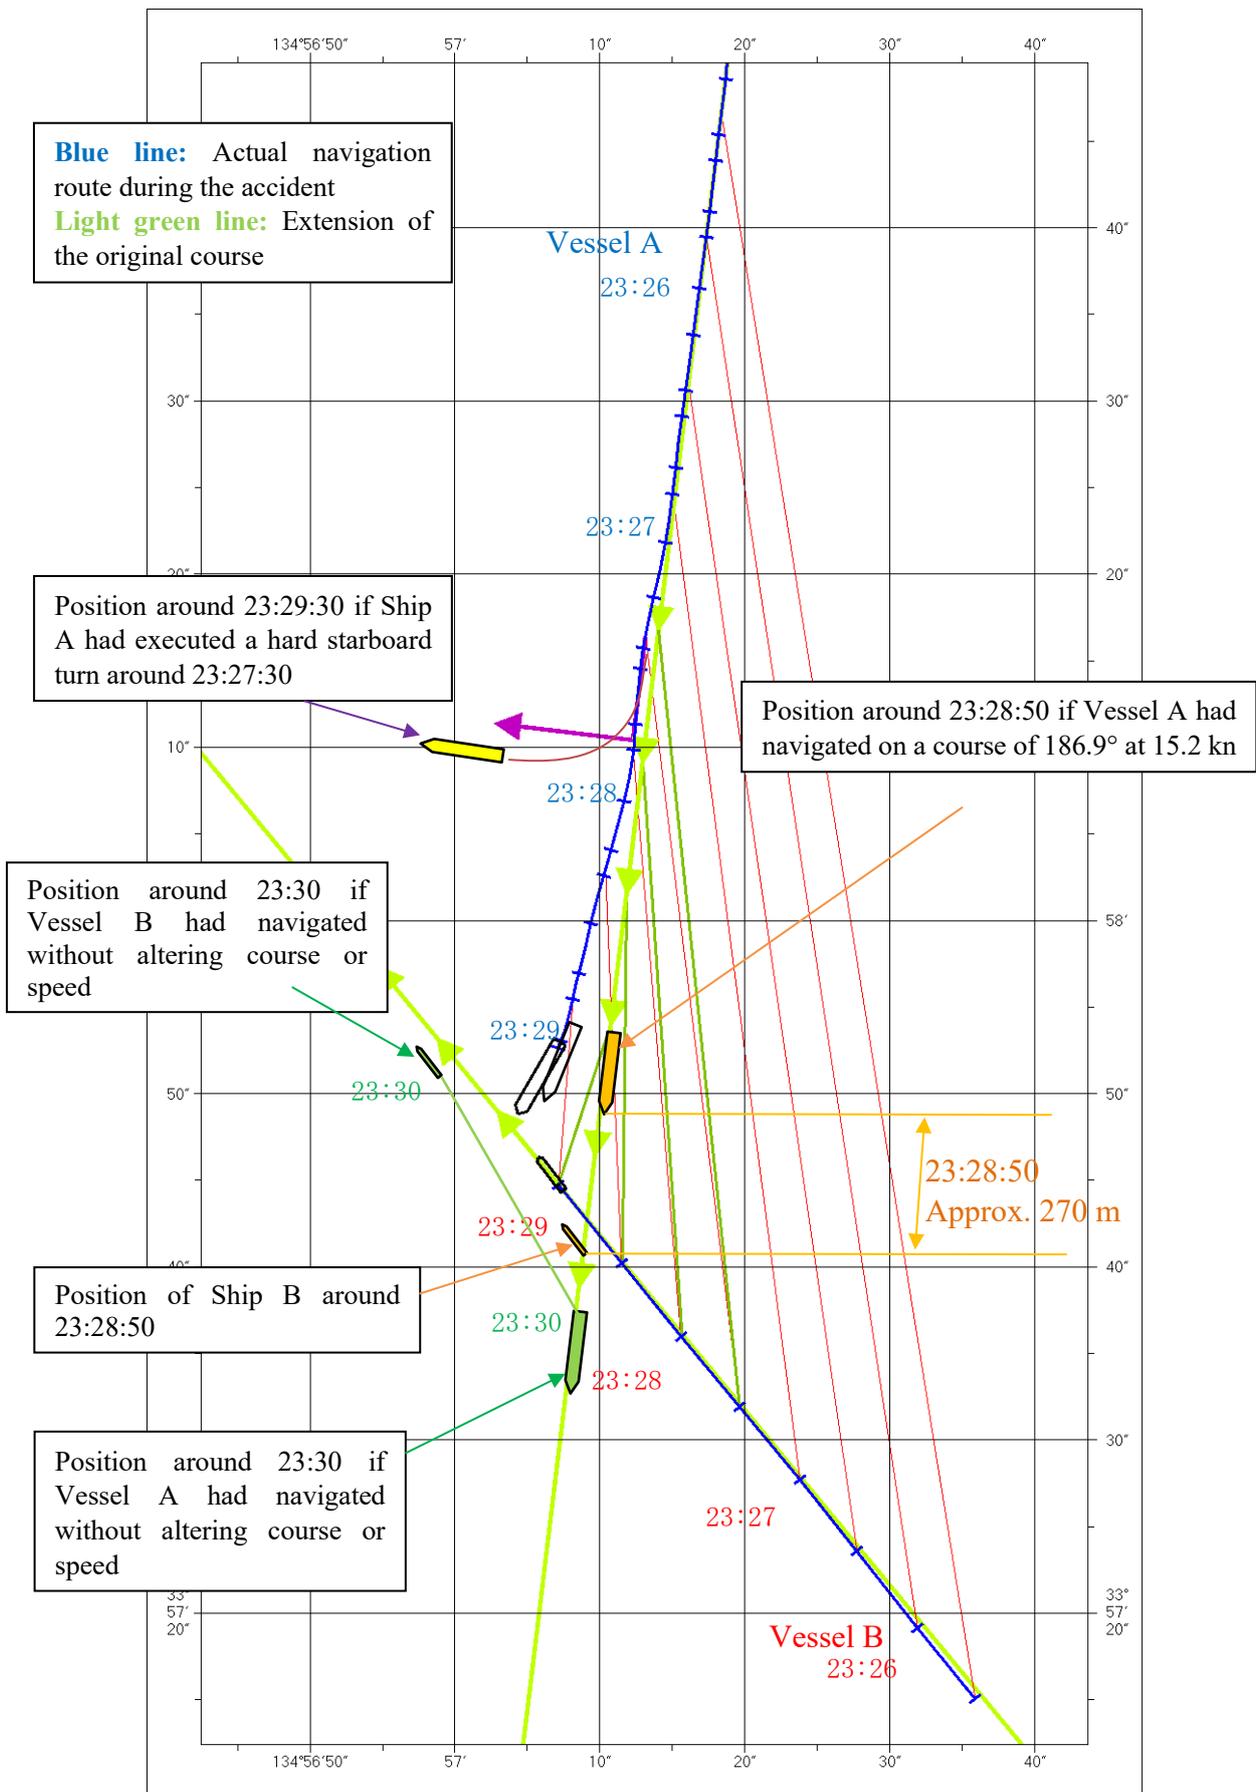
Figure 20: Estimated paths if Vessel A continued on its original course and speed or steered to hard starboard

utterance. If Vessel A had steered to hard starboard at this moment, it could have kept sufficient distance from Vessel B.

Officer A<sub>1</sub> stated that multiple crossing situation vessels were present from the starboard side, and turning to starboard would have resulted in firstly approaching those vessels, making usual maneuvering difficult. However, as described in 2.1.3(1)②, at the time of the accident, the only other vessel besides Vessel B approaching Vessel A was Vessel C, which had a CPA of 0.4–0.5 M and was crossing ahead to the port side, it is probable that there were no other vessels obstructing Vessel A's ability to turn to starboard.

It is probable that, as noted in 3.2.4(3), if Vessel A had steered to hard starboard around 23:27:30, Vessel A could have likely maintained a sufficient distance from Vessel B.

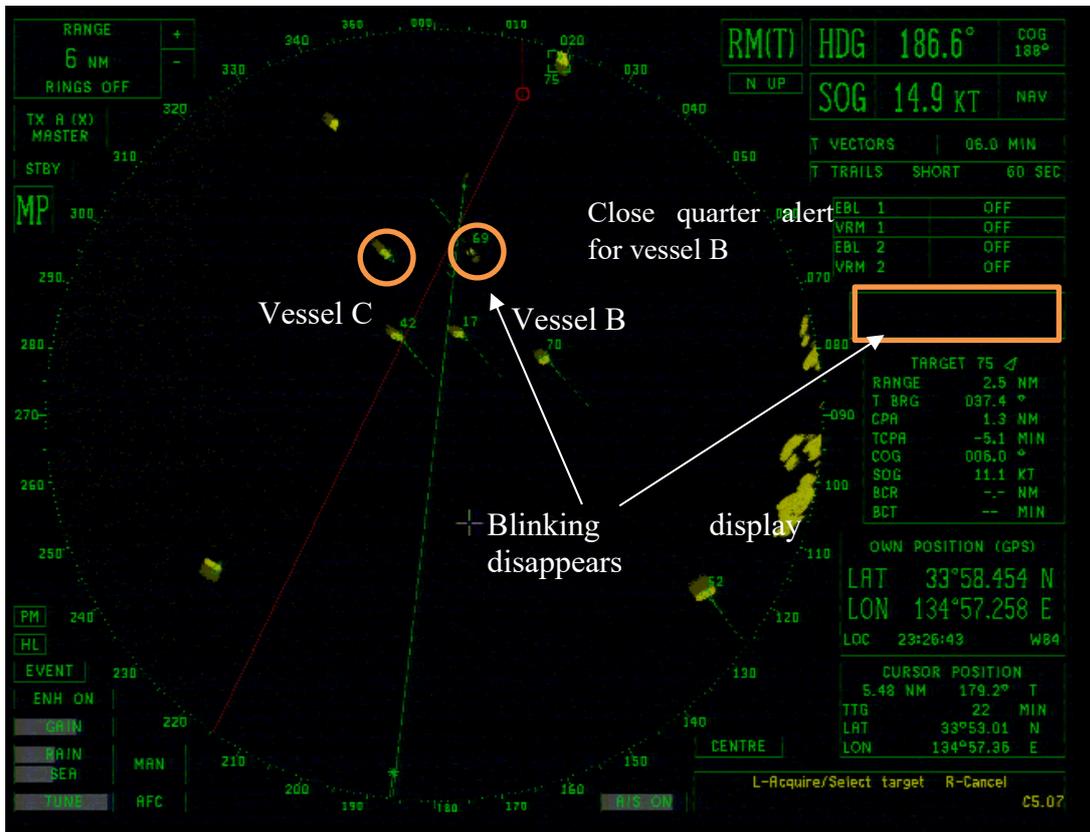
⑨ 23:26:43 (Close quarter alert displayed for Vessel B)

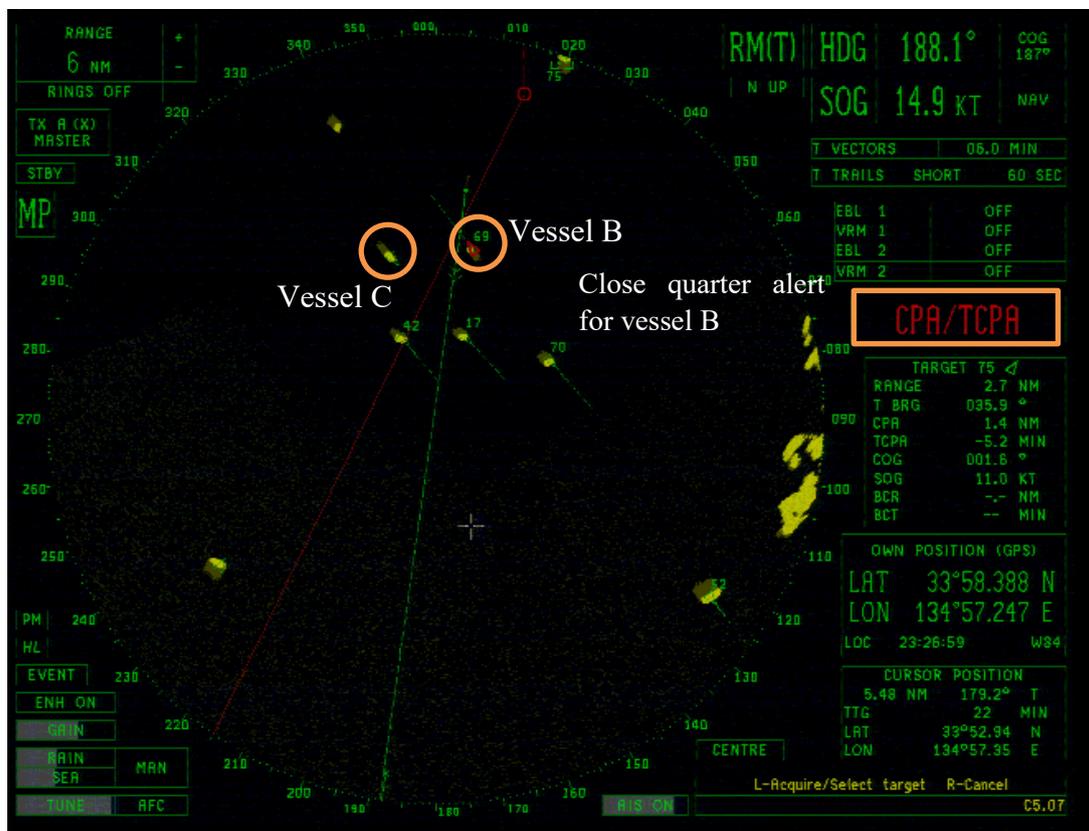
⑩ 23:26:59 (Close quarter alert for Vessel B continues)

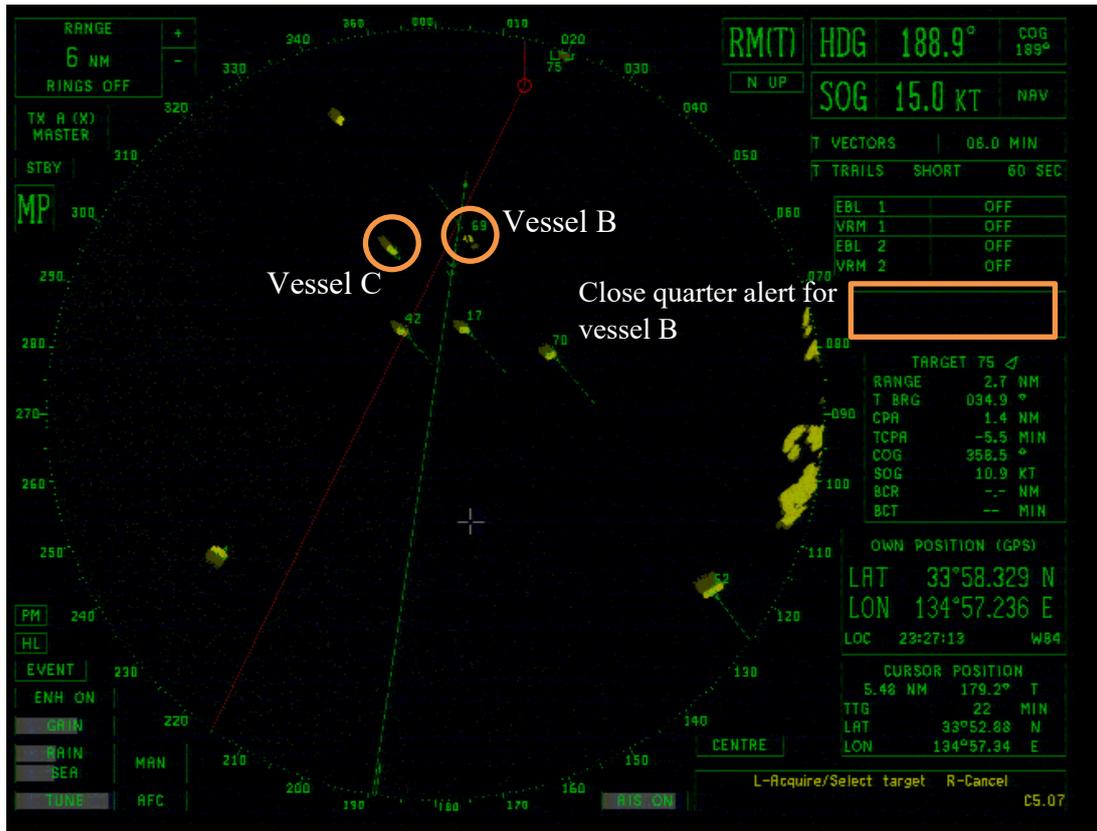
⑪ 23:27:13 (Close quarter alert for Vessel B continues)

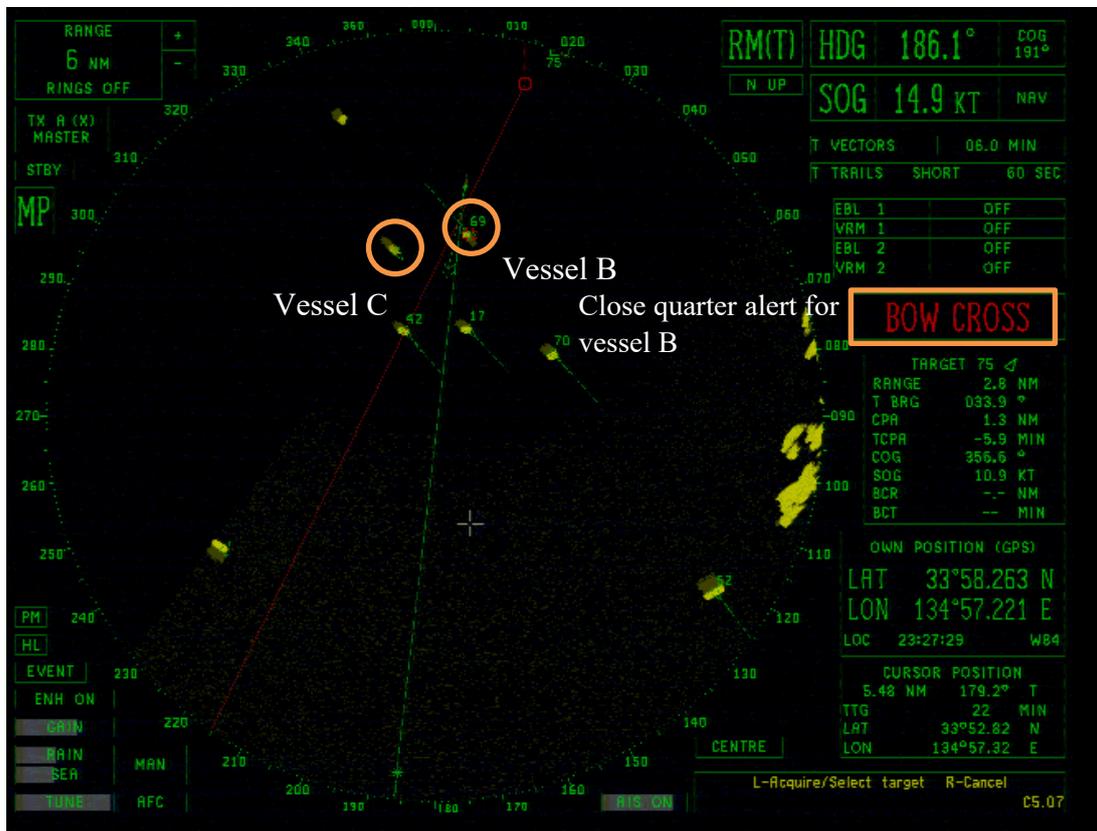
⑫ 23:27:29 (Close quarter alert for Vessel B continues)

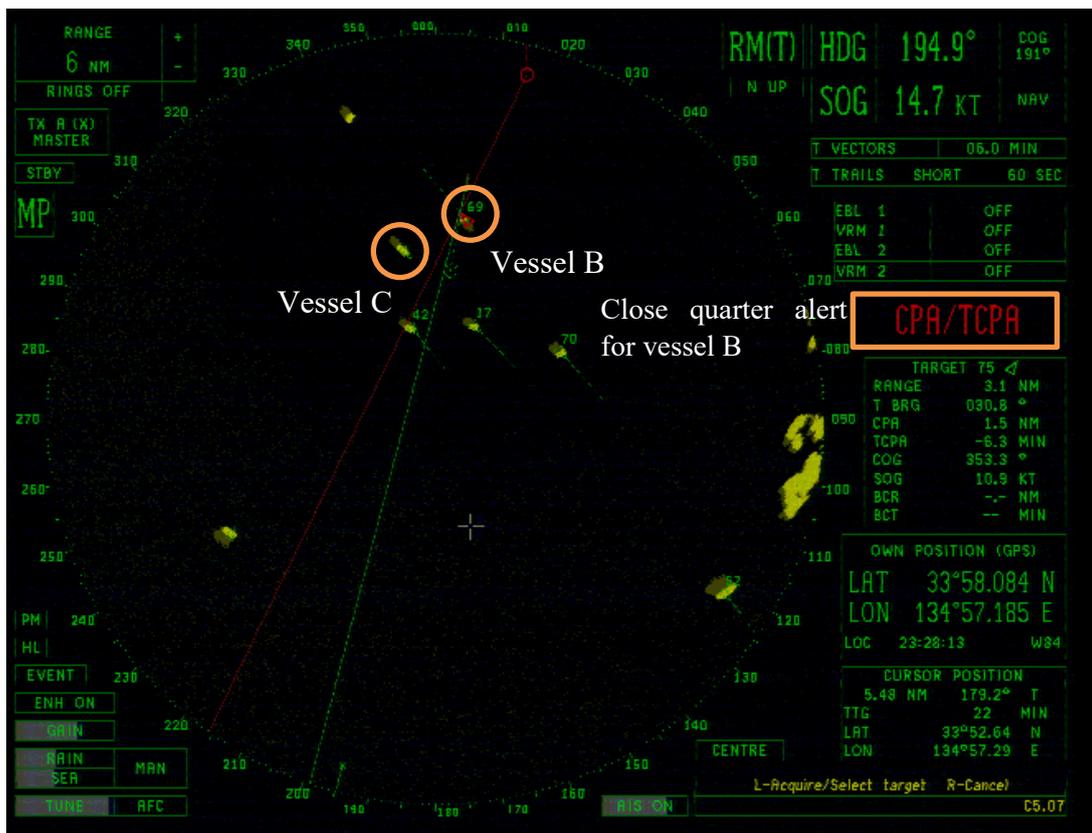
⑮ 23:28:13 (Close quarter alert displayed for Vessel B)

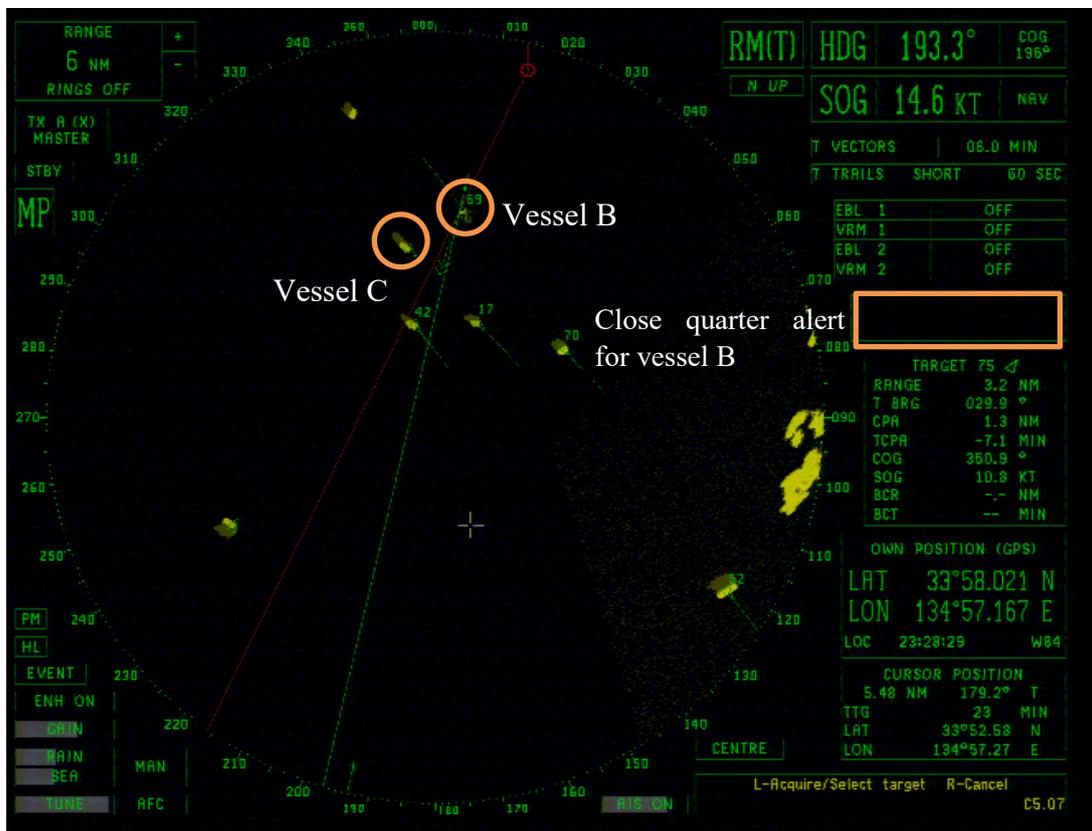
⑯ 23:28:29 (Close quarter alert for Vessel B continues)

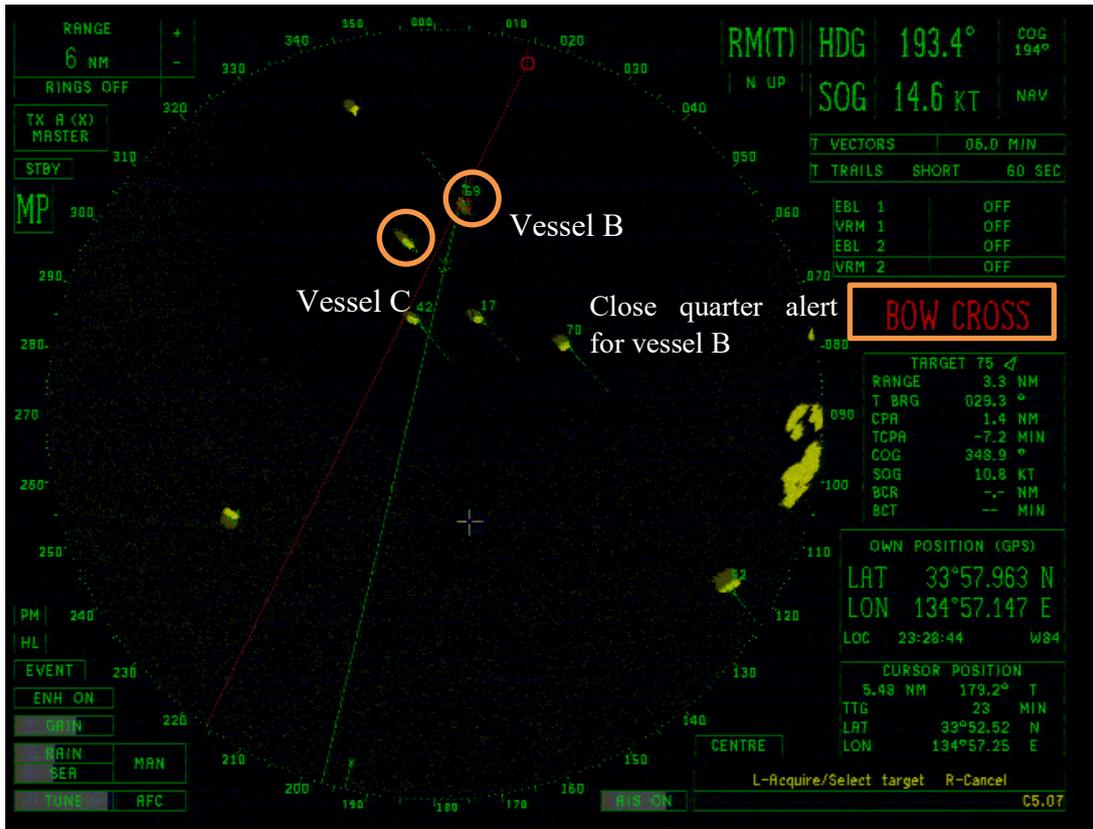
⑰ 23:28:44 (Close quarter alert for Vessel B continues)

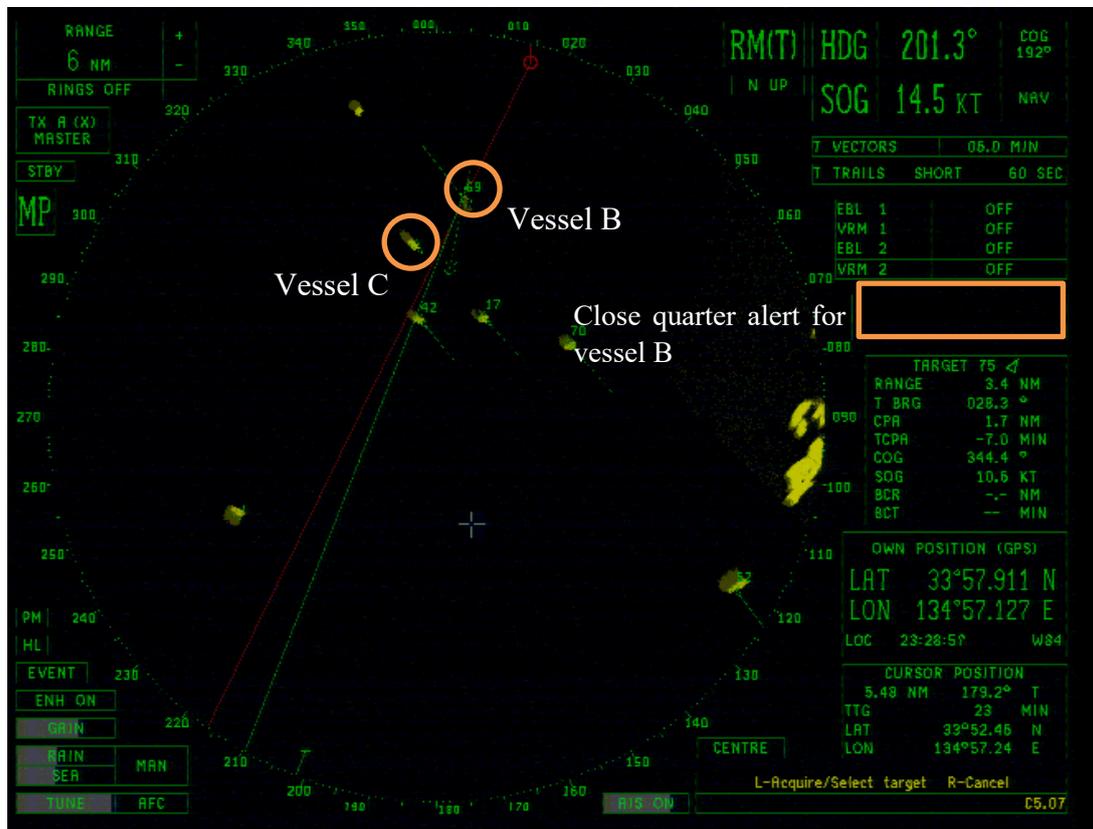
⑱ 23:28:57 (Close quarter alert for Vessel B continues)
