MA2025-4

MARINE ACCIDENT INVESTIGATION REPORT

Vessel Type and Name: Bulk Carrier EVER FELICITY

Accident Type: Injury and Fatality of Stevedores

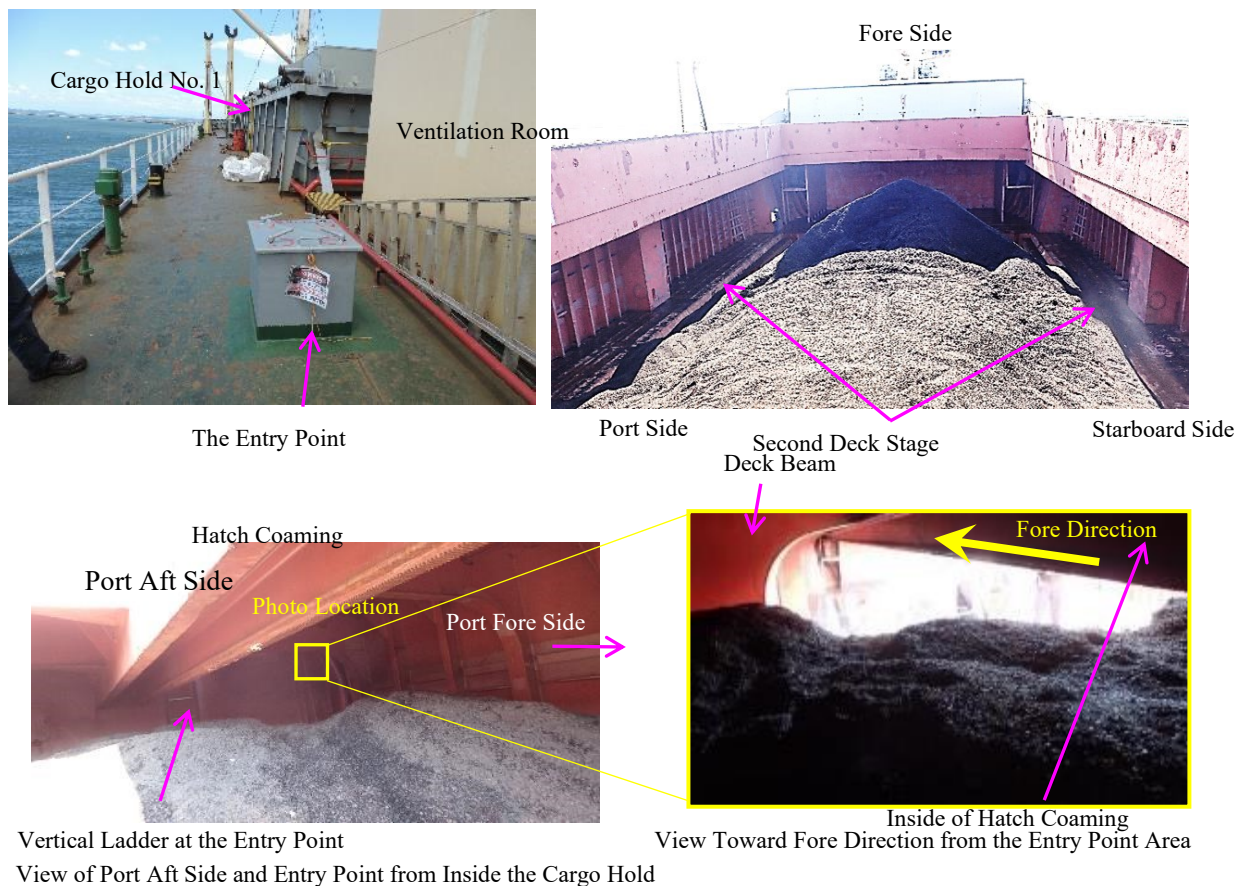
Figure 3 – Condition Inside No.1 CH and at the Entry Point

The entrance to No.1 CH, located at the center of the port side of the upper deck (hereinafter referred to as “the Entry Point”), was positioned at the aft-most section of No.1 CH. At the area beneath this Entry Point, Palm Kernel Shells (hereinafter referred to as “the PKS”) had been loaded to approximately halfway between the upper deck and the second deck—approximately 10.3 meters above the tank top deck, about 3.2 meters below the Entry Point hatch opening, and approximately 2.6 meters below the upper deck. In addition, from approximately the midsection of No.1 CH toward the fore end, the Subject PKS had been loaded to a height at where the stage of the second deck remained visible—about 7.7 meters above the tank top. (See Figure 3.)

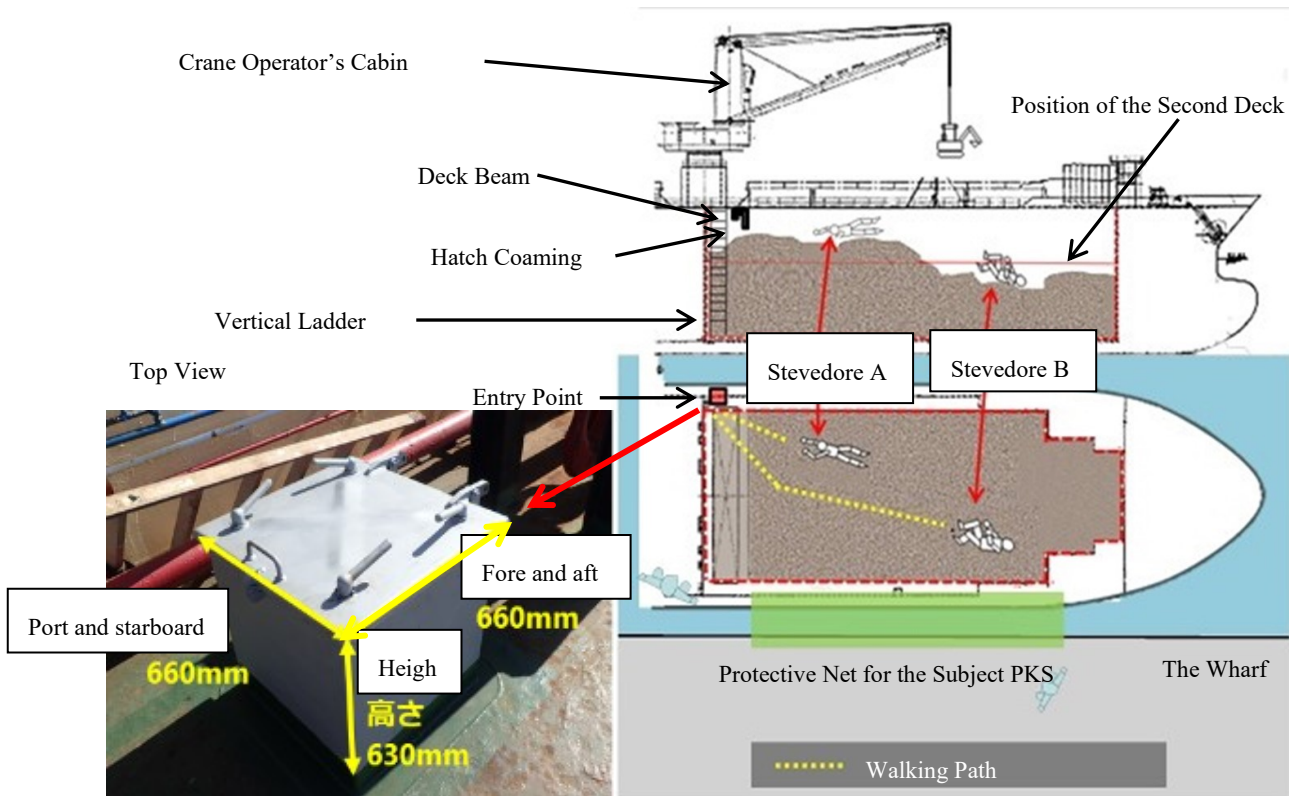
Figure 4 – Injury Locations of the Stevedores Inside No.1 CH

Stevedore B found it difficult to enter from the Entry Point, as the Subject PKS was visibly piled directly beneath the hatch, making access appear obstructed. He attempted to find an alternative entry point, however, unable to locate one, began descending the vertical ladder at the Entry Point. Stevedore A followed behind him.

Note: The walking paths of Stevedore A and Stevedore B are according to information collected by A1 B. Office.

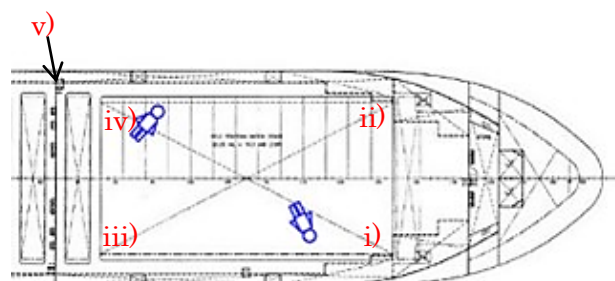
At around 08:15, prior to entering No.1 CH to carry out rescue operations, the rescuers measured the oxygen concentration directly above the PKS at five locations inside the hold: the four corners of the hatch opening and the area near the Entry Point. The measurement results were as follows (Note: The oxygen concentration in standard atmosphere is approximately 21%.):

Location in Cargo Hold	Oxygen Concentration (%)
i) Starboard Fore Side	17.6
ii) Port Fore Side	17.9
iii) Starboard Aft Side	19.9
iv) Port Aft Side	20.6
v) Entry Point	19.1

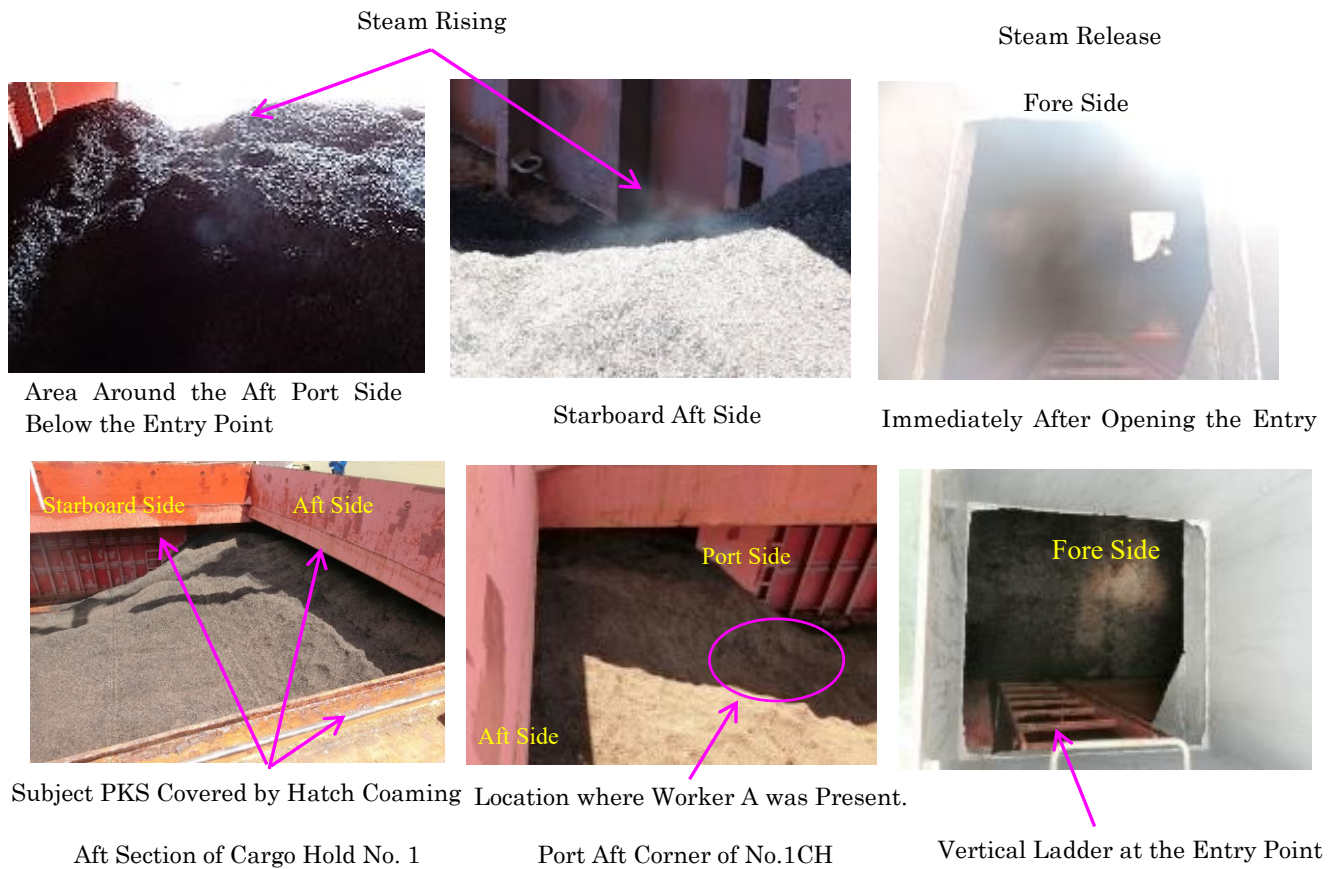
Figure 6 – Condition Inside No.1 CH (May 25)

The port aft side of No.1 CH, where Stevedore A collapsed, had a relatively high accumulation of the Subject PKS. This area was located in a corner near the hold's inner wall and was enclosed above by the overhanging hatch coaming from the upper deck, resulting in poor ventilation even when the hatch cover was open. During the investigation conducted on May 25, steam was observed rising from the surface of the Subject PKS.

open compared to other areas of the hold. The Subject PKS was not loaded as high as in the aft side, and no steam was observed rising from its surface.
