RA2019-1-II

**RAILWAY ACCIDENT
INVESTIGATION REPORT**

**Train Derailment Accident between Tarui station and Ozaki station
of the Nankai Line of Nankai Electric Railway Co., Ltd.**

January 31, 2019

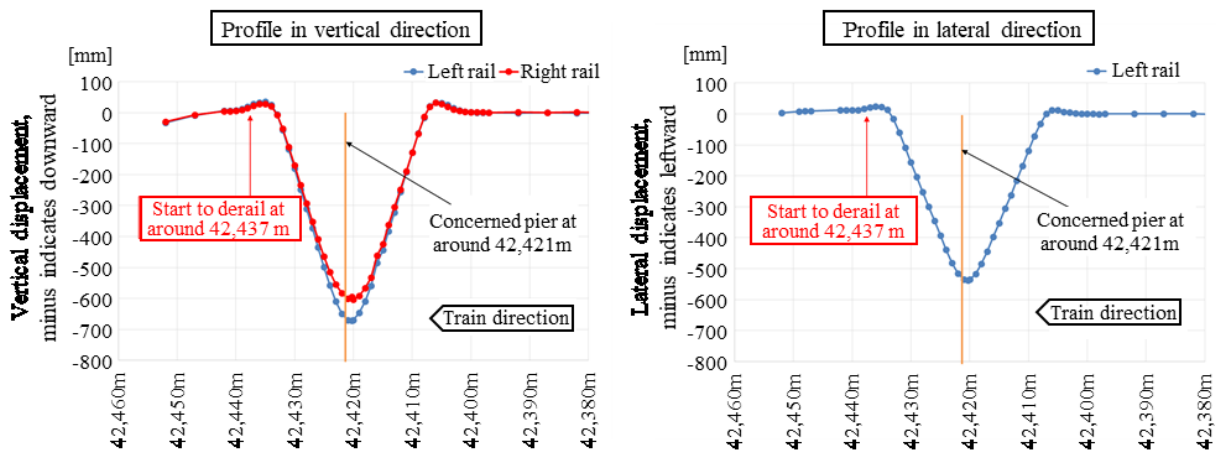
Figure 10. Status of deformation of the track

It was confirmed in the on-site investigation that the track was sagged and wound to left from around 42,407 m to around 42,434 m of the down track, and the amount of deformation of the track was the largest at just above the concerned pier.

* The start point of the derailment in the above figure, i.e. around 42,437 m, was the position based on the analysis described in the following paragraph 3.1.

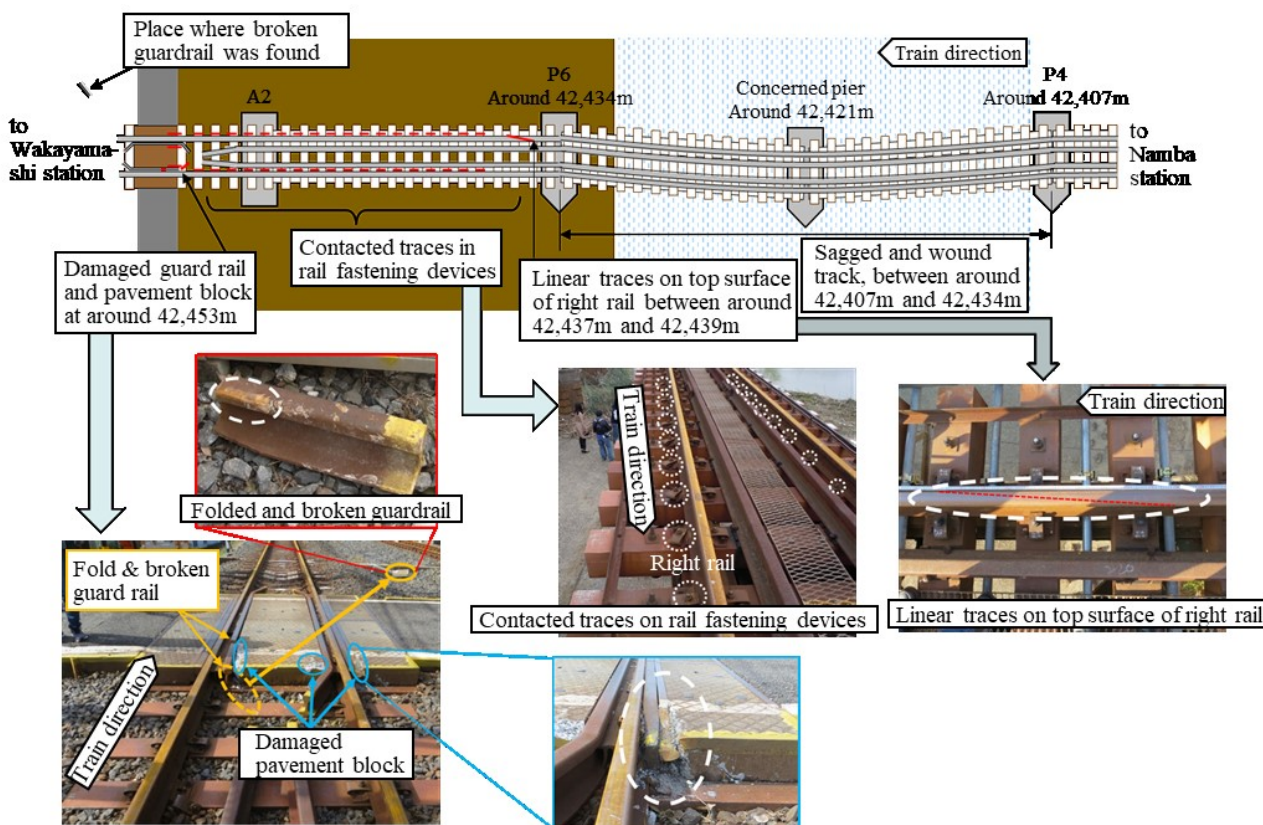
Figure 11. Damaged status of the track and traces of the derailment

Status of the major damages of the track and the traces of the derailment were as shown in Figure 11 and Table 8.

There was the linear trace from inside to outside gauge on the top surface of right rail from around 42,437 m to around 42,439 m. Beyond there to Tarui No.10 level crossing located at 42,454 m, a part of the rail fastening devices^{*32}, etc., in each right side of left and right rails were damaged, and the contacted traces considered as caused by the running wheels were found continuously.

In addition, it was found that the left guardrail^{*33} was folded and damaged and the pavement blocks were damaged in Tarui No.10 level crossing in around 42,453 m, and a part of the folded and broken guard rail was found in between up and down tracks about 8 m distant from the folded and damaged position toward Wakayamashi station.

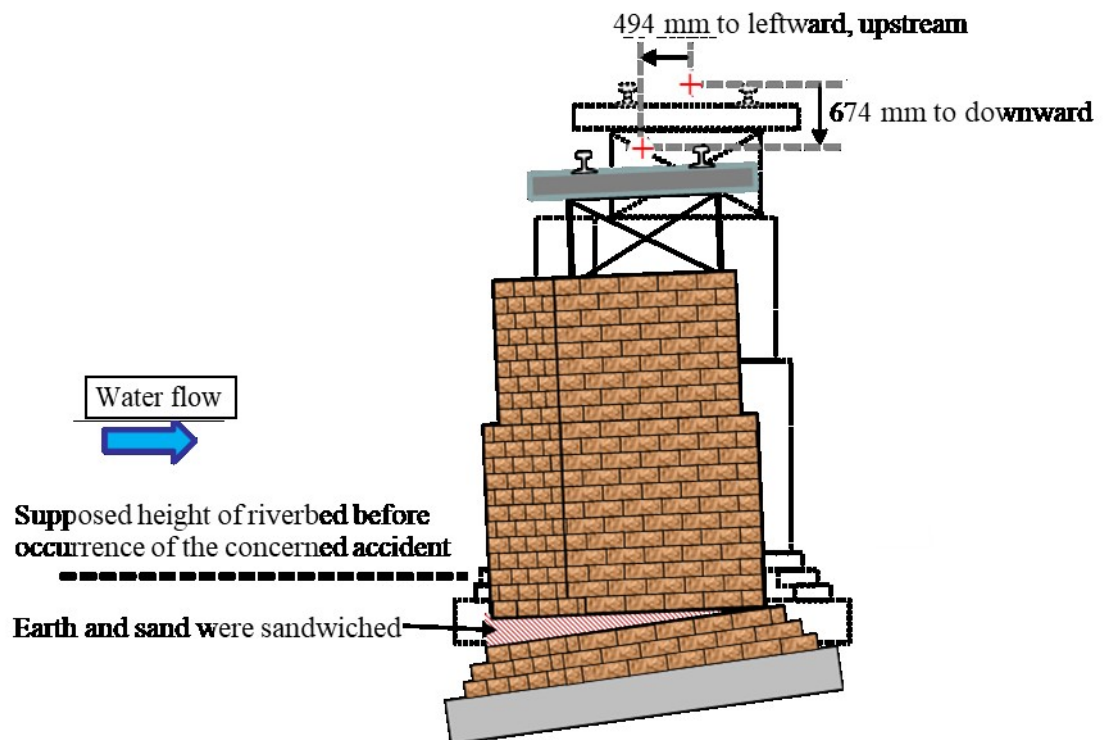
Figure 12. Status of the subsidence and tilting of the concerned pier

According to the survey implemented after that, on October 25, 2017, the concerned pier had been in the status as moved 674 mm downward and 494 mm leftward, *i.e.*, toward upstream, as shown in Figure 12.

Furthermore, according to the investigation implemented after that, the main body and the footing part of the concerned pier were in the status as being separated each other and tilted.

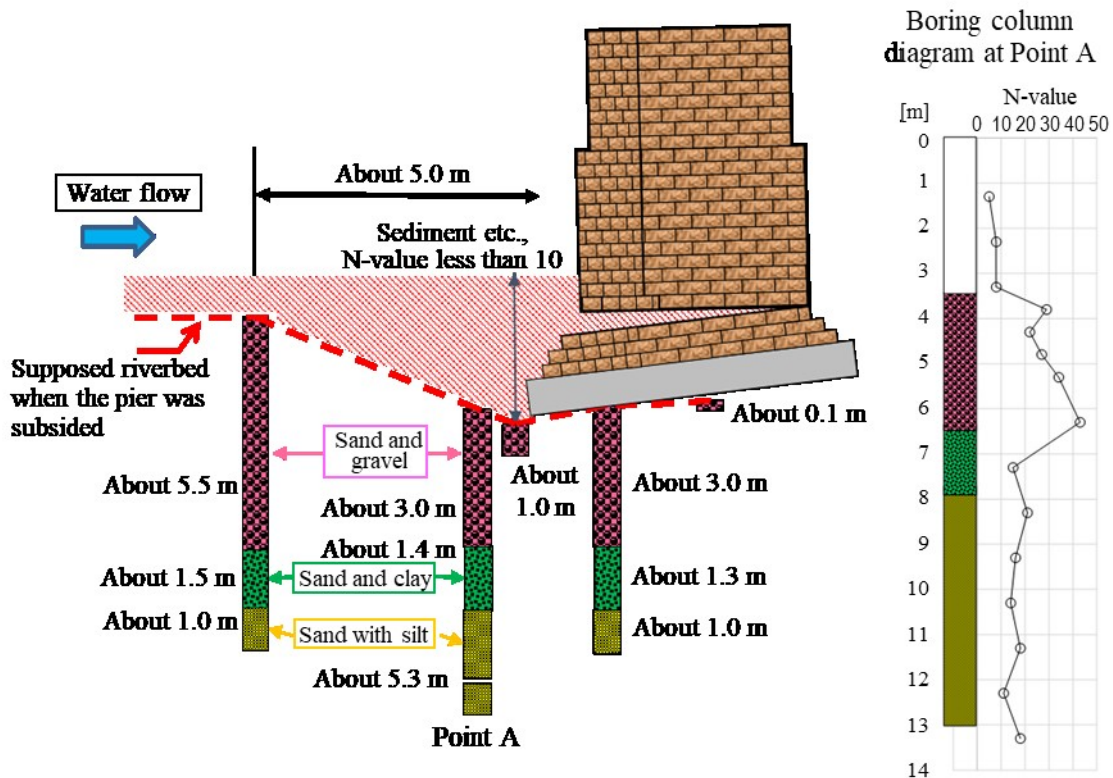
Figure 14. Summary of the results of the boring survey

The summary of the boring survey was as shown in Figure 14. The strata in around the concerned pier were, from ground surface, sand and gravel layer^{*40} of about 10 to 40 N-value^{*41}, arenaceous clay layer, sand layer mixed with the silt layer^{*42}, and these layers are heaped almost horizontally. The bottom of the footing was positioned in the sand and gravel layer.

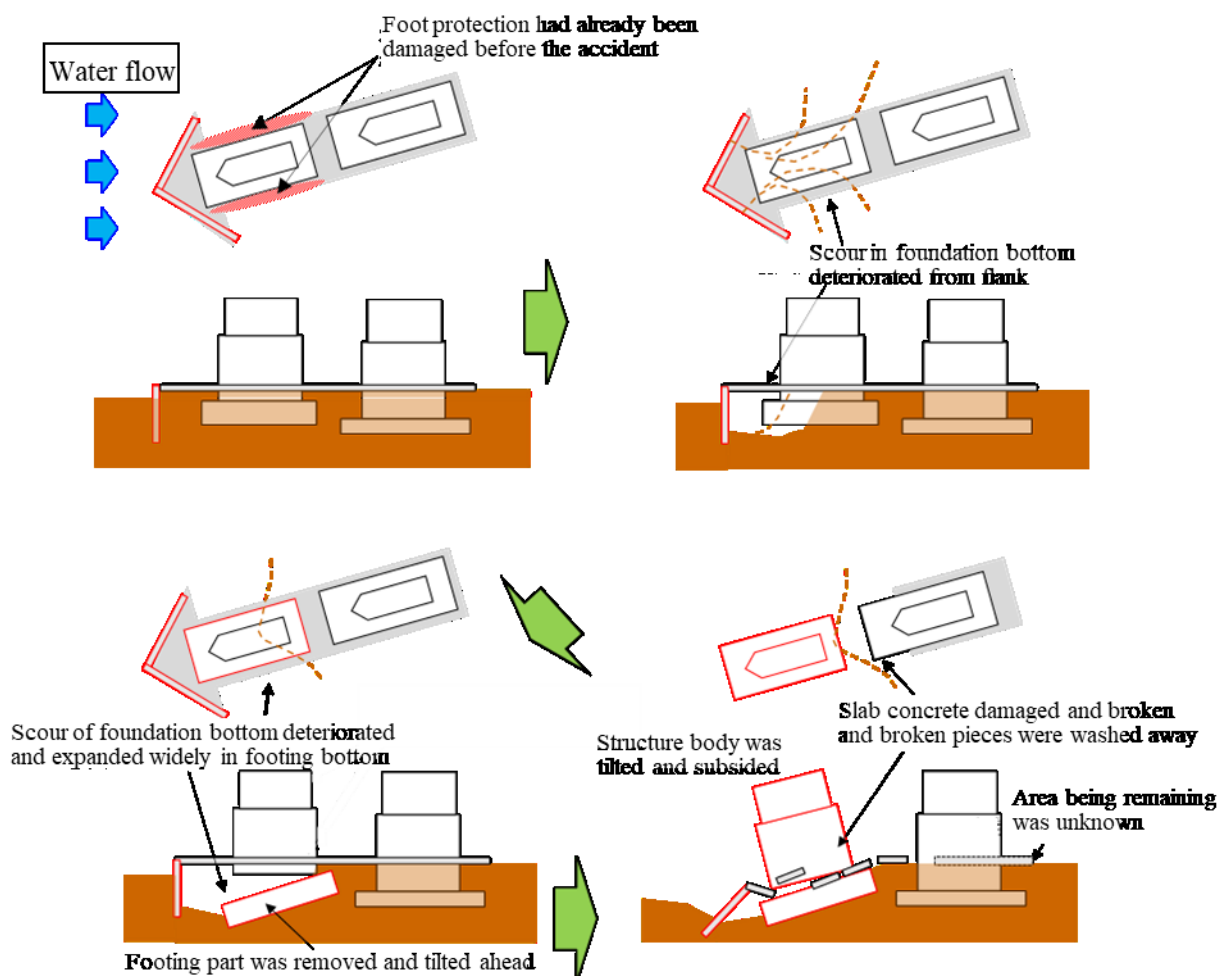
Figure 20. Imaginary figures on the mechanism of subsiding and tilting of the concerned pier

It is probable that the concerned pier had subsided and tilted in the following process due to the swollen river water at the time of the occurrence of the concerned accident while the function to protect scouring in the concerned pier had already been deteriorated before the occurrence of the concerned accident, such as the subsided riverbed in around the concerned pier and damages of the foot protection, etc., based on the analysis in 3.6.1 and 3.6.2. *[Refer to Figure 20]*

- (1) The scouring occurred from the riverbed in the flank of the pier where the foot protection works had been damaged.
- (2) The scouring expanded to wide area in the bottom surface of the footing, and the supporting ground reduced significantly.
- (3) The footing, that lost the suspending force for the bottom surface, separated at the boundary with the structure body, tilted, and subsided.
- (4) The slab concrete had broken and fragmented, and separated with the slab in the up track, then the concerned pier had tilted toward the upstream and subsided.

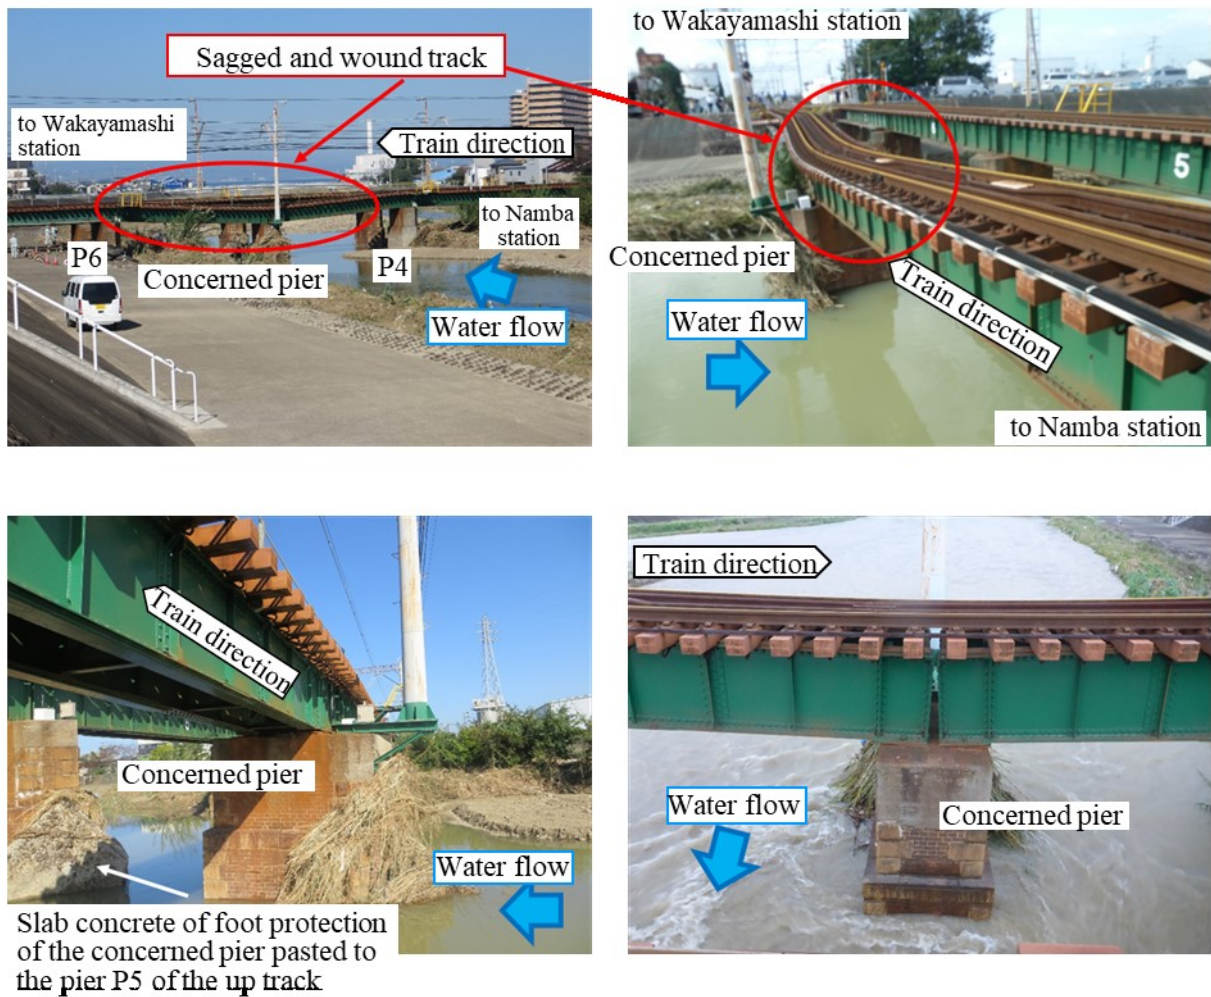
Attached Figure 7. Status of Foot Protection of the Concerned Pier before the Occurrence of the Concerned Accident

The company had been checked the situation that the foot protection of the concerned pier was in the status as a part of the floor deck concrete had lacked and damaged, and the cobble stones, etc., were washed away, in October 2012.

After that, the company checked the status that the damages of the foot protection of the concerned pier were deteriorating, in the on-foot patrol implemented on June 2, 2014 described in 2.3.2.4. Then the company judged that the reinforcement was necessary and planned to implement the reinforcing works in 2018 fiscal year in the long-term budget plan from 2015 to 2025 fiscal years, starting from the next fiscal year.

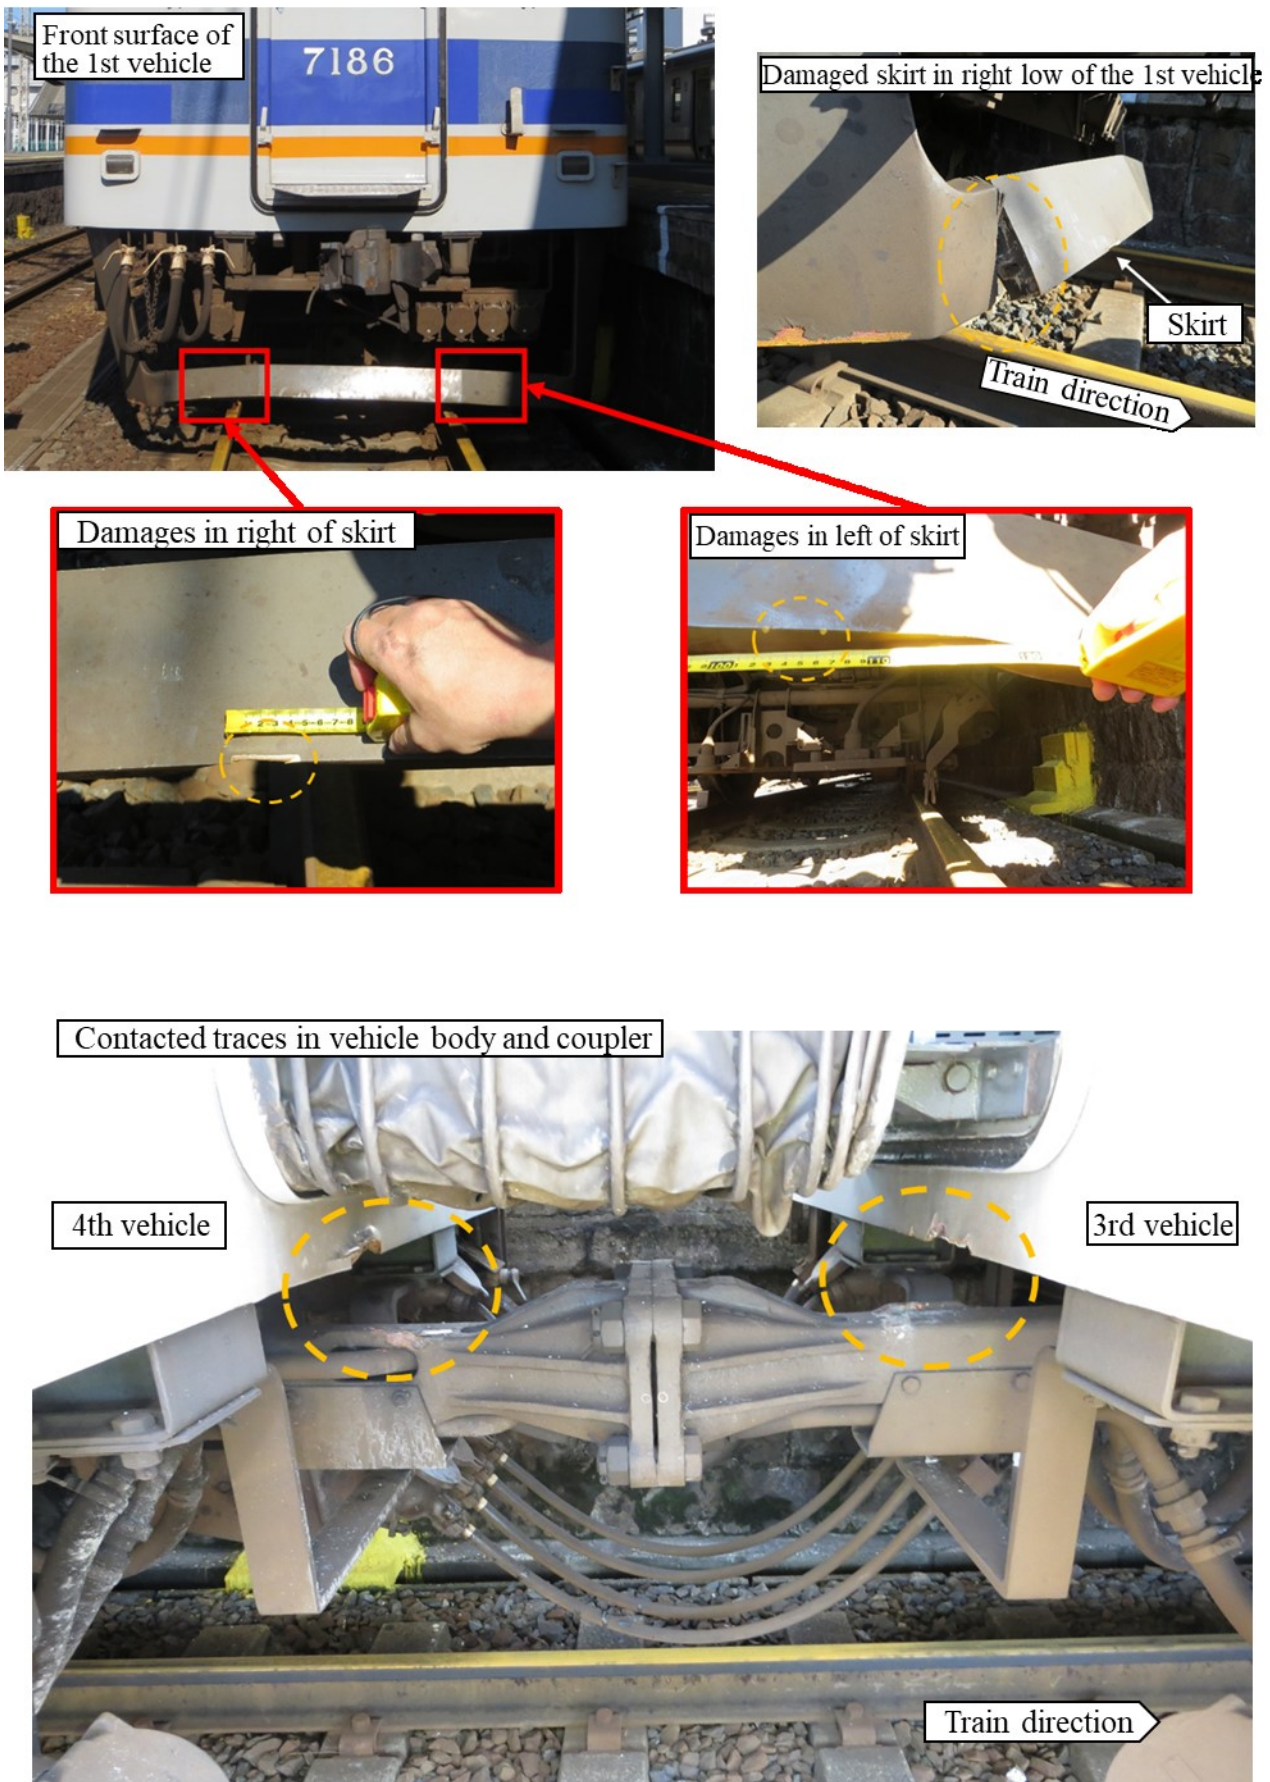
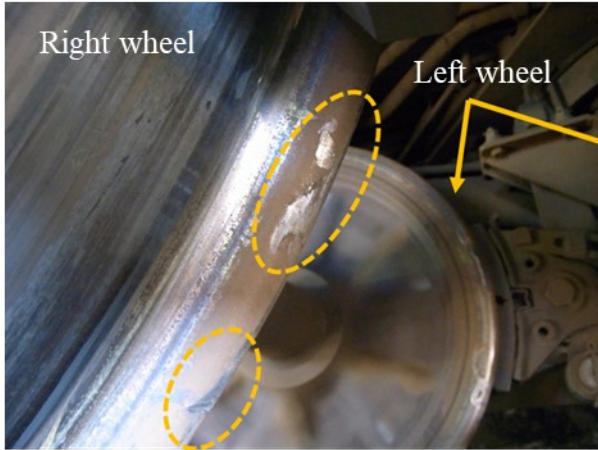
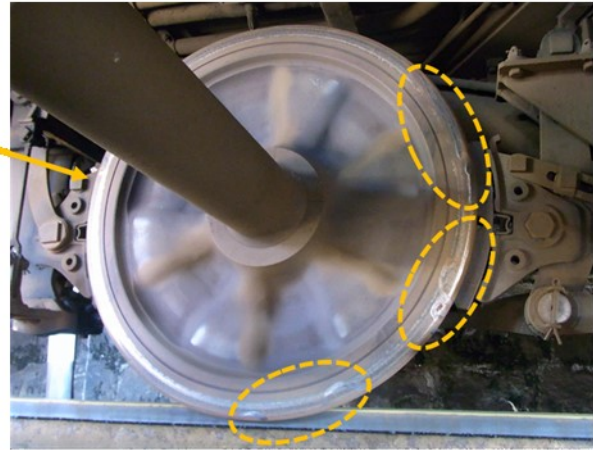
Attached Figure 10. Traces in the Wheels

Here, according to the company, the company judged that the concerned train had derailed once and restored after running for a while, because there were the flaws in right and left wheels of the 2nd axle in the rear bogie of the 3rd vehicle, the damages on the track, and the linear traces on the top surface of the rails in around the accident site.

Hit traces and fretting traces in the wheels of the 2nd axle in the rear bogie of the 3rd vehicle
