~ Accident that the train derailed caused as the side beam of the bogie of the wagon had been pushed up on the ice and snow ~

Railway operator : Japan Freight Railway Company
 Accident type : Train derailment
 Date and time : At about 02:09, February 24, 2018
 Location : In the premises of Tomamu station, Sekisho Line, Shimukappu Village, Yufutsu District, Hokkaido

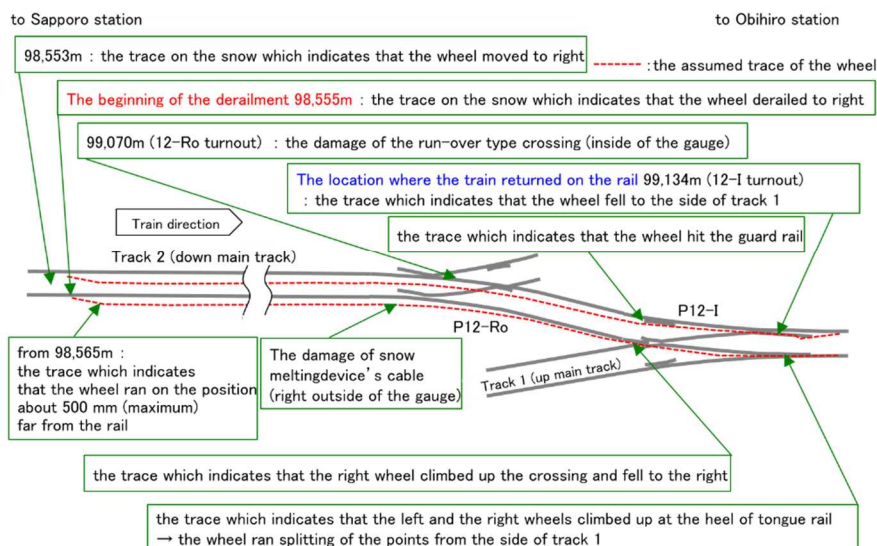
<The situation of the derailment>

It is probable that the accident occurred as the flange of the right wheel of the 1st axle in the front bogie of the 3rd vehicle climbed over the right rail and derailed at the place where large amount of ice and snow were stacked on the track, while the train was passing the straight track section in the premises of the station, and after that the train restored in the turnout while passing in the status as derailed.

It is somewhat likely that the 1st axle in the front bogie of the 3rd vehicle of the train derailed because the side beam of the front bogie of the 3rd vehicle was pushed up over the ice and snow stacked on the railway track, at the same time, the wheel flange was raised up by the hard ice and snow which had existed in around the flangeway.

Therefore, it is required to implement the snow removal works of the railway track by judging the proper timing, target area and methods considering the status such as snowfall, accumulated and stacked snow in the site, etc. Then, it is considered that to increase the frequency of the mechanical snow removal works as far as possible and implementation of the manual snow removal works to complement the mechanical snow removal works by judging the places required to secure the safety of train operation, not limited to the under platform, are effective as the measures preventing the recurrence of the similar accident.

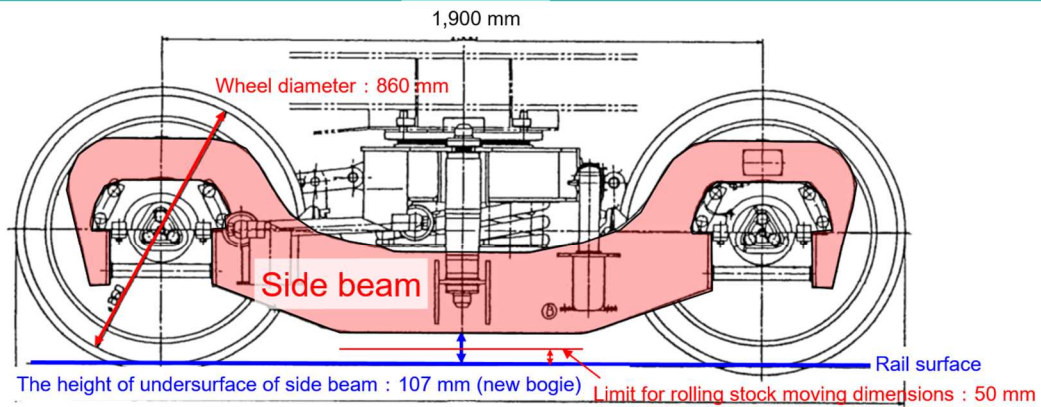
The side beam of the wagon's bogie

Here, it is required to pay special attention for the ice and snow formed higher than the height of rail surface in outside gauge in the track section where the freight trains are operated, considering the position of the side beam of the wagons that caused the concerned accident, when the snow removal works are implemented.
