~ Accident that the train derailed because the gauge widened significantly while the train was passing through the curved track ~

Railway operator : Kumamoto Electric Railway Co., Ltd.
 Accident type : Train derailment
 Date and time : At about 06:50, January 9, 2019
 Location : At around 1,660 m from the origin in Kita-Kumamoto station, between Kurokami-machi station and Fujisakigumae station, single track, Fujisaki Line, Kumamoto City, Kumamoto Prefecture

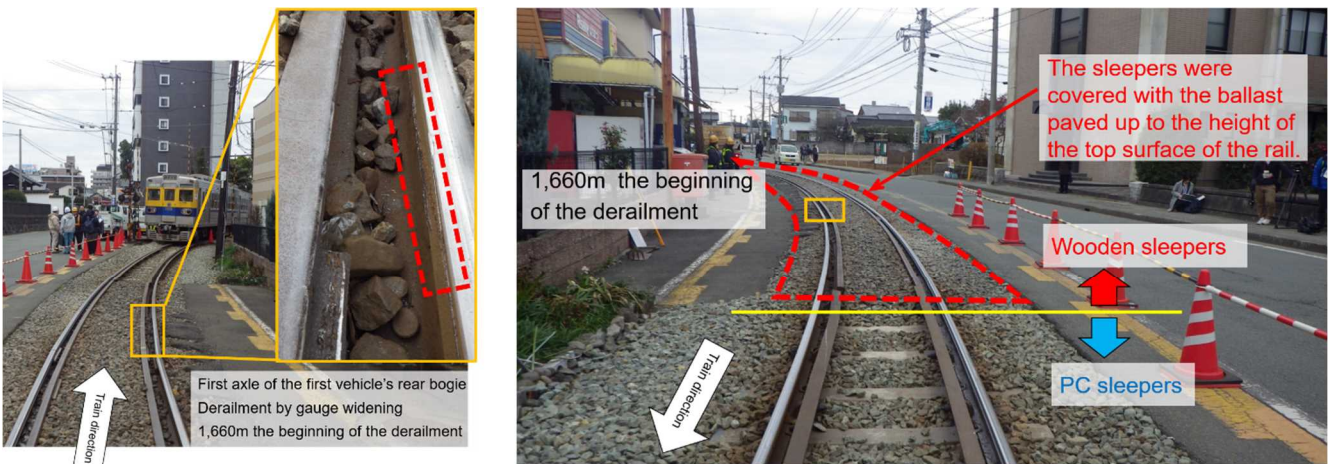
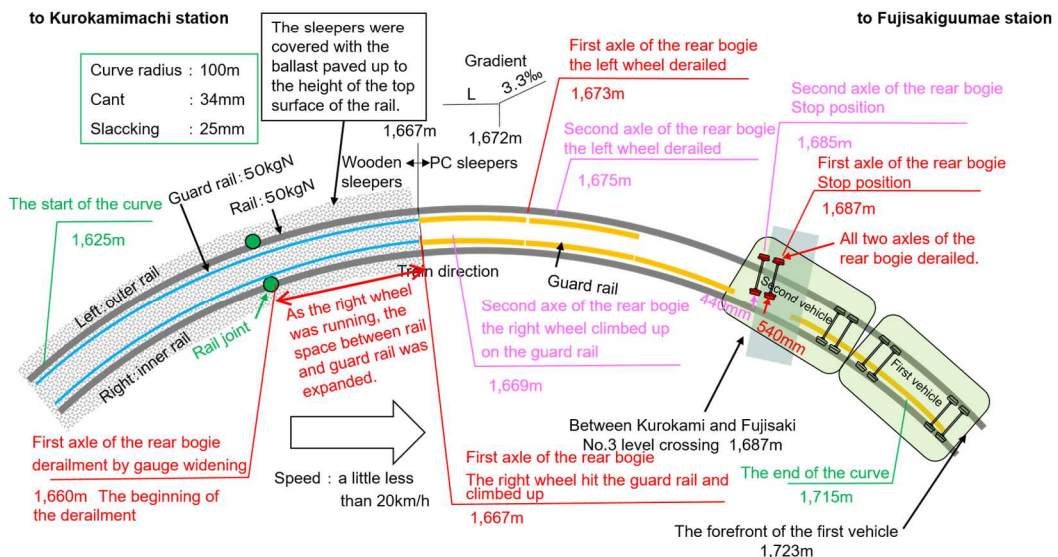
<The situation of the derailment>

After the train stopped, the driver checked the situation and found that all two axles in the rear bogie of the rear vehicle had derailed to left.

It is probable that the concerned accident occurred as the right wheel of the 1st axle in the rear bogie of the rear vehicle fell to inside gauge because the gauge was widened significantly while the train was passing the right curved track of 100 m radius, and after running as being widening the gauge, the left wheel flange of the same axle climbed up left rail and went off to left, and the 2nd axle of the same bogie followed to went off to left.

It is probable that the gauge had widened significantly as the gauge was dynamically widened due to the rail tilting etc., caused by the lateral force by the running train, because the inferior rail fastening devices existed continuously in the concerned curved track.

It is probable that the inferior rail fastening devices existed continuously because the inspection of the sleepers and the rail fastening devices was not implemented well as the sleepers were covered by the ballast spread in the height of upper surface of the rail, and the measures preventing the recurrence of the same kind accident occurred in 2017, such as the replacement to the prestressed concrete sleepers or the additional driving spikes, had not been implemented.

In addition, it is somewhat likely that the occurrence of the concerned accident was related with that the function of the guardrail to prevent the derailment could not work well, because of the decreased margin against derailment to inside gauge due to the relatively large slack in the curved track, and the dynamically enlarged width of the flange way by the tilting, etc., of the guardrail due to the lateral force acting on backside of wheel, etc., from right wheel caused by the insufficient fastening of the guardrail to the sleepers.

- (1) Steady implementation of the track maintenance
- (2) Revision of material of the sleepers
- (3) Study on the reduction of the slack
- (4) Proper installation and maintenance of the guardrails, etc.
- (5) Measurement of the dynamic irregularity of gauge

The above measures to prevent the recurrence of the accident had been implemented partly by the concerned company as the measures taken after the train derailment accident occurred in 2017, but it is necessary to implement certainly in the steeply curved track including the concerned accident site in high priority.

In addition, it is desirable that the improvement works should be implemented earlier as possible as to remove the ballast covering the sleepers, reinforce the track, etc., because the place where the sleepers were covered by the ballast for long extension in around the concerned accident site was in the status that the track maintenance works will become difficult as it is necessary to remove the ballast when the periodic inspections are implemented.
