RAILWAY ACCIDENT INVESTIGATION REPORT

Train Derailment Accident between Shibukawa Station and Shikishima Station, Joetsu Line, East Japan Railway Company

July 30, 2020

Railway operator: East Japan Railway Company
Accident type: Train derailment
Date and time: At about 22:53, June 28, 2019
Location: Around 98,246 m from Omiya station, between Shibukawa station and Shikishima Station, double track, Joetsu Line, Shibukawa City, Gunma Prefecture

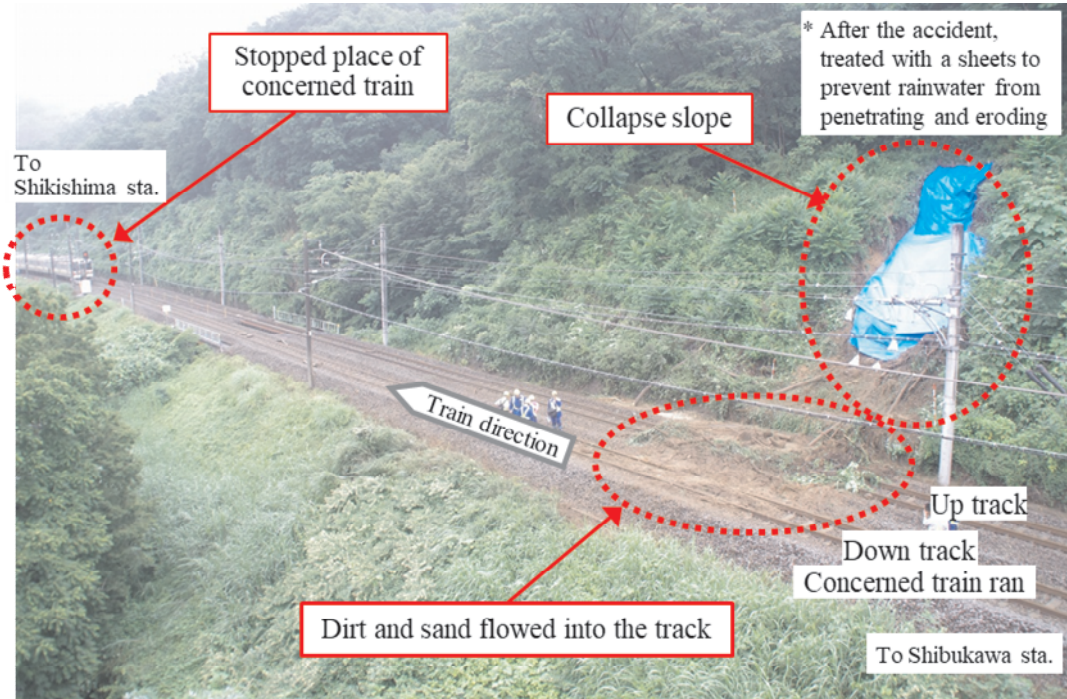
Attached Figure. 3 Status in around the Accident Site

Subsequently, when I checked the vicinity of the place where the fallen trees were found in the track, the slope on the adjacent track, the up track, side had been collapsed, and the dirt and sand on the collapsed slope flowed into the track. In addition, a large amount of water was continuously flowing from the collapsed slope, and a large amount of mud was deposited and spread between the slope and the railway track.

In addition, when the condition of the dirt and sand that flowed into the track was checked in the site investigation after the accident, a retaining wall with a height of about 1.3 m was installed at the lower part of the slope near the collapsed place, but the collapsed dirt and sand etc., overcame it and flowed into the track. The up track of the inflowing place of dirt and sand, centered in around 98,246 m, was covered by the fallen trees including logged woods and earth and sand for about 12 m in the direction of the track, and up to the position of about 0.6 m in height from the top surface of the rail, and the down track was covered for about 6m in the direction of the track, and up to the height of the top surface of rail, respectively. Besides, in the site investigation after the accident, there were no traces of spring water, etc., in the collapsed surface.

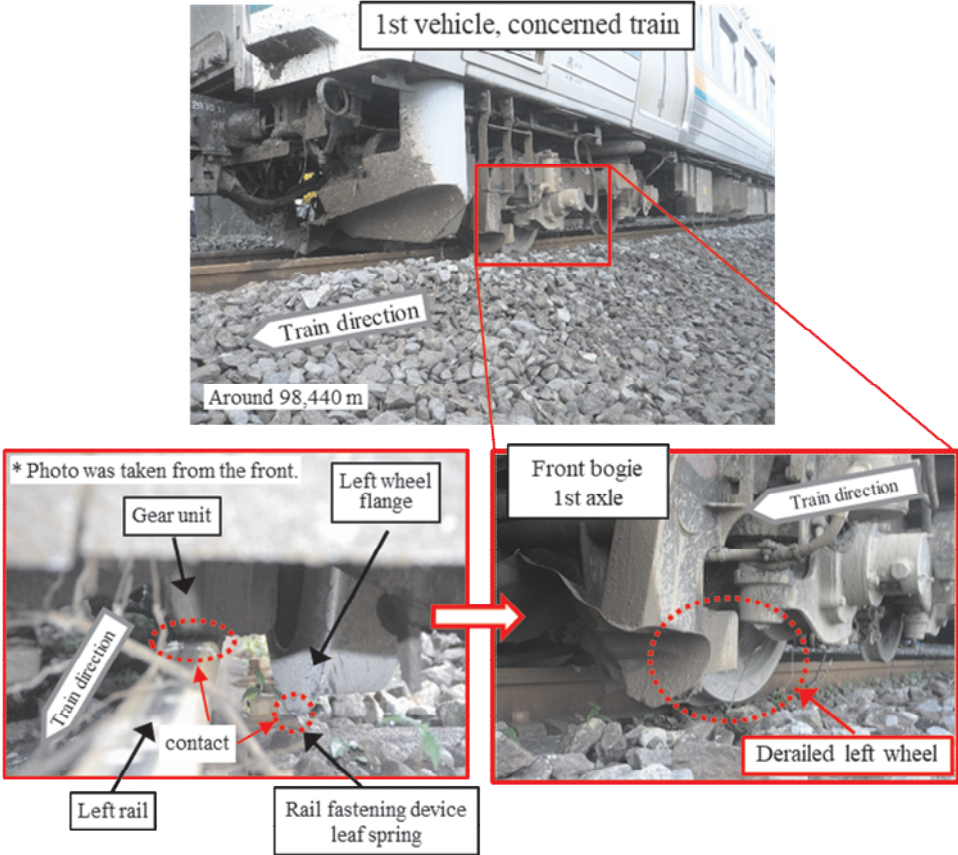
Attached Figure 4. Status of the Derailment

The first axle of the front bogie of the first vehicle of the train derailed to left.

The first axle of the front bogie of the first vehicle of the train derailed to left, *hereinafter, front, rear, left and right are based on the traveling direction of the train, and the vehicles are counted from the front.*

- (5) As described in 2.4.1 (1) (i), there were two consecutive damages in the direction of travel to the head of the rail fastening device bolts on the outside of left rail on the down track near 98,251 m.
- (6) As described in 2.4.1 (2), no trace of the running wheel flanges leading to derailment were found on the top surface of the rail before and after the inflowing place of dirt and sand.

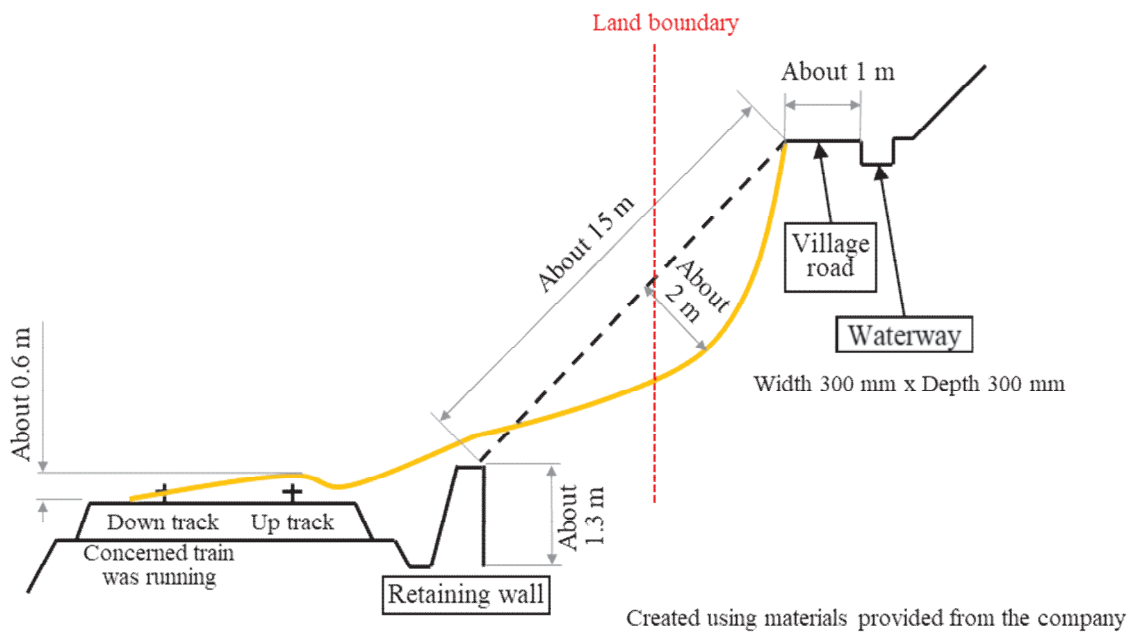
Attached Figure 6. Schematic Profile of the Collapsed Slope

As described in 3.5.2, it is likely that slope collapses were caused because the water content of the topsoil of the slope increased and the slope became unstable, as it is probable that the water overflowed from the waterway flowed as concentrated into the slope.

Therefore, it is desirable for the company to take measures such as installing equipment for detecting disasters and slope protection work in the collapsed slope in preparation for damages caused by flooding, etc., from the waterway. If measures are required outside the company's site, it is desirable to request and provide information to the managers, etc., and discuss on the measures among the parties.

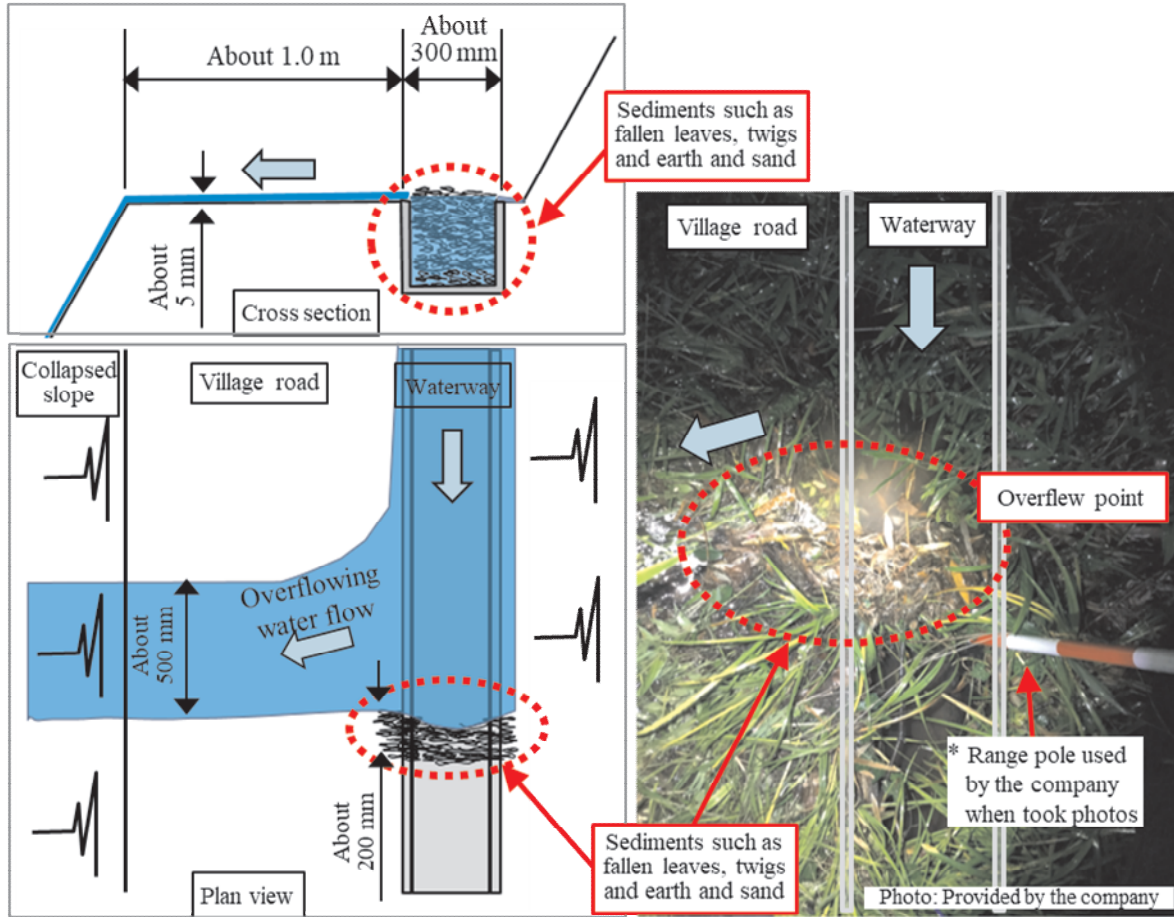
Attached Figure 7. Status of the Upper Part of the Collapsed Slope

When the condition of the upper part of the collapsed slope was checked in the site investigation after the accident, there were no abnormalities such as the damage to the waterway structure near the overflow point that could hinder the water flow function. In addition, there was the trace that water flowed from the waterway to the collapsed slope on the village road in the upper part of the collapsed slope.

- (1) As described in 2.3.1 (5) (i), when the facility staff of the company checked the upper part of the collapsed slope, it was confirmed that overflow occurred near the place of the collapsed slope of the waterway, and from there, the overflowed water crossed the village road in a continuous flow path shape with a width of about 500 mm and a height of about 5 mm and flowed into the collapsed slope.
- (2) As described in 2.3.1 (5), when the status of the upper part of the collapsed slope was checked in the site investigation after the accident, the trace of water flow was found on the village road in above the collapsed slope from the waterway to the collapsed slope.

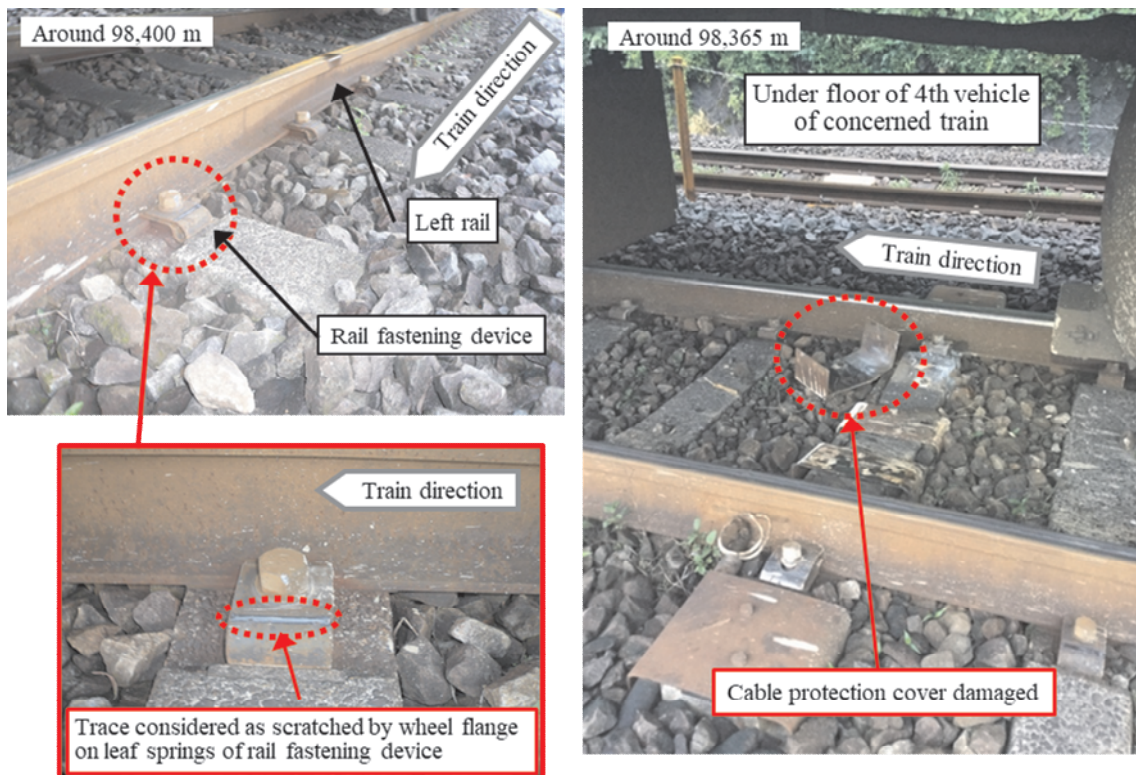
Attached Figure 8. Status of Major Damages of the Track

- (i) There were two consecutive damages, considered as caused by being contacted by the wheel flange, in the direction of travel on the head of the bolts of the rail fastening devices on the outside of left rail of the down track in around 98,251 m.
- (ii) There were intermittent traces, considered as caused by being scratched by the wheel flanges, on the leaf springs of the rail fastening devices on outside of left rail from around 98,252 m to around 98,440 m.
- (iii) A part of the PC sleepers in around 98,262 m and in around 98,340 m were damaged.
- (iv) The cable protection covers in around 98,340 m and in around 98,365 m were

damaged.

It is likely that the PC sleepers, cable protection cover, vehicle underfloor equipment, etc., were damaged as described in 2.4.1 (1) (iii) and (iv) and 2.4.2, were caused as the stones, trees, etc., were caught under the vehicle floor by traveling after the derailment, and these were in contact with the PC sleepers, the cable protection cover, the vehicle underfloor equipment, etc., and damaged, based on the followings.

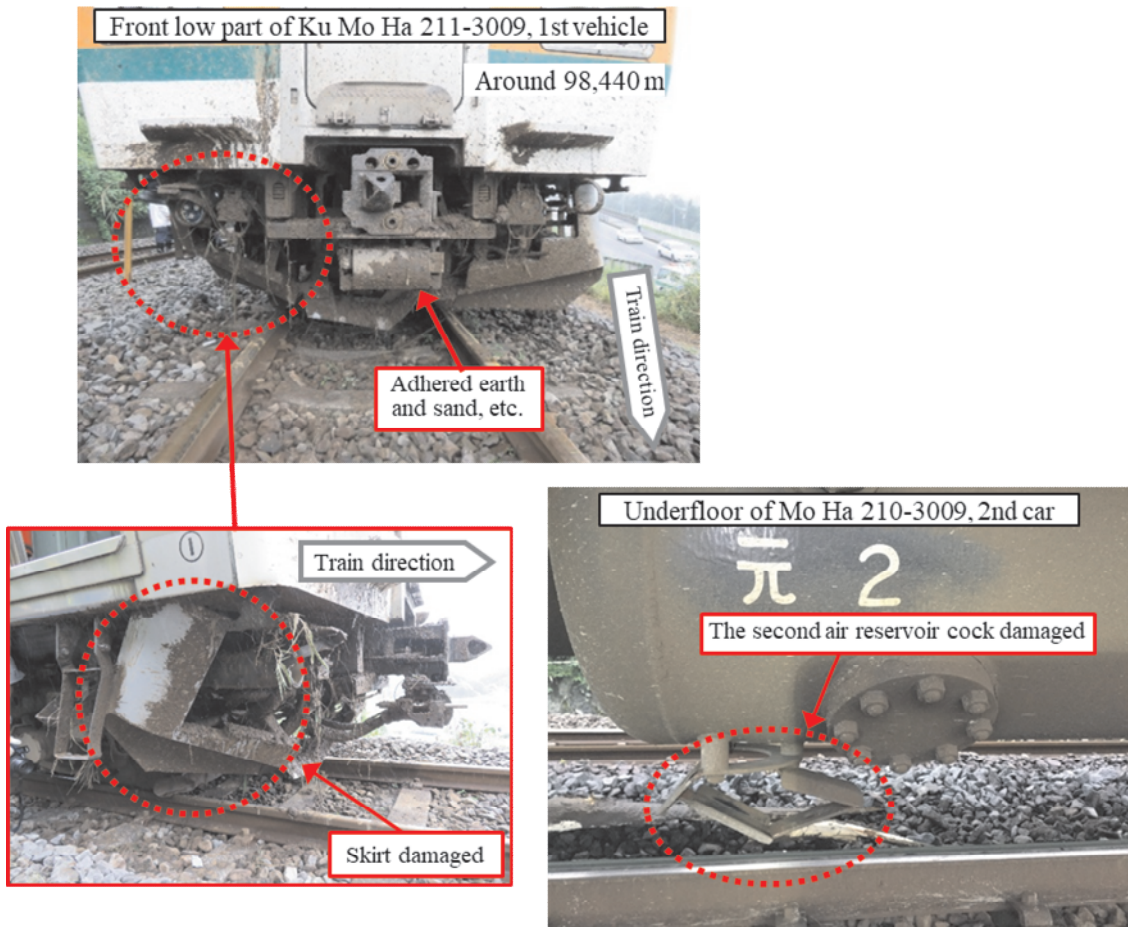
Attached Figure 9. Status of Major Damages of the Vehicle

The statuses of major damages in each vehicle are as follows. In particular, dirt and sand, etc., adhered, and many damaged parts were found on the equipment and wheel treads, in the underfloor of the 1st and 2nd vehicles.

The front skirt damaged, the front snowplow broken and damaged, the gear unit case, *i.e.*, the oil level gauge, damaged, the stroke adjuster rod support plate in each front and rear bogie bent and damaged, the ladder for climb up and down bent and damaged, the ATS onboard device damaged, the circuit breaker box, the traction motor isolator box, the auxiliary resistor box and the main resistor box, were bent and damaged, etc.

Each cock of the 2nd main air reservoir and the supply air reservoir were damaged, the stroke adjuster rod support plate in each front and rear bogie bent and damaged, the ladder for climb up and down bent and damaged, lower part of the traction motor damaged, etc.

- (4) As described in 2.4.2, earth and sand adhered to the underfloor of the 1st and 2nd vehicles, and there were many damaged places on the equipment and wheel treads, and the front skirt of the 1st vehicle was damaged.

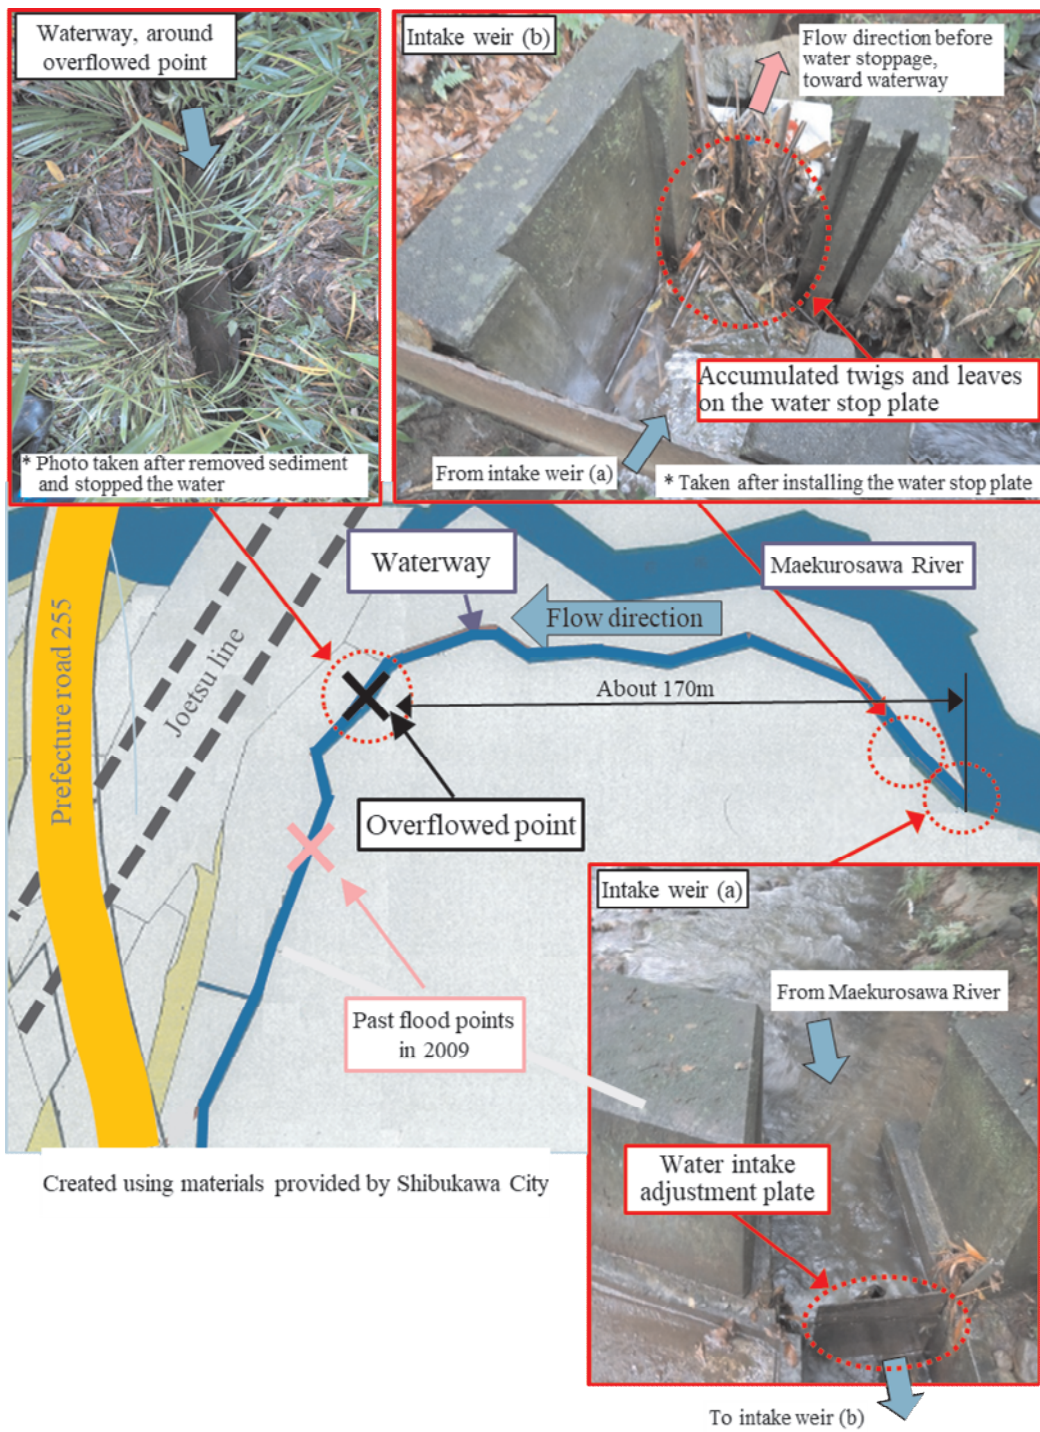
Attached Figure 12. Status of the Waterway

When the condition of the waterway was checked in the site investigation after the accident, a board, etc., for stopping water were installed at the intake weir, and twigs and leaves were accumulated there. According to the company, the board was installed by the local residents after the accident and before the site investigation was started.

According to the company, regarding the status of flooding in the waterway so far, in August 2009, at a position about 20m downstream from the location where the flood occurred at the time of the accident, it is said that the accumulation of leaves, etc., in the waterway caused poor water flow and overflowed water, which caused the slope outside the nearby railway site to loosen and collapse. At this time, the collapsed earth and sand, etc., did not flow into the track, so the train operation was not hindered. In light of the occurrence of this event, measures have been taken to raise the side wall of the waterway over about 10 m near the overflow point.

these works were not set on a planned date in advance but was carried out when it was noticed that the amount of water in the waterway that was passed to the vicinity of the village had decreased. Therefore, it is probable that the management was not always properly performed according to the facilities of the waterway, which has a structure in which branches and leaves are likely to accumulate in the waterway, such as that the inspections, etc., have not been carried out in advance from the viewpoint of preventing flooding due to poor water flow caused by the sediments, and the waterway is in an open status without being covered, and the screen including the intake weir is not installed.

- (iii) An urgent inspection was conducted in all lines of the company, targeting areas, where waterways are laid in the upper part of the cut slope along the track side similar to the accident site, etc., and urgent measures such as repairs were taken for areas where abnormalities such as waterway damage and poor water flow, etc., that might hinder the train operation were found in the result of the inspection. In addition, the company requested the owners of each waterway that took urgent measures, to ensure proper management of the waterway.

- (iii) After extracting similar waterways near the railway track same as the waterway, the laying environment and usage conditions were investigated, and study on the measures to prevent flooding were started.
