"The accident that the train derailed because the gauge widened significantly while the train was running in the curved track"

Railway operator : Aizu Railway Co. Ltd.
 Accident type : Train derailment
 Date and time : About 19:08, December 24, 2019
 Location : Around 26,888 m from the origin in Nishi-Wakamatsu station, between Tonohetsuri station and Yagoshima station, single track, Aizu Line, Shimogo Town, Fukushima Prefecture

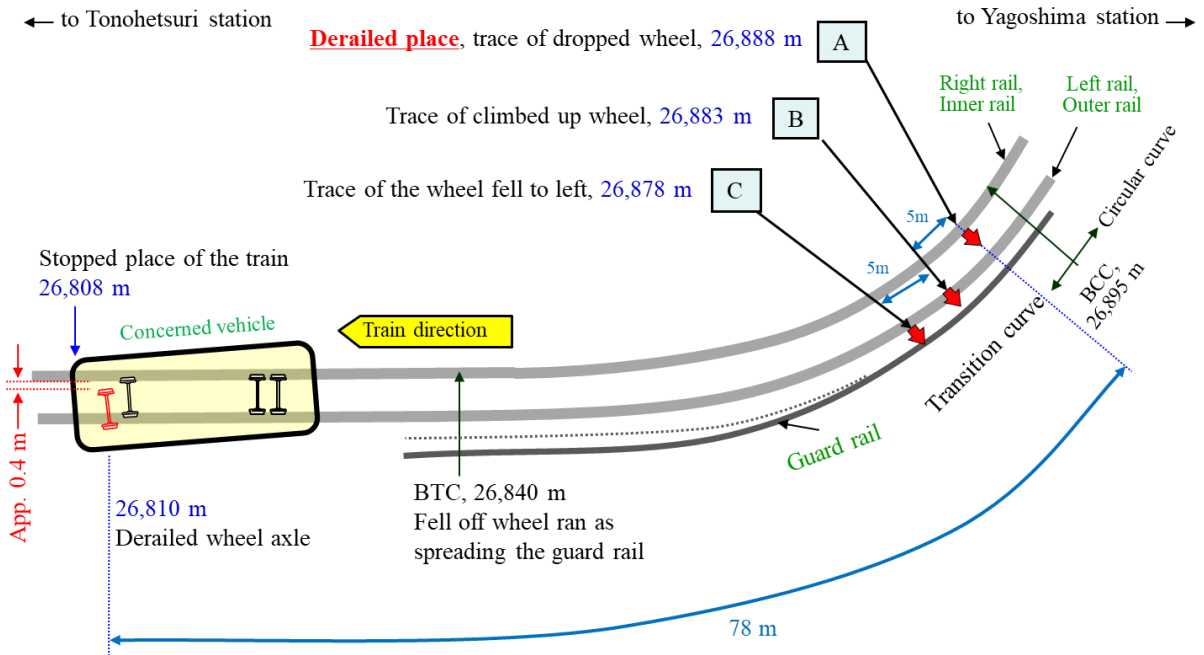
<STATUS OF THE DERAILMENT>

When inspected the vehicle after stopped, it was found that the 1st axle in the front bogie of the vehicle had been derailed to left.

It is probable that the concerned accident was caused as that right wheel of the 1st axle in the front bogie fell to inside gauge because the gauge widened significantly while the train was passing through the 200 m radius right curve.

It is probable that the gauge widened significantly because the rail tilting and the lateral displacement of rails occurred due to the lateral force acted while the train was running caused by the continuously existed poor sleepers and the floating spikes in the rail fastening devices, in addition to the large track irregularity of gauge in the concerned curved track.

- (1) Steady implementation of the inspection of sleepers, etc., and the track maintenance.
- (2) Change the material of the sleepers.
