RA2021-1-I

# **RAILWAY ACCIDENT INVESTIGATION REPORT**

**Railway accident with casualty in the premises of Shin-Sugita station,  
Kanazawa Seaside Line, the Yokohama Seaside Line Co., Ltd.**

Railway operator           Yokohama Seaside Line Co. Ltd.  
Accident type               Railway accident with casualty  
Date and time               About 20:15, June 1, 2019  
Location                     In the premises of Shin-Sugita station, Kanazawa Seaside Line,  
                                  City of Yokohama, Kanagawa Prefecture

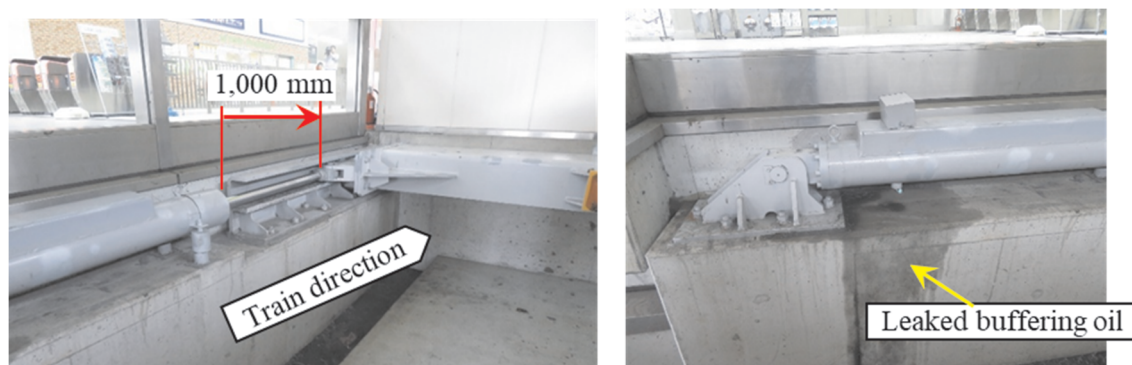
Figure 3. Status of the hydraulic buffering device after this accident

The hydraulic buffering device of the car stop in the track No.1 of Shin-Sugita station, described in 2.3.3, struck the guide end and stopped after lengthened about 1,000 mm by the collision of the Train. However, there was no significant damage in the other facilities in the station, even though the oil leaked from the hydraulic machinery.

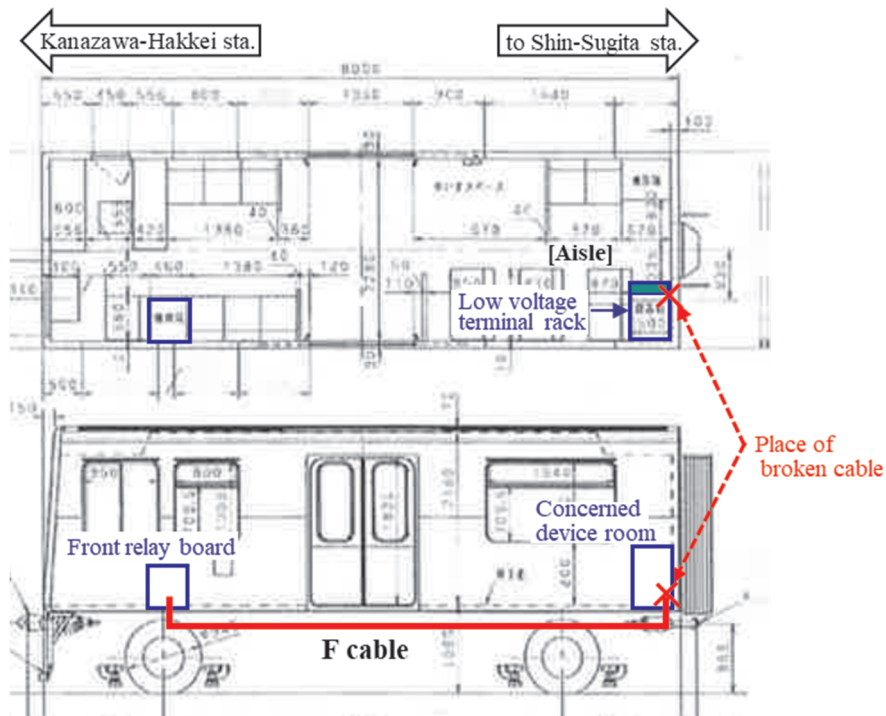
Figure 4. Route of the F cable and the broken place in the Vehicle

In the investigation on the status of the vehicles implemented after this accident, it was found that the F cable, which is the command cable transmitting the running direction of the train to the motor control device, etc., described in 2.3.2, was broken in the device room in the rear left of the

cabin of the 1st vehicle, hereinafter referred to as "*the Device Room*" and sometimes referred to as "*the Vehicle*", respectively, and the other side of the broken part was melted and adhered to the part of the end structure\*<sup>23</sup> attached to near floor board of the vehicle body, hereinafter referred to as "*the end rail*"\*<sup>24</sup>. [Refer to Figure 4]

The F cable, which is wired from the front relay board, via under floor, lifted to above the floor through the wiring hole in the floorboard of the Device Room and connected to the low voltage terminal base installed in aisle side in the Device Room, was broken at the upper part of the end rail in the Device Room, and the broken electric wire in the side to be connected to the low voltage terminal base, was melted and adhered to the end rail. On the other hand, the tip of the broken electric wire in the side to be connected to front side was in the status as a little round. In addition, the broken electric wire connected to front side was the side to be connected to the control circuit breaker and the front relay board, and the melted and adhered electric wire in the low voltage terminal base side was the cable connected to the motor control device and to the 2nd vehicle.

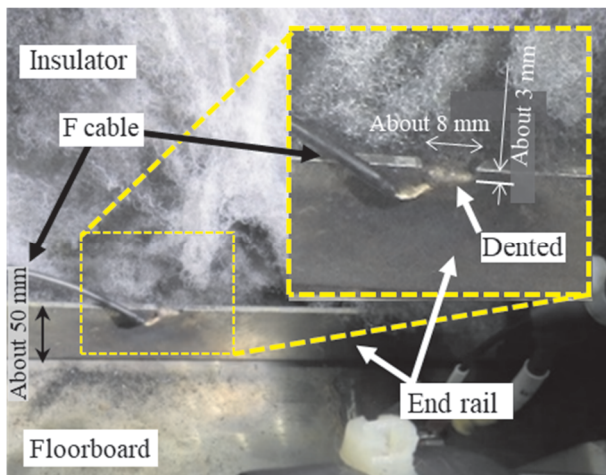
In addition, the adhered part in the end rail was dented in about 8 mm wide and about 3 mm depth, and the black materials were adhered in the both surfaces of the parts in its peripherals.

Status of electric wire, in low voltage terminal side, melted and adhered to the vehicle material.

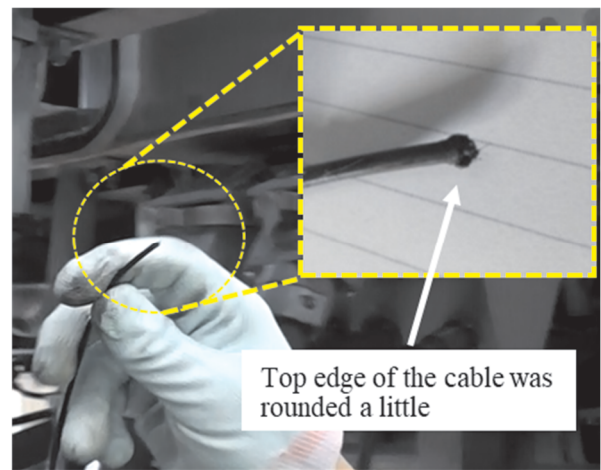
Broken status of electric wire in front side

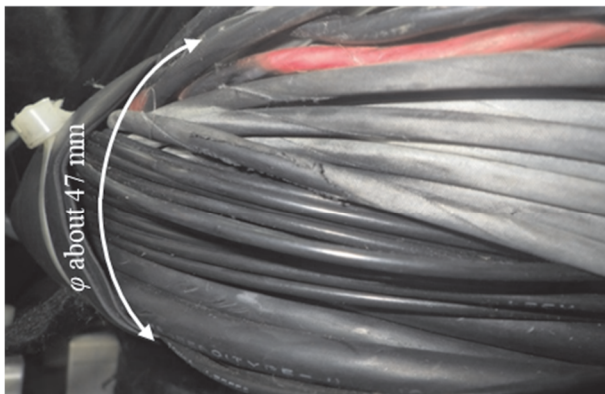
Furthermore, the black materials were adhered in around the melted and adhered place in the bundle of cables\*<sup>25</sup> wired in the nearest place to the end rail, and the sheath of the outer most cable was torn. [Refer to Figure 5]

Status of bundle of cables in around the place where cable was melted and adhered

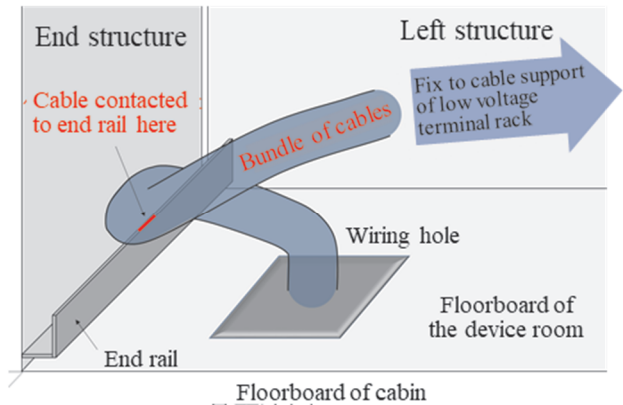
Status of bundle of cables in the Device Room

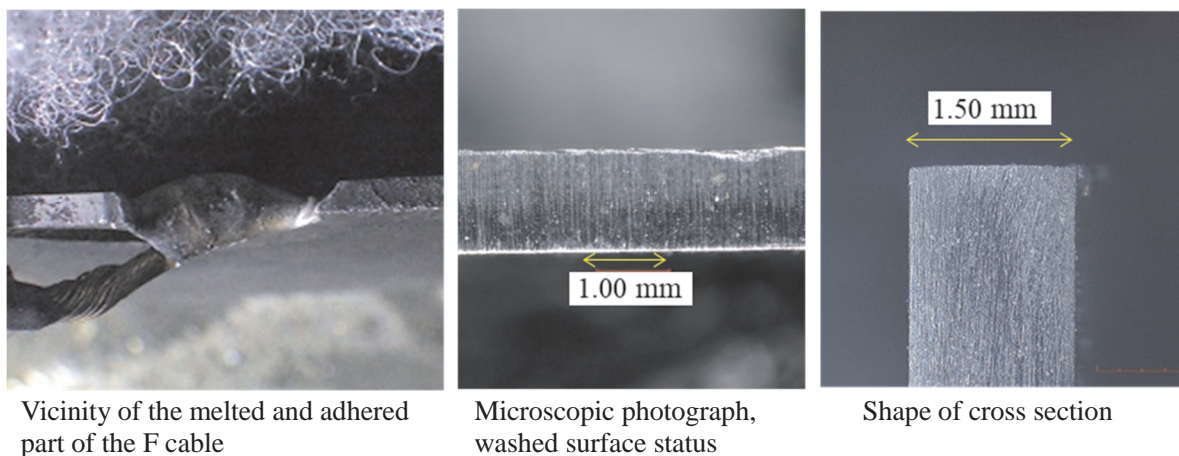
Figure 8. Shape of the top surface of the end rail

The end rail is the 1.5 mm thick stainless steel plate, attached in the Device Room as its upper surface is about 50 mm apart from the floor board, about 20 mm apart to inside from the end structure.

The upper surface of the end rail is made as square shape cut by the laser cutting, but the resin protecting material, *hereinafter referred to as "the vehicle material side protectors"*, to prevent damage of the electric wires, etc., attached to the materials of vehicle such as the body structure, the racks for devices or the interior finishing materials, etc., *hereinafter referred to as "the vehicle materials"*, was not attached. Furthermore, the adhesive for insulating material pasted to inside of the end structure were adhered on its surface. The shape of the corner part was almost rectangular, without chamfered nor grinder finishing, then the surface felt rough when touched by hand. [Refer to Figure 8]

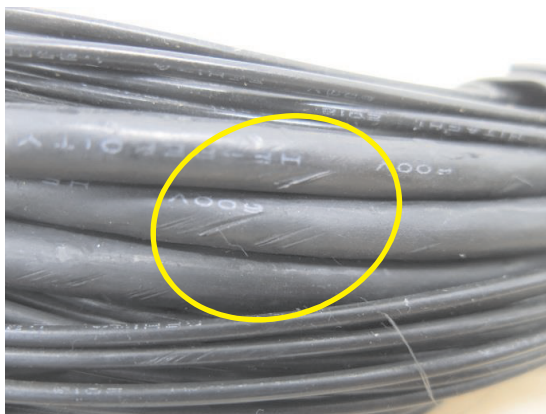
Figure 10. Flaws in the other cables

As the results, there were 107 electric wires, etc., in the bundle of cables, and the broken wires, etc., was not found except for the F cable, but there was the cable having the askew flaw in its insulator, and the black material adhered to the surface was the soot. In addition, as the results of the analysis on the surface of the end rail, where the F cable had melted and adhered, the surface of the melted and adhered portion was the alloy of the stainless steel and the copper. As the melting point of the stainless steel is over 1,400 °C, it is confirmed that the temperature when short circuit was in high temperature. [Refer to Figures 10 and 11]

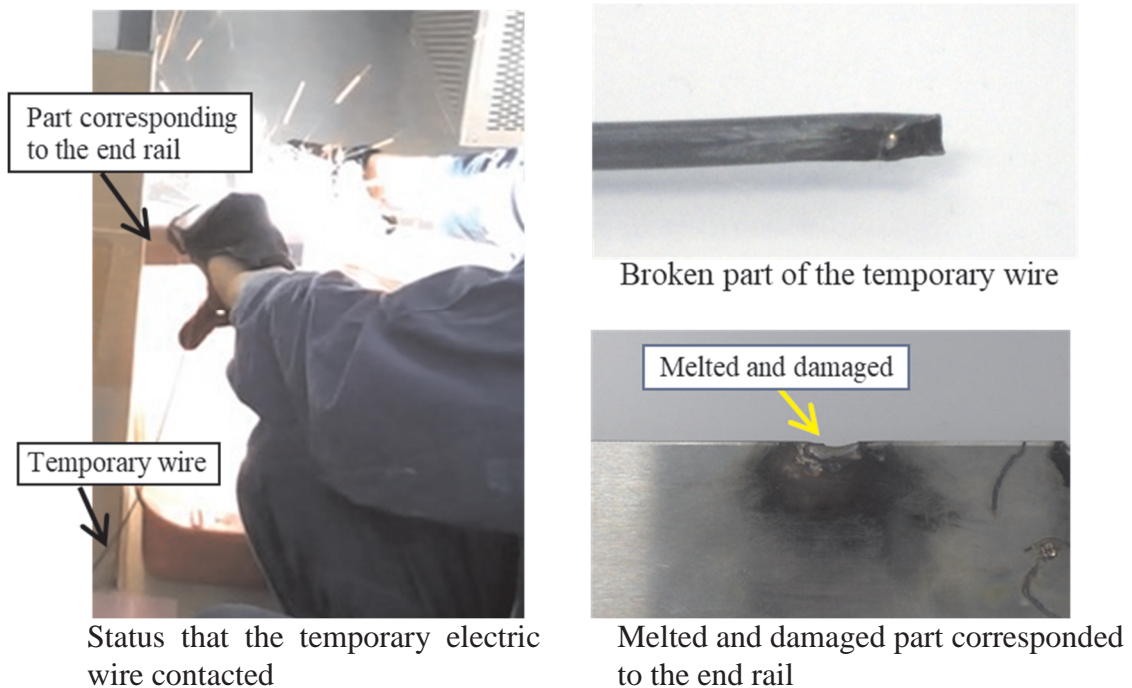
Figure 13. Status of the reenacting test of the ground faults

When the temporary electric wire covered by the flawed insulator was made to contact with the parts made of the same material and thickness as the end rail fixed to the body structure, the spark was generated and the temporary electric wire was broken. The tip of the broken temporary electric wire was discolored a little as same as the F cable in the Vehicle, and the part corresponding to the end rail was melted and damaged in the place contacted with the temporary electric wire. [Refer to Figure 13]

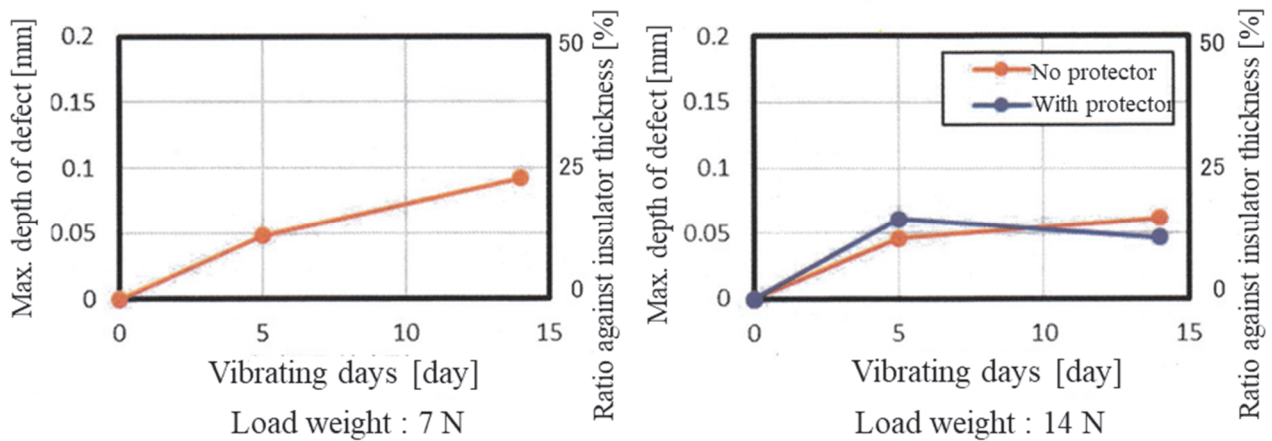
Figure 17. The maximum fault test of the vibration testing electric wires by the vibration test

After vibrating 5 days or 14 days, the maximum depth of the faults in the insulator of the vibration testing electric wires were measured, individually. As the results, the major results as the followings were obtained in the above test conditions.

- It was confirmed that the insulators flawed in both cases of the load weights 7 N and 14 N.
- The thickness of the insulators reduced over 10 % by the 14 days vibration test.
- The insulator of the vibration testing electric wires flawed even in the case that the vehicle material side protectors was attached to the jig, and the maximum depth of the flaw was in around the same level when the protector was not attached. [Refer to Figure 17]

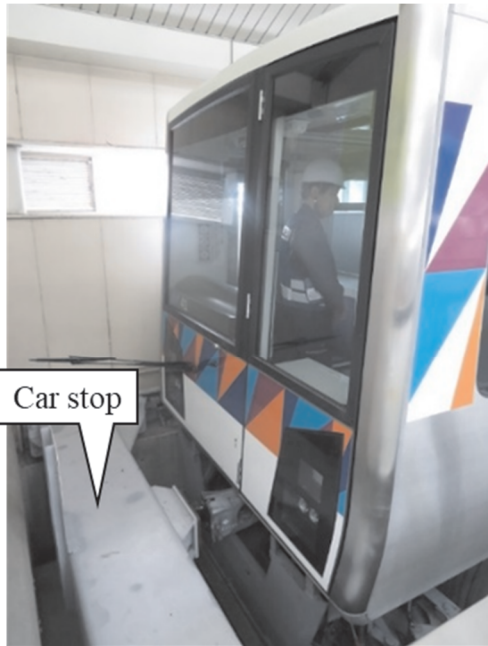
Status of collision with the car stop, the 5th vehicle

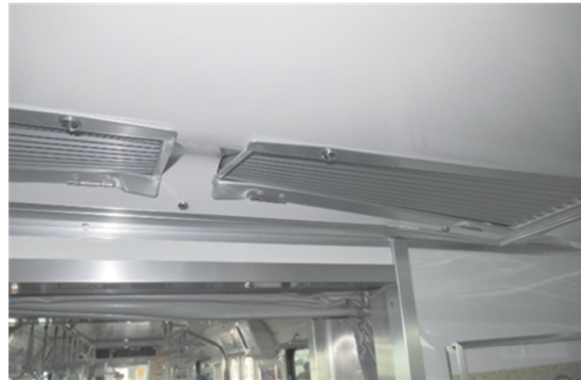
Distortion of the ceiling panels in Shin-Sugita station side of the 4th vehicle

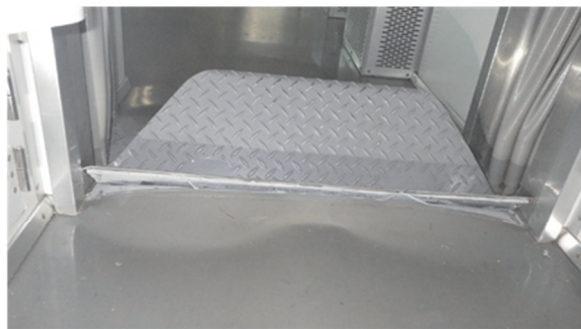
Inside cabin in the coupled part between the 4th and the 5th vehicles

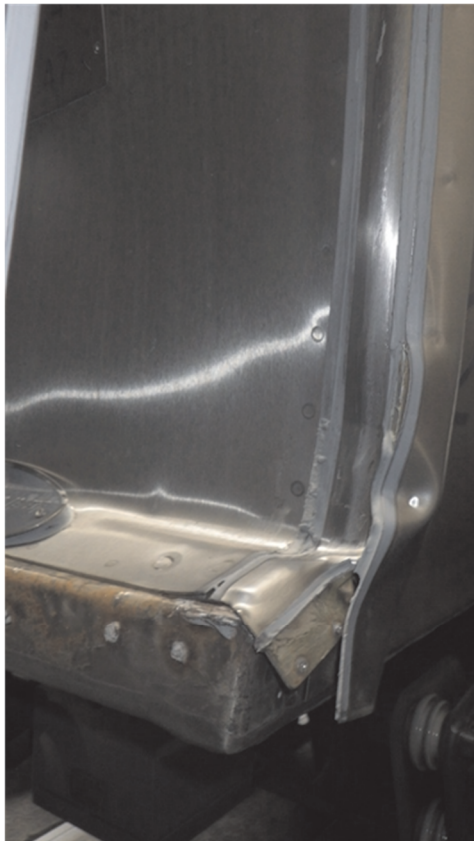
Dent of the end plate, Shin-Sugita station side of the 2nd vehicle

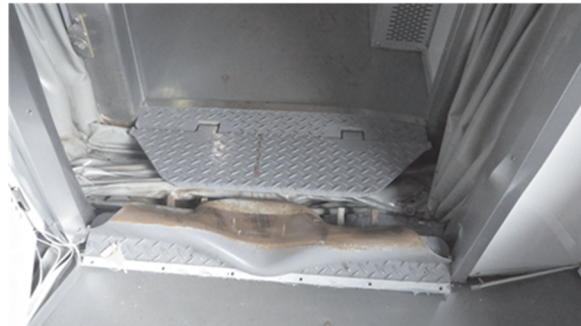
Inside cabin of the coupled part between the 2nd and the 3rd vehicles

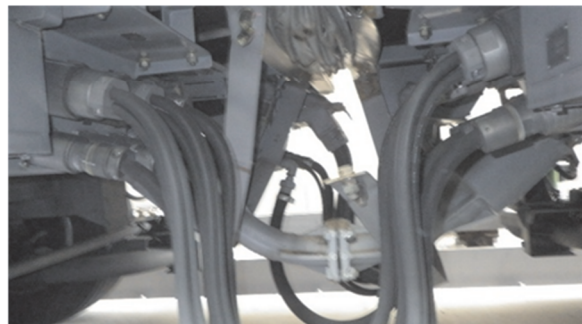
Bent intermediate coupler, between the 4th and the 5th vehicles
