RA2021-1-II

RAILWAY ACCIDENT INVESTIGATION REPORT

**Train derailment, accompanied to the level crossing accident,
in the premises of Kanagawa-shimmachi station,
Main Line, Keikyu Corporation**

February 18, 2021

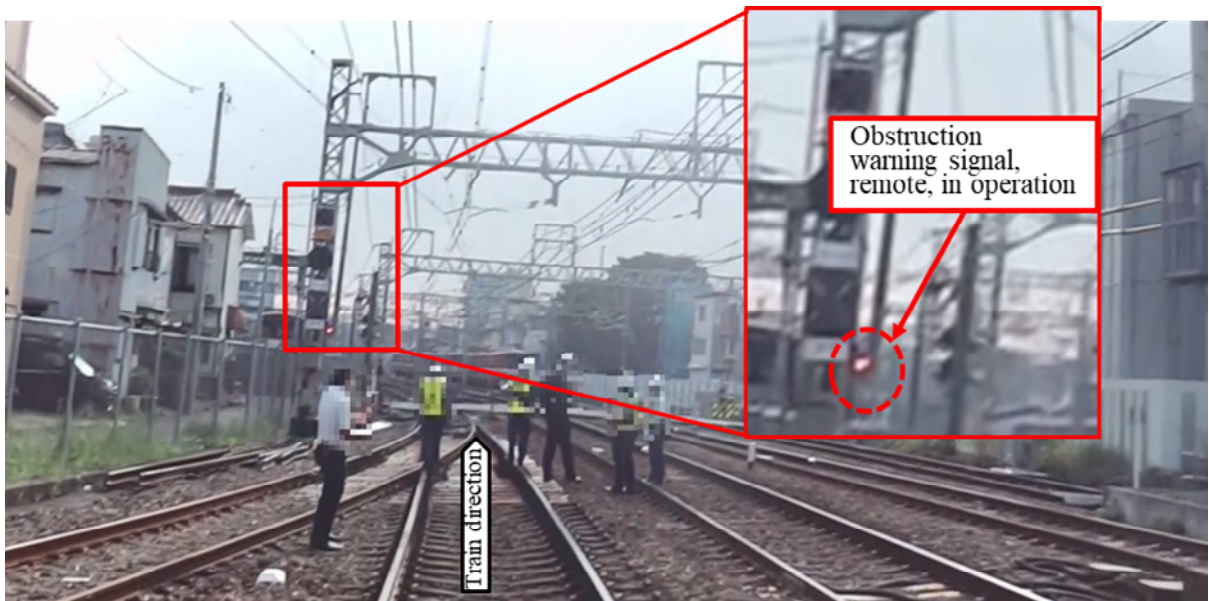
Figure 6. Sighting status of the remote OWS on the accident day

The sighting status of the remote OWS was confirmed from the edge of the platform for down line of Koyasu station, at 19,398 m, around the sighting position of the signal for the remote OWS of the Level crossing described in 2.4.2.9, and then the flickering status could be confirmed as shown in Figure 6. Additionally, the confirmation of the sighting status was implemented in the status that the railway accident investigator was watching on the sleeper around the left rail, where the eye height was about 1.6 m above tail surface, while the remote OWS was indicating the stop signal, *i.e.*, flickering, on the day of the occurrence of this accident.

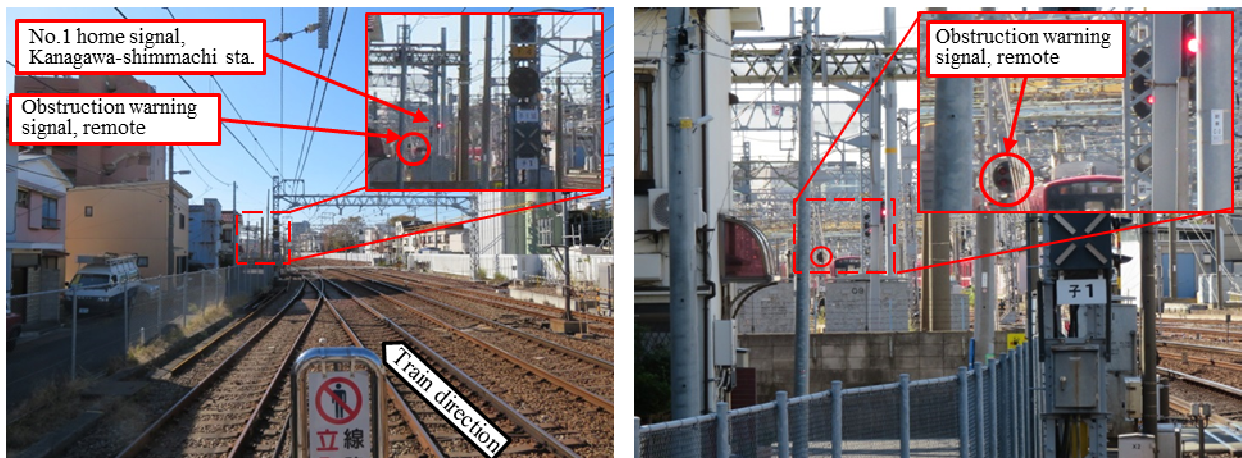
Figure 7. Sighting status of the remote OWS from the platform of Koyasu station

As shown in Figure 7, the display part of the remote OWS in the turned off status of the lamps could be sighted from the platform through the gaps between poles, etc., installed in the main tracks and the depot lines, etc.

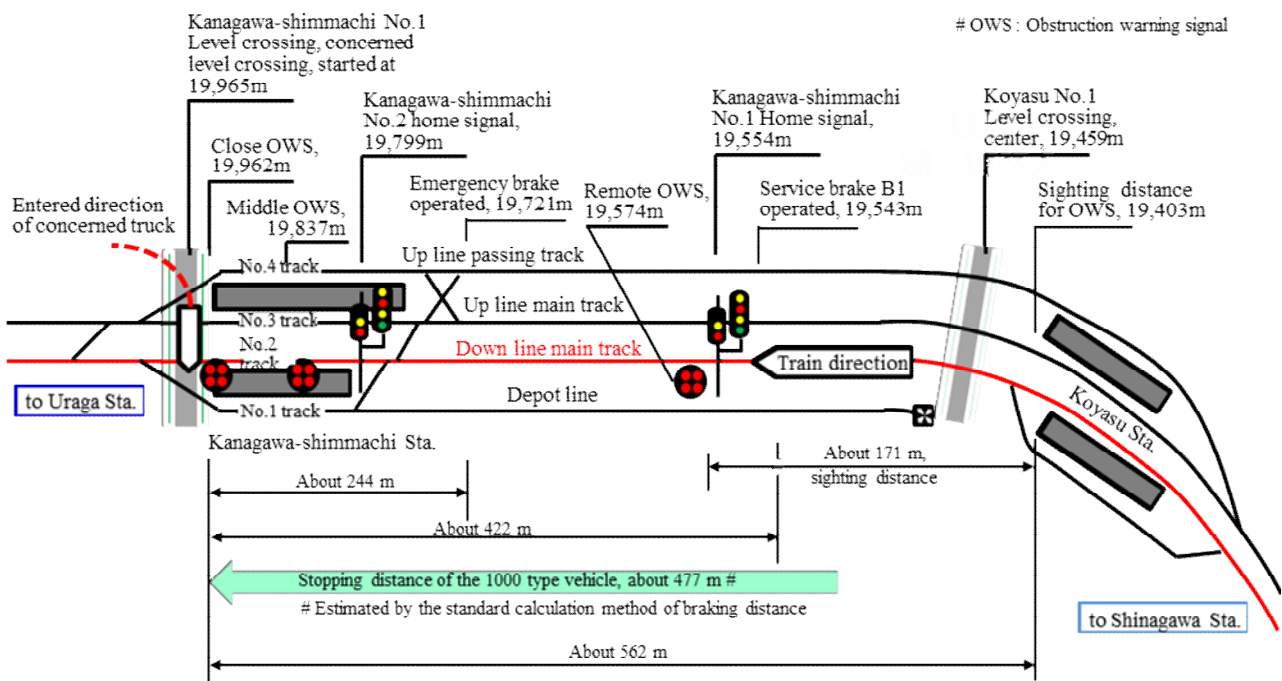
Figure 9. Relationship between the braking operation of the Driver and visibility of the OWS

The distance from the Train described in the above to the end edge, in the direction to the origin, of the Level crossing, 19,965 m, was about 422 m. Furthermore, the braking distance by the emergency brake from the velocity 120 km/h excluded the idle running distance of the 1000 series vehicle was about 477 m by the trial calculation, as described in 2.5.3.1. Therefore, it is probable that the Train could not stop before the Level crossing, even if the Driver operated the emergency brake when he had operated the service brake.

It is likely that the velocity could be reduced at the time of collision if the Driver took the emergency stop procedures by the emergency brake promptly when he had operated the service brake. However, the Company stipulated to use the service brake when the driver stops the train as the principle, under the rule "when the special signal was indicated, stop immediately". And the Company had been entrusted the driver to judge which brake of the service brake or the emergency brake should be used when the stop signal is indicating in the OWS considering the velocity and the distance, etc. Therefore, it is likely that the above situation related with that the brake to be used had not been stipulated clearly in the implementing standard of handling operation and the working standard of the driver of electric railcar.

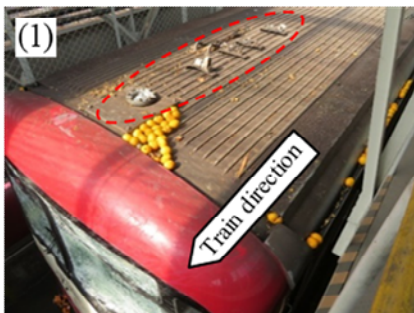
Train radio antenna damaged.

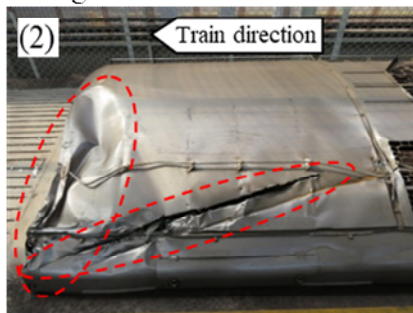
Air conditioner damaged.

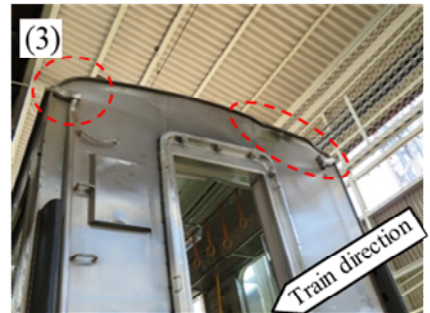
End of vehicle body damaged.

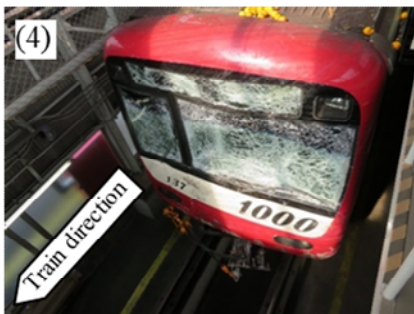
Glass in front window damaged.

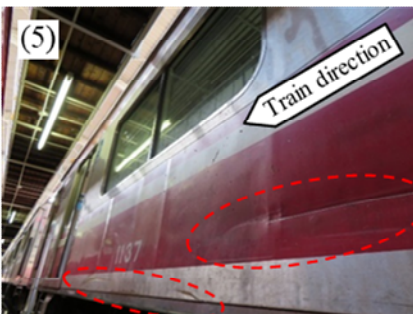
Side of vehicle body damaged.

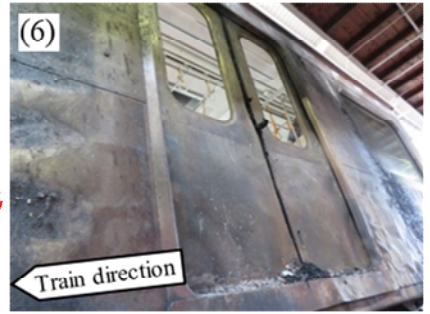
Doors for passengers damaged.

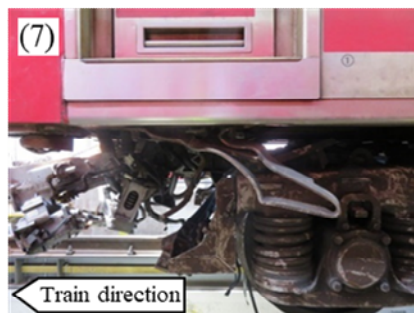
Front skirt damaged.

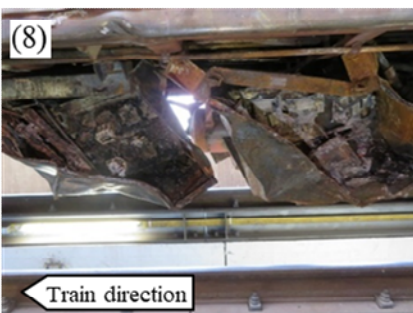
Underfloor apparatus damaged.

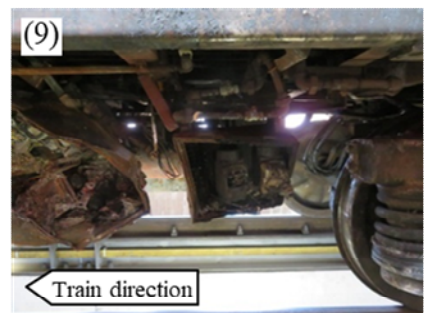
Underfloor apparatus damaged.

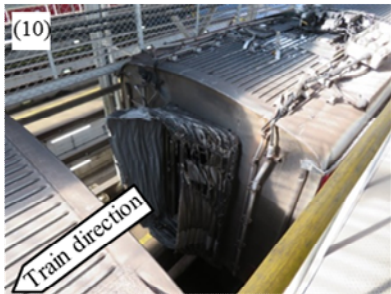
End of vehicle body damaged.

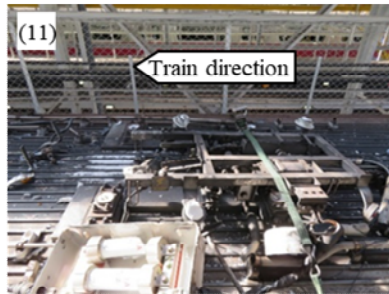
Pantograph damaged.

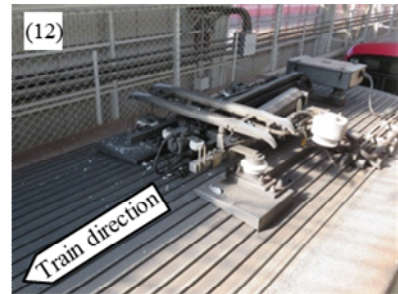
Pantograph damaged.

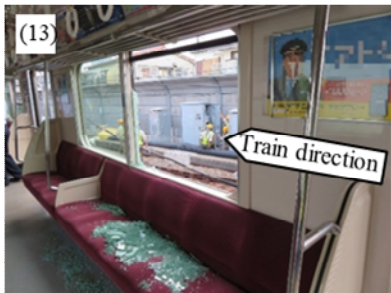
The glasses of right windows, the end part of the vehicle body, the rear part of left side surface, and the under floor equipment were damaged.

Glass in right window damaged.

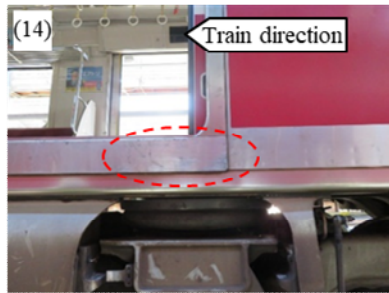
Rear left side surface damaged.

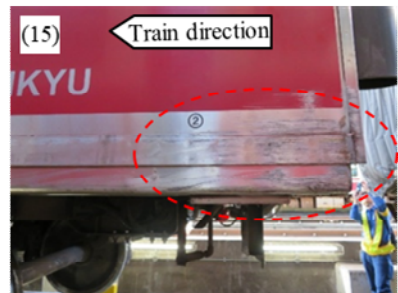
Rear left side surface damaged.

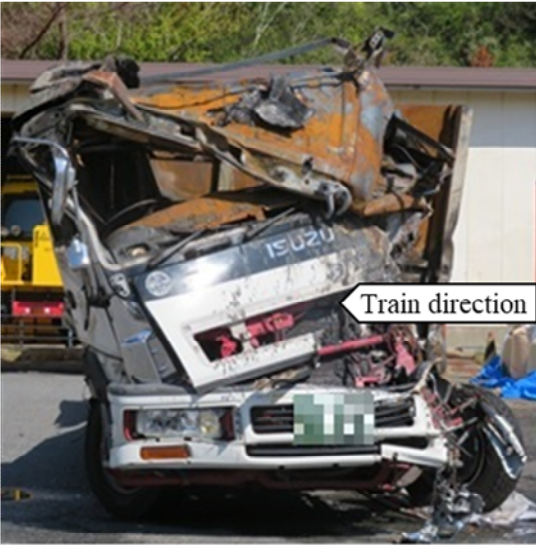
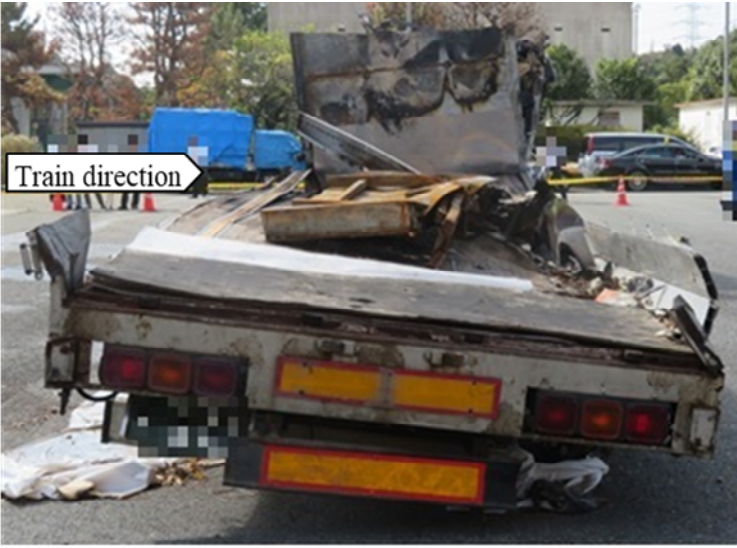
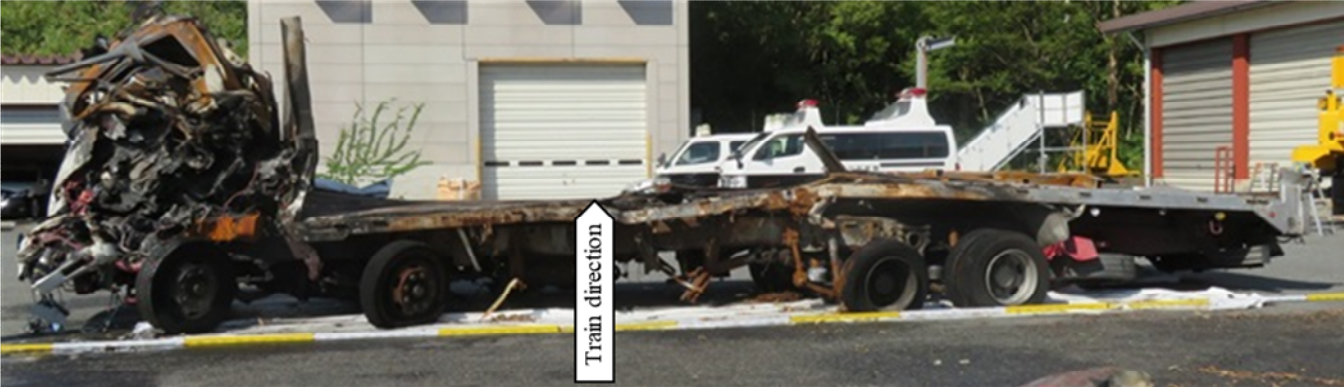
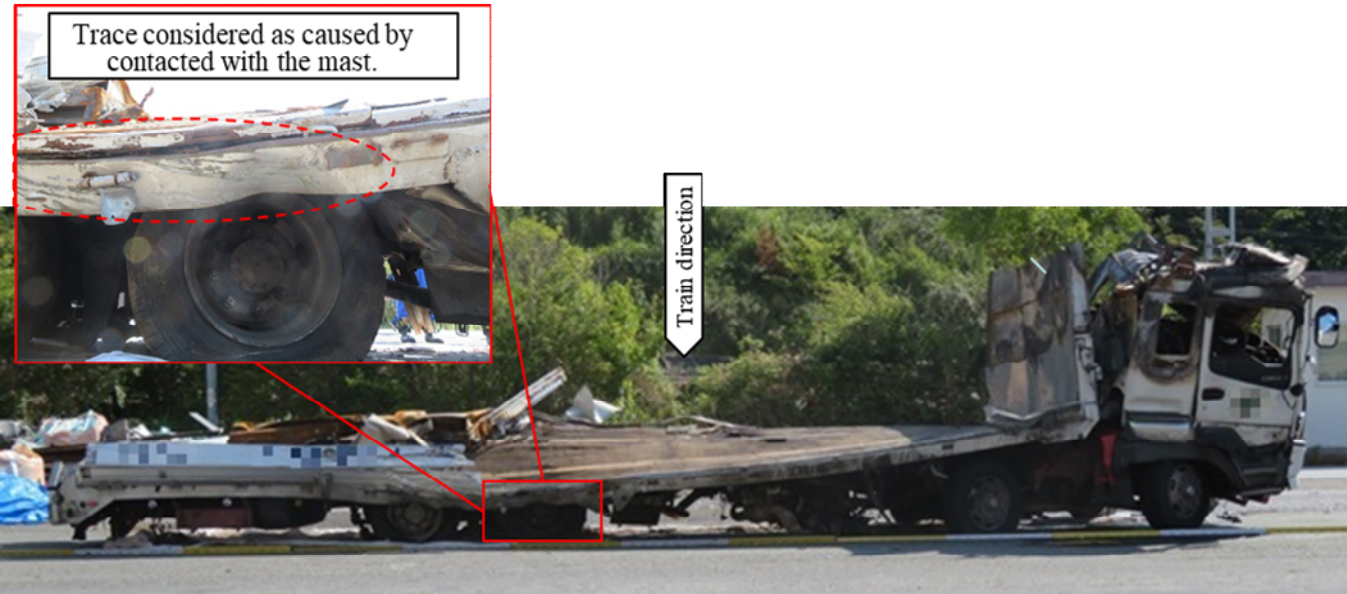
Attached Figure 8. Damaged Status of the Truck

The status of the major damages by this accident of the Truck were the damages and deformations around the center part of left side of the load-carrying platform considered as caused by collision with the Train. In addition, there were the damages and deformations, considered that the bogie of the 1st vehicle of the Train climbed up after collided, from the assistant driver's seat to the driver's seat, and the cabin was damaged by a fire. Additionally, there was the trace considered as caused by hit with the mast planted in the direction of Nakakido station of the Level crossing, around the rear wheels in right side of the load-carrying platform.

- (2) As described in 2.3.1, there was the trace, considered as caused by the impact against the mast planted in Nakakido station side of the Level crossing, in the Truck.
