"The train derailment accident caused by the collision of train and compact sedan occurred in the class 1 level crossing"

Railway operator : Chikuho Electric Railroad Co. Ltd.
 Accident type : Train derailment, accompanied to the level crossing accident
 Date and time : About 19:22, March 10, 2020
 Location : Around 11,137 m from Kurosaki-ekimae station, Chikuho-Katsuki No.7 level crossing, Class 1 level crossing equipped with crossing gate and road warning device, between Kusubashi station and Chikuho-Katsuki station, double track, Chikuho Electric Railroad Line, Kitakyushu City, Fukuoka Prefecture

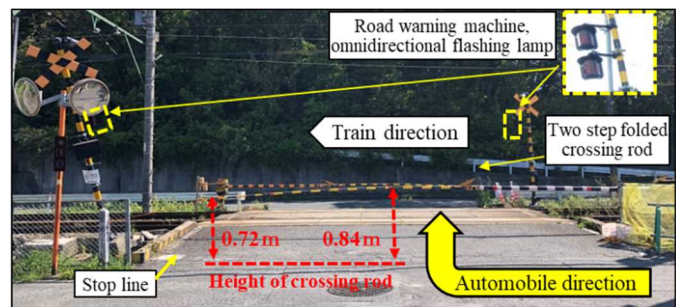
<Status of Chikuho-Katsuki No.7 level crossing viewed from entered direction of the compact sedan>

The JTTSB concludes that the probable cause of this accident was that the approaching train collided with the compact sedan at the velocity of about 50 km/h, and right wheels of the train ran onto right rail and derailed in this accident, because the compact sedan turned right and

entered the level crossing as pushing up the crossing rod in the status that the road warning device was operating and the crossing rod had been lowered, and stopped, and the compact sedan was caught between left side surface of the train and the concrete column for the overhead trolley, etc., and pushed out the vehicle body of the train to right.

It is desirable to make the level crossing easier to be noticed such as to install the signs. etc., to aware the existence of the level crossing while running in the road before turn right, at the same time, to paint again the blurred stop lines and to install the dangling belts to the crossing rod, etc., in order to prevent accidents from happening, because this accident had occurred in the level crossing just after the compact sedan had turned right. In addition, it is desirable to let the passersby of the level crossing known well to stop once before the level crossing and confirm the safety thoroughly. Furthermore, it is desirable for the railway operators to discuss with the relevant parties such as the road administrators or the police, etc., to take measures to prevent stopping of cars in the level crossing by securing the space just across the level crossing to confirm the status of the road as being stopped cars responding to the status of the road traffic volume.

[3] Responding to the discussion in the above [2], the road administrator, *i.e.*, Kitakyushu City, painted again the blurred stop lines, and installed the light-emitting type road rivets to promote the attention of car drivers, on October 2, 2020.
