"The accident that the train running in the curved section, where poor rail fastening status had been existed continuously, derailed due to the widening gauge"

Railway operator : Nagaragawa Railway Co., Ltd.  
 Accident type : Train derailment  
 Date and time : About 14:44, March 18, 2020  
 Location : In the premises of Mino-Ota station, Etsuminan Line, Minokamo City, Gifu Prefecture

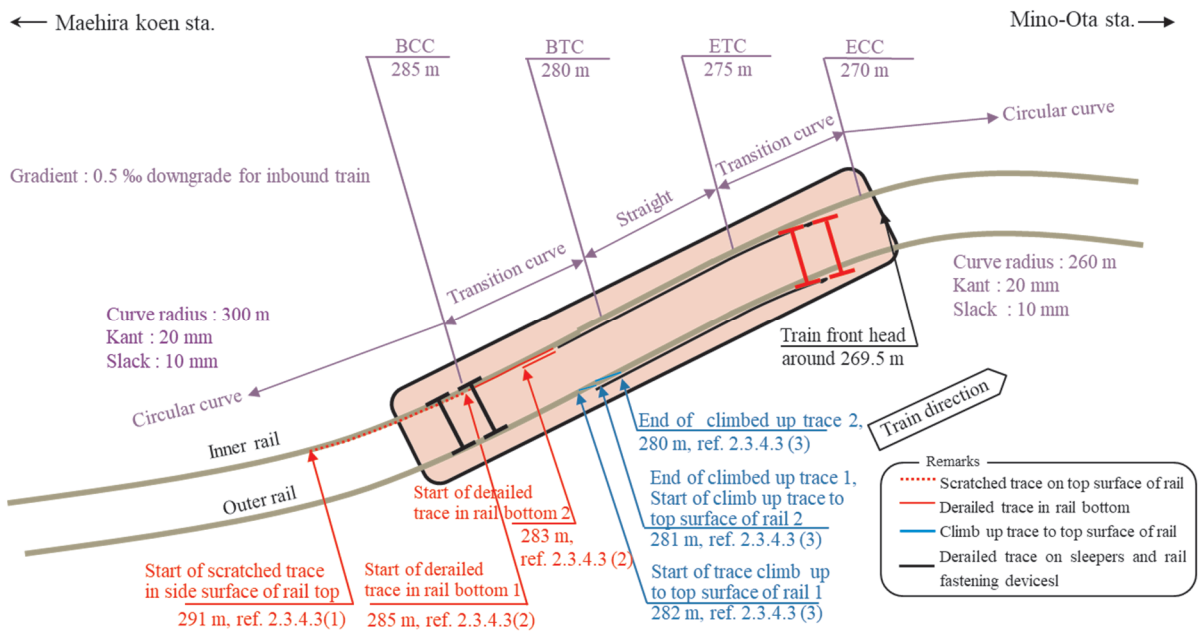
<Outline of the accident site and the derailed traces>

At about 14:44, March 18, 2020, while the one-man operated inbound 12 train, composed of one vehicle and started from Hokunou station bound for Mino-Ota station, Etsuminan Line of Nagaragawa Railway Co., Ltd., was running in around the left curved track of 300 m radius in the premises of Mino-Ota station at the velocity of about 17 km/h, the driver of the train felt the impact and applied the emergency brake to stop the train.

- The JTTSB concludes that the probable cause of this accident was that, the left wheels of all 2 axles in the front bogie went off to the inside gauge, after that the right wheels of all 2 axles in the front bogie went off to outside gauge in this accident, because the gauge was widened dynamically while the train was passing through left curved track of 300 m radius.

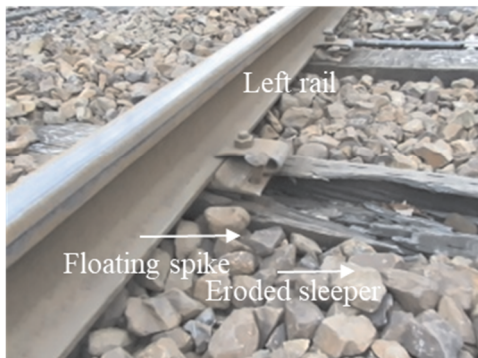
<Status of sleepers & spikes in around the accident site>

- It is probable that that the gauge was widened dynamically by the rail tilting and the rail movement caused by the lateral force while the train was passing, because the poor sleepers and the poor rail fastening status had been existed continuously.

- It is probable that the poor sleepers and the poor rail fastening status existed continuously because the company staff in the work-site division, who was assumed as lacked in the technical abilities, had judged that the status was enough to be observing the progress and had not been implemented the maintenance, in the management of the sleepers and the rail fastening status. In addition, it is probable that the lack of the technical activity was caused by the insufficient education and confirmation for the staffs in the work-site division by the head office.

- (i) As it is probable that the possibility to cause the derailment inside gauge becomes higher depending on the status of rail fastening, even when the measured irregularity of gauge did not exceed the maintenance standard value, to study on the introduction of the preventive measures such as to attach the gauge ties, although there was no need to be repaired, depending on the fastening status of rails.

- (ii) As for the exchange of sleepers, exchange to the PC sleepers, which are superior in the durability and the easiness of the maintenance compared to the wooden sleepers, as earlier as possible. Furthermore, as for the wooden sleepers, implement the maintenance not to continue over three poor sleepers. When the maintenance could not be implemented in time, study the introduction of the preventive measures such as to attach the gauge ties.

- (iii) When conducted the inspection of the track materials such as the sleepers, or the on-foot track patrol, etc., pay attention to the abrasion of the sleepers and the floating spikes, and secure the required rail fastening forces, if necessary, by implementing change of the sleepers, and the certain hammering and change of the spikes, etc., as soon as possible. Furthermore, as for the fastening method of rails, implement the additional hammering based on the standard of the hammering spikes as giving priority in the steep curved track, etc., where feared to widening gauge, and increase the rail fastening force by hammering the spikes correctly.

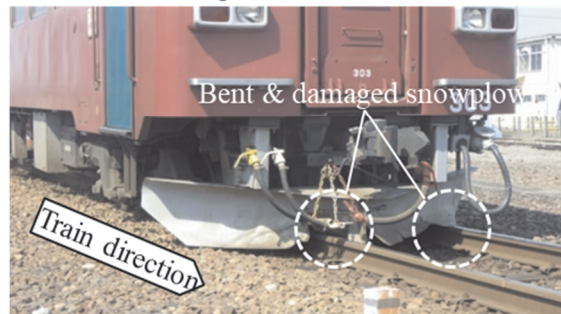
<Damaged status of vehicle>

After the train stopped, the driver checked the under floor of the vehicle and found that all axles in the front bogie had been derailed to right.
