"The train derailment accident due to the collision of the train and the unattended light motor truck, occurred in the Class one level crossing"

Railway operator : Hankyu Corporation
 Accident type : Train derailment accident
 Date and time : About 19:42, November 23, 2020
 Location : Takaha Level Crossing, the Class one level crossing equipped with crossing gate and road warning device, at around 27,423 m from Osaka-umeda station, between Rokko station and Mikage station, double track, Kobe Line, Kobe City, Hyogo Prefecture

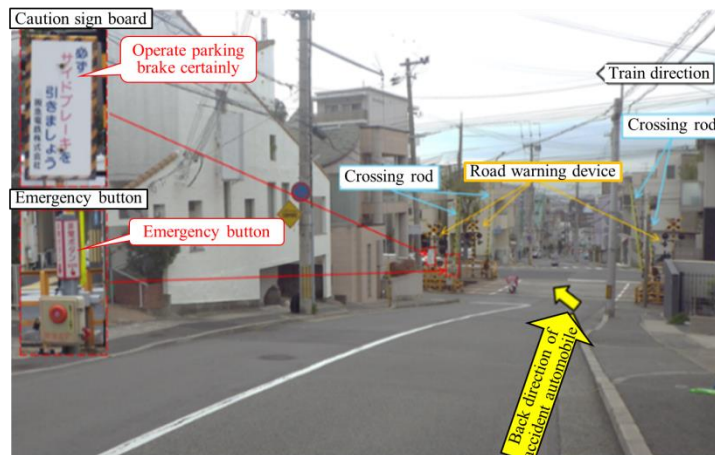
Status of the Takaha Level Crossing

It is highly probable that the train derailed because **an unattended light motor truck backed the sloping road, and entered the Takaha Level Crossing in the status as the crossing rod had been lowered responded to the approaching train, and collided with the approaching train.**

It is probable that this accident was caused as that the driver of the light motor truck left from the driver's seat in the status that the braking force of the parking brake had been lacked in the city road Takaha Kita Route 2 crossing with the Takaha Level Crossing. In addition, the accident that the braking force of the automobile waiting before the level crossing had loosened and entered the level crossing, in the past.

Therefore, it is necessary for the local police to reinforce the regulation and the watching for parking in the concerned city road, in cooperation with the road administrator and the railway operator. Furthermore, it is desirable to make thoroughly, against the drivers of automobiles passing the concerned city road continuously, on the importance of the handling brake when stopping, *i.e.*, set the gear in the "reverse" position in level ground or downward slope and in the "low" position in upward slope in the manual car, or set the change lever in the "parking" position in the automatic car, and actively use the wheel stoppers, in order to implement sufficiently the required measures to keep the stopped status, when stopped automobile inevitably.

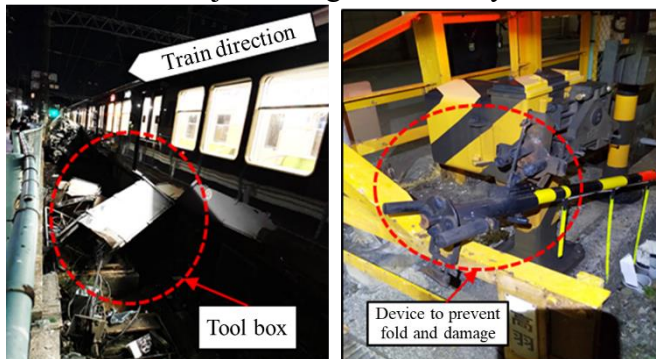
Status of major damages of railway facilities

As for that the train had derailed, it is probable that left wheel of the first axle ran onto the rail and derailed due to the impact of the light motor truck which collided with lower left part of the train, in addition, the involved part of the light motor truck was caught between left wheel of the first axle of the front bogie of the first vehicle and rail, furthermore, left wheel of the second axle ran onto the rail and derailed due to the impact acted by the involved parts and the vibration acted by the derailed wheel.

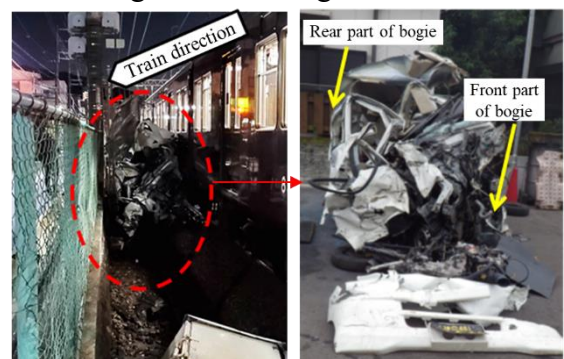
Damaged status of light motor truck

It is probable that the light motor truck had backed because the driver of the light motor truck left from the light motor truck in the status that the measures required to keep the stopping status of the light motor truck had been insufficient, although the stopped place was the sloping road.
