RA2022-2-I

# **RAILWAY ACCIDENT INVESTIGATION REPORT**

**Railway accident with train derailment in the premises of Aoto station,  
Main Line, Katsushika City, Tokyo Metropolitan,  
Keisei Electric Railway Co., Ltd.**

Railway operator	Keisei Electric Railway Co., Ltd.
Accident type	Train derailment
Date and time	About 10:16, June 12, 2020
Location	In the premises of Aoto station, Main Line, Katsushika City, Tokyo Metropolitan

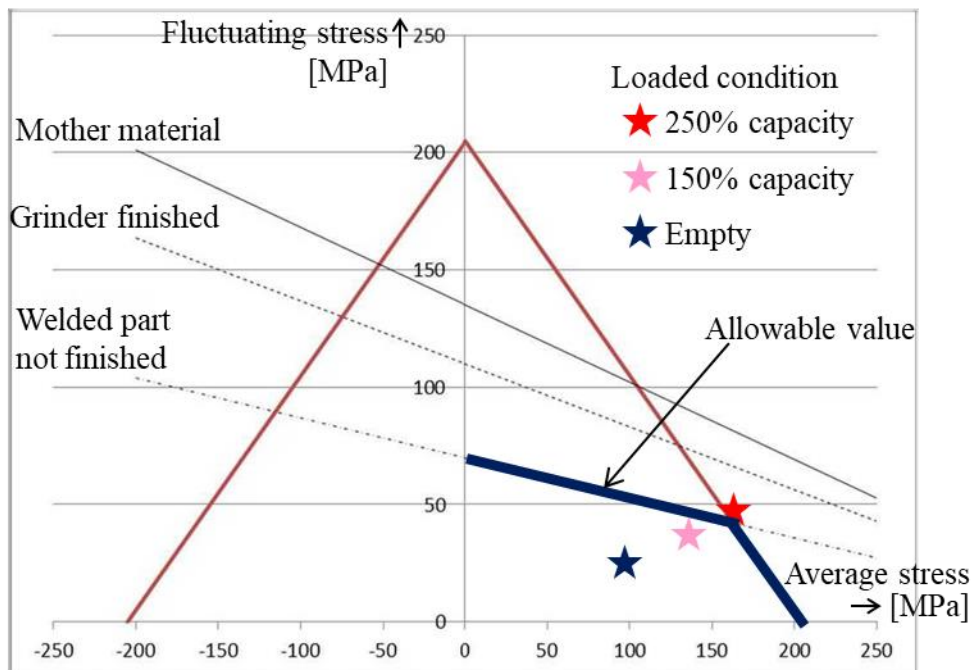
Figure 4. Critical stress chart for the vertically loaded condition in the welded part stress measuring place in the FS513 type bogie

The result of the static load test in the 250% capacity loaded condition showed that the stress exceeded the allowable value in the critical stress chart. Furthermore, the stress measured at the weld end edge part in the welded part stress measuring place was about 2.4 times of the stress measured in the lower part of the side beam in the vicinity of the welded part stress measuring place, regardless of the loaded conditions.

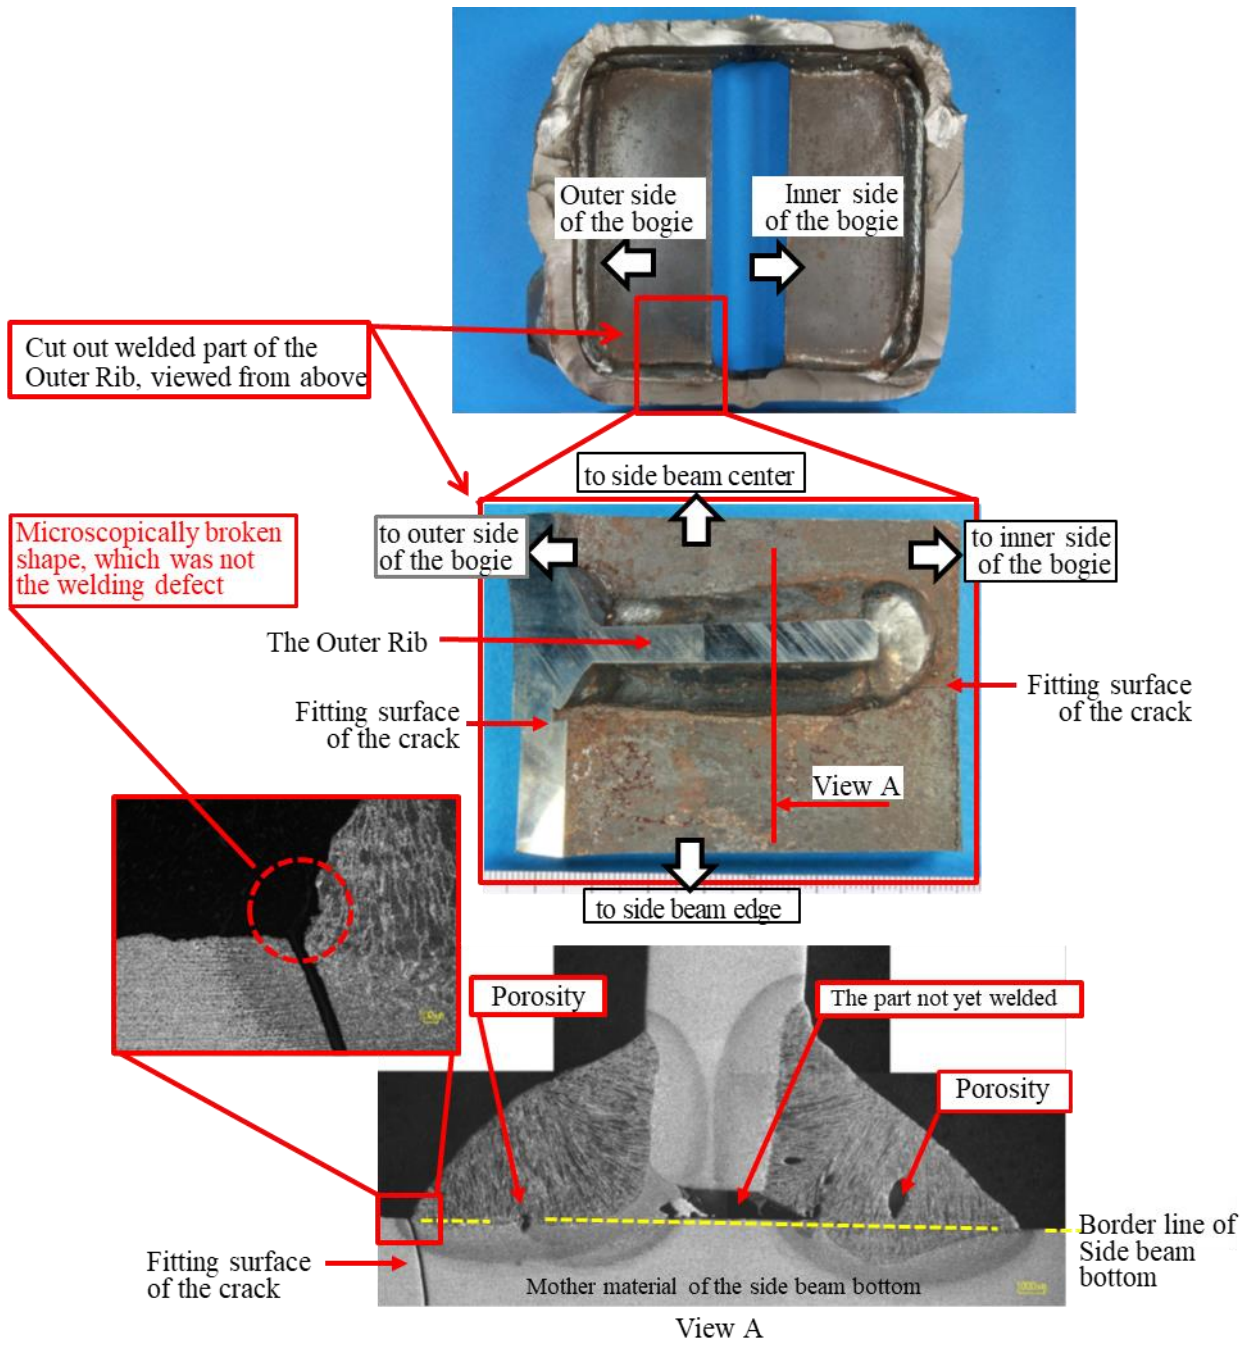
Figure 5. Observed results of cross section of the Welded Part

Although the incompletely welded parts such as the overlap, the blowhole<sup>\*28</sup>, etc., were found in each welded part, the cracked trace was not found in these incompletely welded parts.

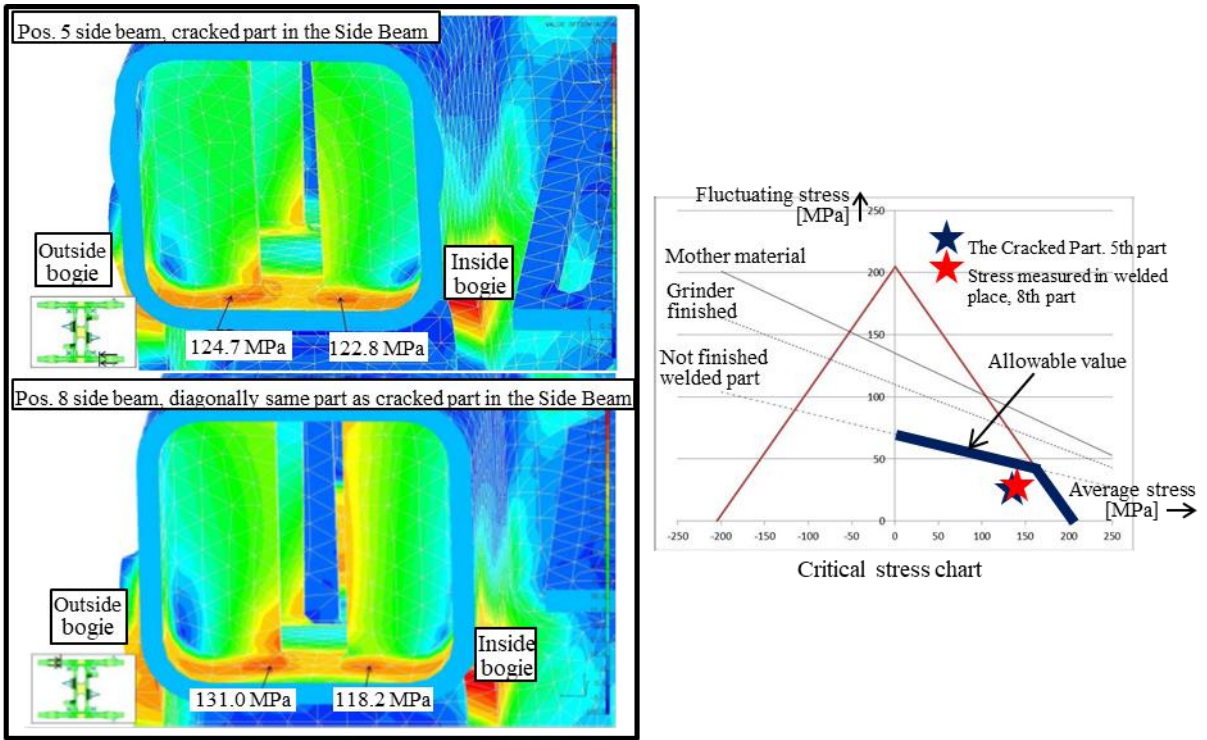
Figure 12. Results of the FEM analysis for the side beam, Pos. 5 and Pos. 8, of the Bogie.

As shown in Figure 12, the maximum stresses generated in the Welded Part when the designed maximum vertical load was loaded were 124.7 MPa at the weld end edge, 131.0 MPa at the weld end edge in the welded part stress measuring place in the Pos. 8 in the side beam. Therefore, the stresses considering the vertical vibration against the vertical load were all within the allowable value at the welded part without finishing work in the critical stress chart for the Welded Part and the welded part stress measuring place, and the maximum stresses at the Welded Part and the welded part stress measuring place were in the same level.

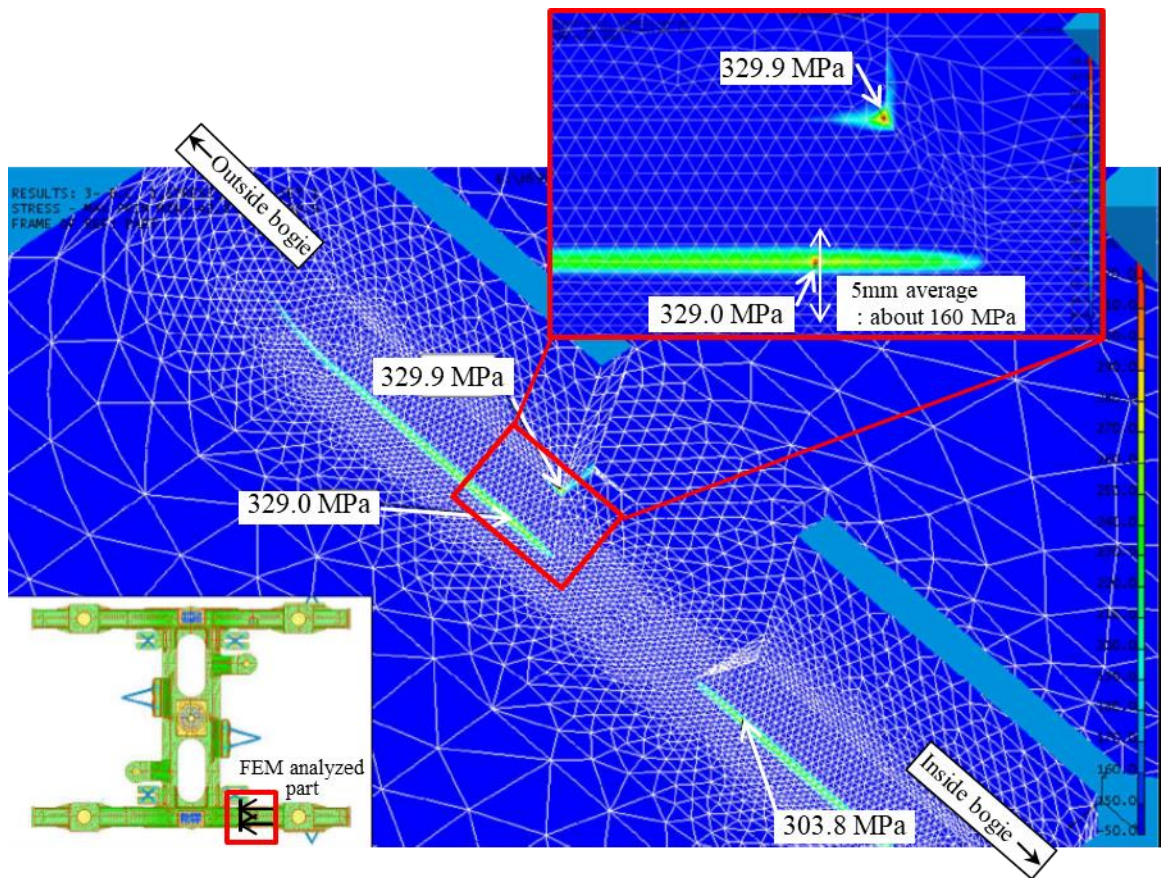
Figure 13. Precise stress distribution in the weld end edge, Pos. 5, of the Welded Part, results of the FEM analysis.

Furthermore, the FEM analysis was implemented for the side beam model, which the elements in the weld end edge part is the equilateral triangle of 1 mm sides, in order to confirm precisely the stress distribution generated in the weld end edge part at the Welded Part. As shown in Figure 13, the stress generated in the weld end edge part at the Welded Part was 230 MPa or above, which was the analyzed result as to become to 329 MPa in the extremely local point. The average stress at 5 mm in vertical direction, considered the weld end edge part as the center, was about 160 MPa in the place where the stress became to 329 MPa in extremely local.

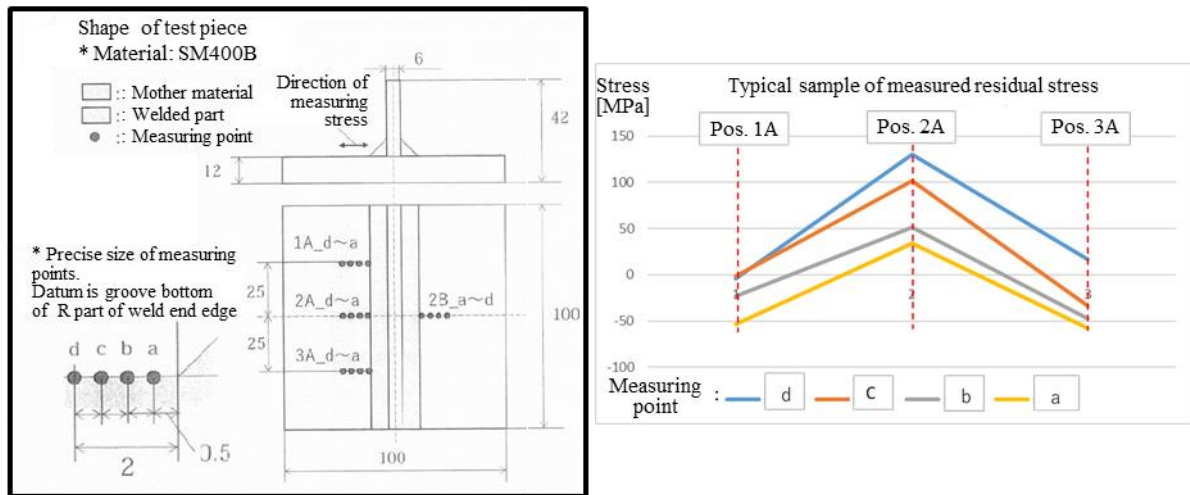
Figure 14. Test piece to measure the residual stress and the typical sample of measured results

There was unevenness in the measured results of the residual stress for each test piece, but there was the trend that the tensile residual stress, *i.e.*, the positive stress, became small, at the measuring point a, *i.e.*, close to the weld end edge part, as shown in the typical sample of the measurement shown in Figure 14.

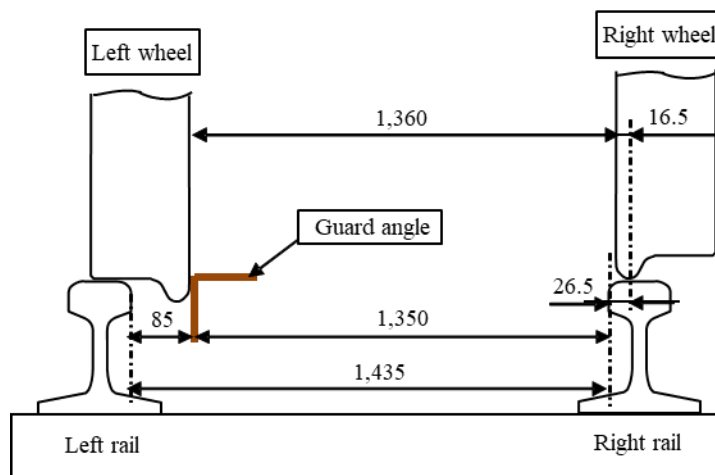
Figure 15. Positional relations between rail and wheel, from around 11,750 m to around 11,670 m.

It is probable that right wheels in the Bogie had been running as being climbed up right rail as shown in Figure 15, in the section between around 11,750 m and around 11,670 m in the Curve, because derailment has been protected by the guard angle in the Curve, as described in 3.1.3, and the status at this time was that the spacing between the guard angle and left rail was 85 mm, as described in 2.3.2.2 (3).

Additionally, it is likely that right wheel of the front axle climbed up right rail, after that, right wheel of the rear axle climbed up, because single trace was found in around 11,750 m, and the second trace was found as to move in the direction to Aoto station, as described in 2.5.1.1 (2).

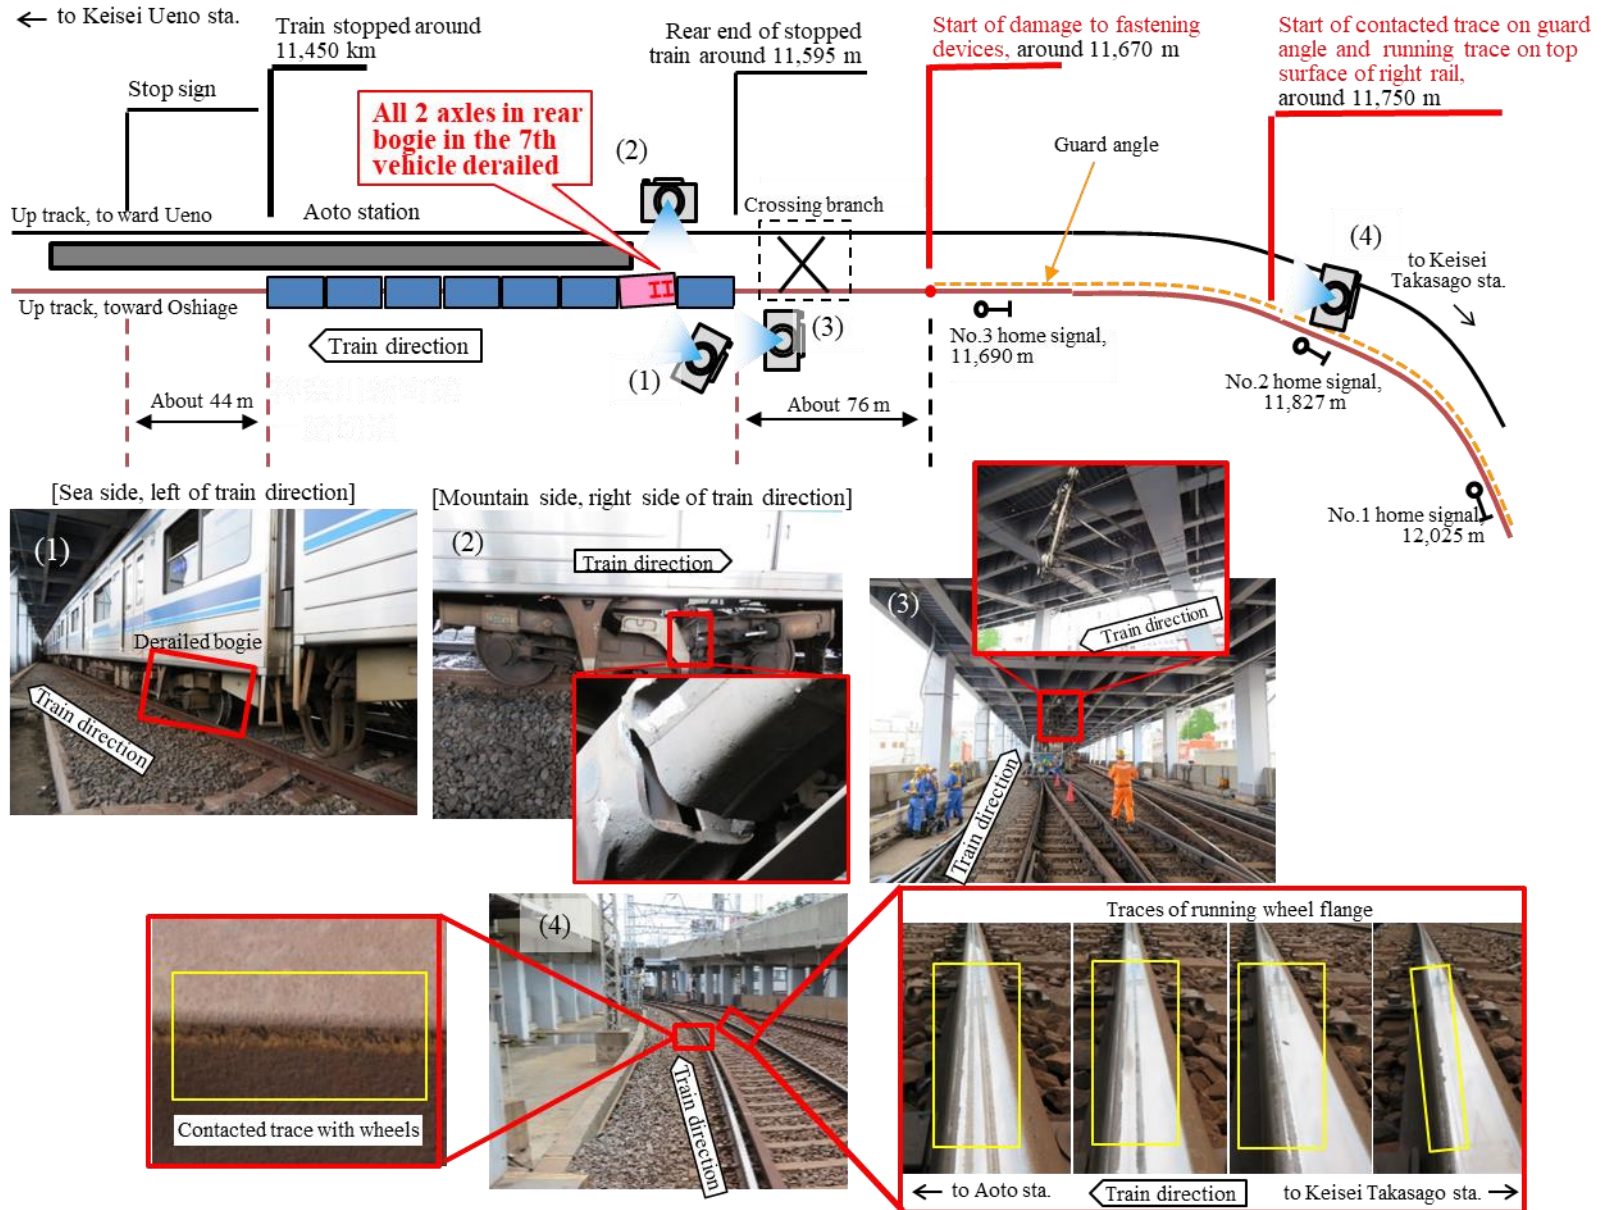
Attached Figure 4. Major traces, etc., of the Track

There were the traces considered as caused by the Train on the sleepers, the rails, the rail fastening devices, etc., in the range from around the end of the guard angle in the direction to Aoto station, at around 11,670 m, to the place where the Bogie of the Vehicle had been halted,

at around 11,570 m. Furthermore, there were the traces considered as caused by being contacted with the wheels on the guard angle, and the traces considered as caused by the running wheel flanges on the top surface of right rail, from around 11,750 m to around 11,670 m.

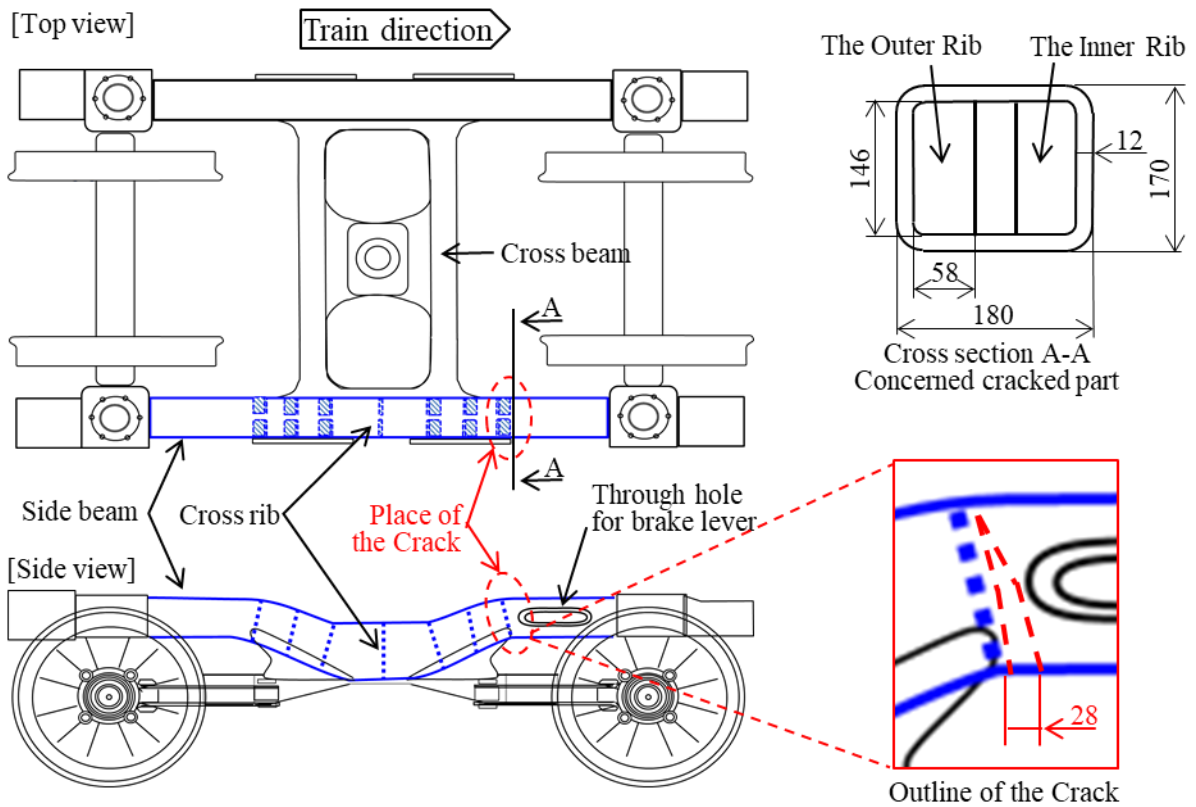
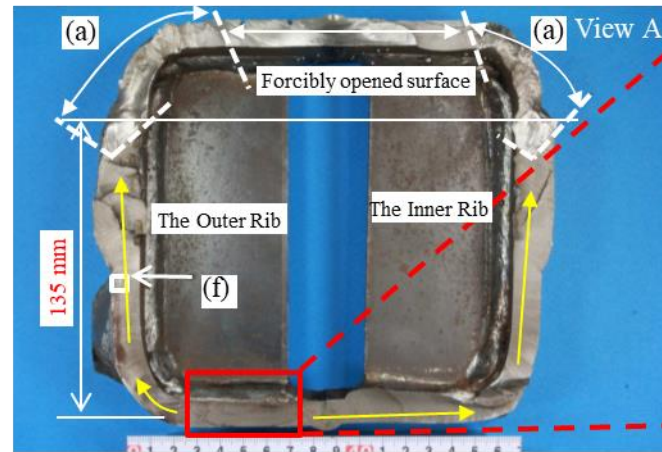
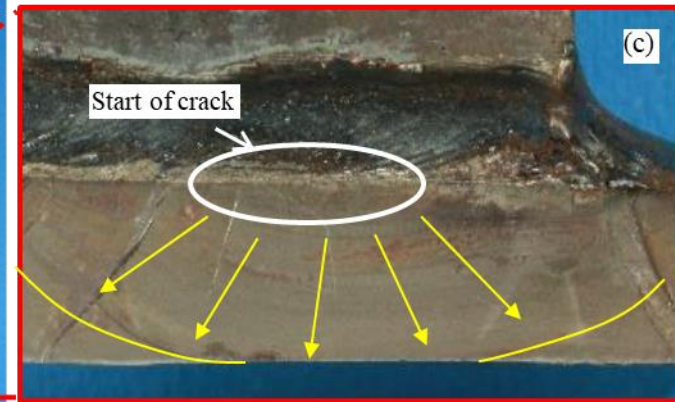
Attached Figure 7. Status of the Broken Surface of the Crack

- (i) Based on the results of the macro-observation of the broken surface of the Crack, the beach mark<sup>\*20</sup>, which is considered as the feature of the fatigue crack, was found from the lower surface of the side beam to the height of about 135 mm, and the whole length of the trace of the fatigue crack was about 450 mm, except for the forcibly opened part cut for the investigation and the part of crashed broken surface. The uneven pattern had become larger from lower part to upper part, and broken surface had been crashed from around the curved part from side surface to upper surface of the side beam. Generally, size of unevenness in broken surface was affected by the expanding speed of the crack, and when the expanding speed is high the unevenness becomes large.

Furthermore, the ratchet mark<sup>\*21</sup> was found in around the weld end edge part in the Outer Rib, and the beach mark had been expanded from around the ratchet mark

toward the lower surface of the side beam, and the crack had expanded further toward side surface of the side beam.

- (ii) Based on the results of the microscopic observation of the broken surface of the Crack, the elongated dimple pattern, which is the feature of the ductile fracture, was found in a part of upper surface side of the side beam. There was no characteristic pattern in other places.

- (a) Broken surface with the possibility of ductile fracture, from (d).
- (b) Yellow arrows indicate the direction of **trace of fatigue fracture**.
- (c) Red arrows indicate the ratchet mark. There is arch shaped beach mark from weld end edge of outer rib to side beam bottom.
- (d) Dimple pattern which is feature of ductile fracture.

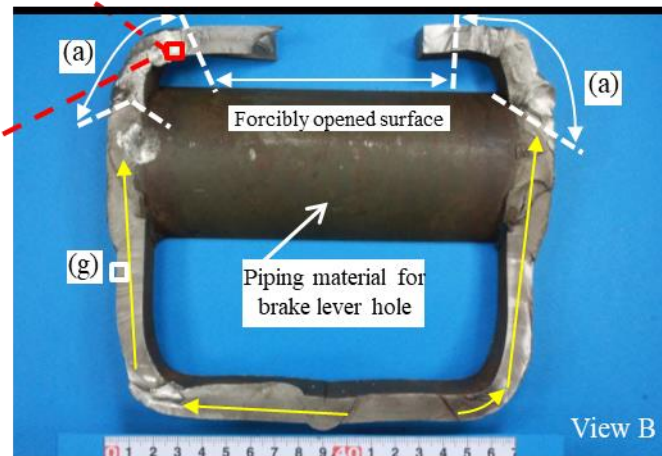
- (e) Trace of fatigue crack existed to 135 mm, total length was 450 mm, from side beam bottom .

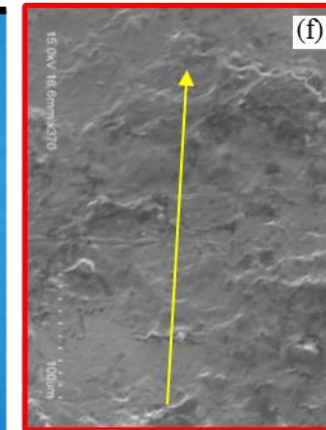
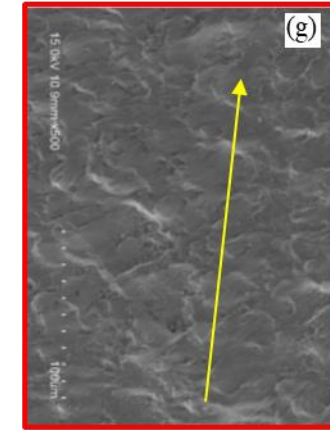
- (f) and (g) Enlarged figure of side surface of side beam. Trace of the beach mark, striation, were found in the direction to yellow arrow.
