"The accident that freight wagon derailed due to be acted by excessively large compressive coupler force when the freight train was operated in the pushing operation by locomotive in the premises of the station"

Railway operator : Japan Freight Railway Company  
 Accident type : Train derailment  
 Date and time : About 10:05, July 24, 2021  
 Location : In the premises of Sumidagawa station, Joban Line, Arakawa-ku, Tokyo

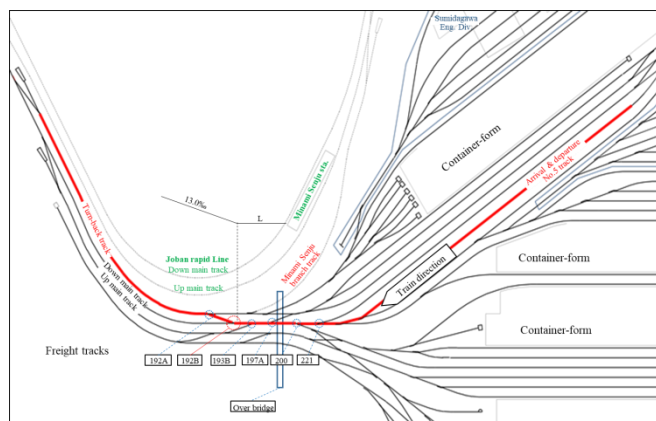
Operating status of the train

On July 24, 2021, the 72 train, composed of 20 vehicles started from Sumidagawa station bound for Tokyo Freight Terminal station, of Japan Freight Railway Company, departed from the arrival and departure No.5 track of Sumidagawa station on schedule, at 10:03. While the driver of the train was operating in the powering operation at the velocity of about 18 km/h in the pushing operation by locomotive toward the turn back track in the premises of the station, noticed a cloud of dust rising at around the freight wagon in ahead to the direction of travelling, therefore, applied the emergency brake immediately. Here, the words, left, right, front, rear, were based on the running direction of the train.

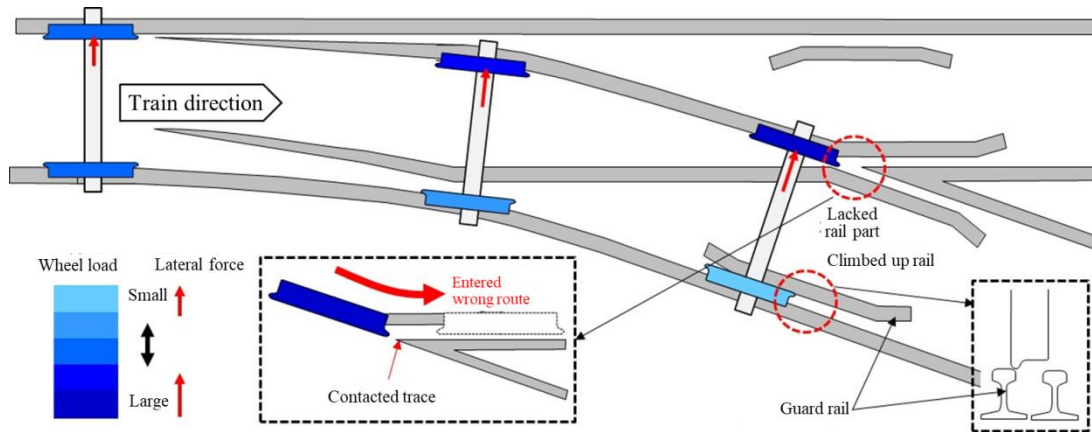
Status of the derailment

After the train stopped, the driver detrained and checked the situation, and found that all two axles of the front bogie of the third vehicle had been derailed. Here, vehicles are counted from the locomotive.

It is probable that the train, coupled with 19 freight wagons, derailed while running by the pushing operation by locomotive, in the concerned accident, because right wheel of the front axle of the front bogie of the third freight wagon climbed up the branch line side guard rail at the crossing part of the turnout, after that left wheel entered the wrong track side.

It is probable that right wheel climbed up the branch line side guard rail at the crossing part of the turnout, because back side of right wheel of the freight wagon had climbed up the branch line side guard rail at the lacked rail place in the crossing part, due to the increase of lateral force of the front axle of the front bogie and the decrease of wheel load of right wheel of the same axle, caused by the excessively compressive coupler force generated in the status that the coupler swaying angle of the freight wagon had been enlarged due to the horizontal displacement of the vehicle body while the empty loaded freight wagon was running in around the turnout.

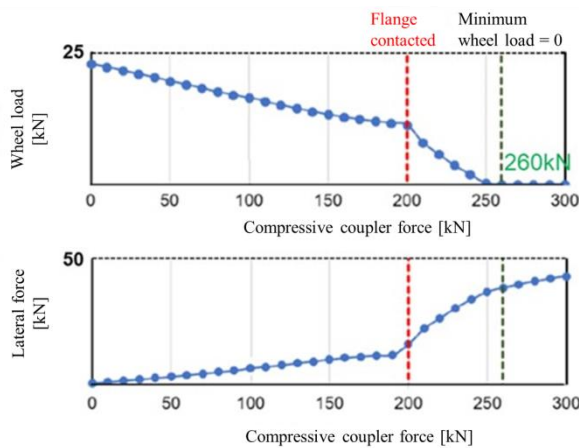
Analyzed results of the relation of wheel load and compressive coupler force vs. compressive force

It is probable that the excessive compressive coupler force had been generated because the operation of the main handle of the master controller had not been implemented obeyed to the prescribed operation, related with that the setting of the weight selecting switch before started the pushing operation by locomotive was not in the prescribed position, and that the driver had been understood that the rule of handling operation in the pushing operation by locomotive did not applied to the concerned train, and the driver's consciousness had been concentrated to velocity and stopping position, although the velocity had not exceeded the limited velocity, just before when the front bogie of the third freight wagon was running in around the crossing part of the 192B turnout.
