**RAILWAY SERIOUS INCIDENT
INVESTIGATION REPORT**

**Vehicle damage of West Japan Railway Company
In the premises of Nagoya station, Tokaido Shinkansen**

March 28, 2019

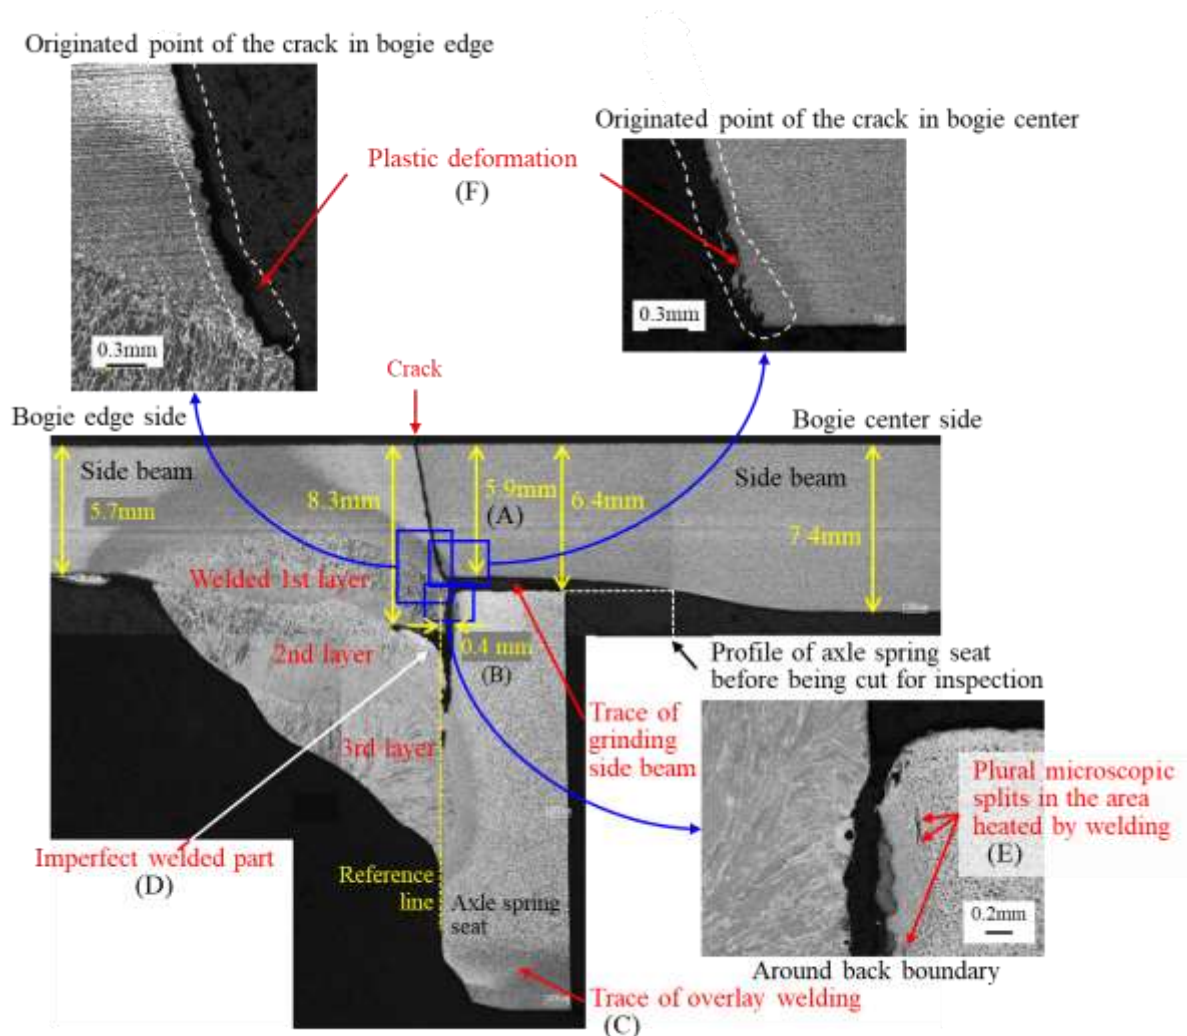
Figure 4. Status of the cross section of the crack in the slot welded part in inside of the bogie

(1) Cross section of the slot welded part in inside of the bogie

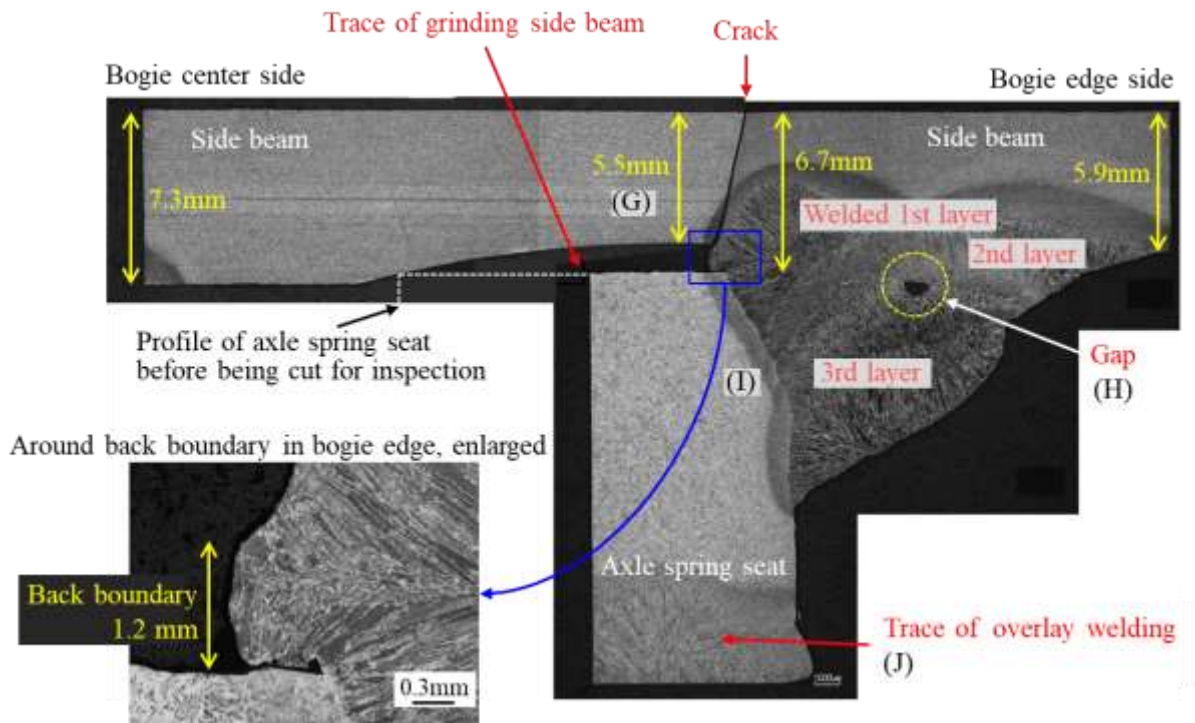
Figure 5. Status of the cross section of the crack in the slot welded part in outside bogie

- (i) The thickness of the bottom plate of the side beam at the point where estimated as the originated point of the concerned crack was 5.5 mm, as indicated as (G) in Figure 5.
- (ii) There were microscopic gap in the boundary of the 2nd and the 3rd layers of welding, as indicated as (H) in Figure 5, but there was no incomplete penetration as found in the slot welded part in inside of the bogie, indicated as (I) in Figure 5.
- (iii) There was the aspect different from the material of the axle spring seats in the bottom surface of the axle spring seat. It is highly probable that the aspect was the trace of implementation of the overlay welding, as same as found in the cross section of the inside slot welded part, as indicated as (J) in Figure 5.
- (iv) The definite slits, etc., as found in the cross section of the slot welded part in inside of the bogie, were not found.

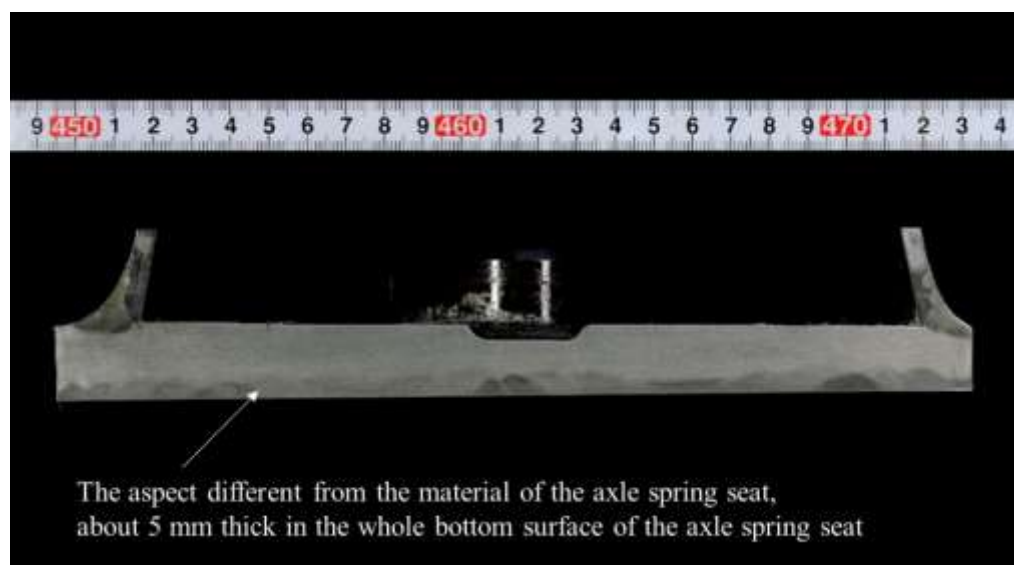
Figure 6. Status of cross section of the concerned axle spring seat

The aspect, which was different from the material of the axle spring seat, found in the bottom surface of the axle spring seat described in 2.4.2.3 (1) (iii) and 2.4.2.3 (2) (iii), was observed in the whole bottom surfaces of "the axle spring seat in beneath the place where the concerned crack originated", hereinafter referred to as "the concerned axle spring seat", and the axle spring seat neighboring in the direction to the bogie edge, and was not observed in the other axle spring seats.

The thickness of the axle spring seat in around the concerned place, before cutting the bottom plate of the axle spring seat by machine tools, *hereinafter this process is referred to as "the machining process"*, was 20 mm as the designed value.

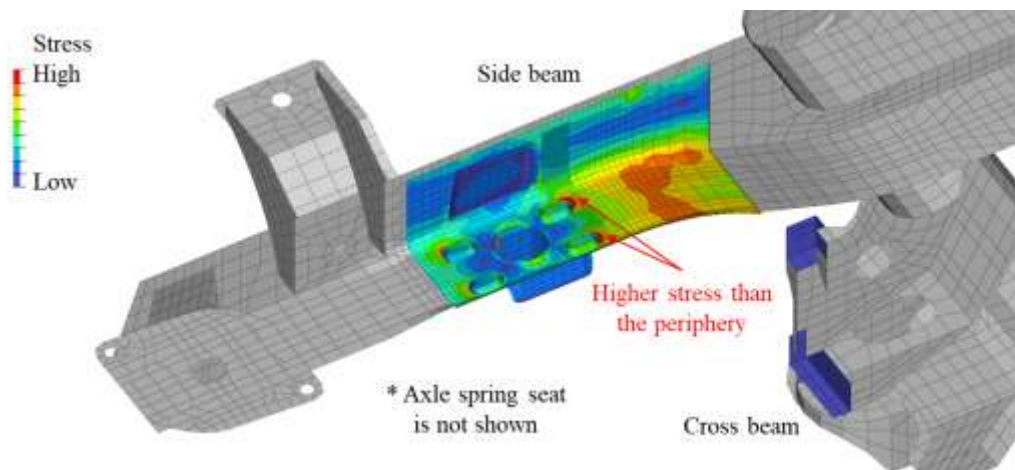
Figure 8. Model and results of the FEM analysis recreating the slot welded part

After the occurrence of the serious incident, in order to implement the simulation to estimate the expanding status of the fatigue crack, described in the following paragraph 2.6.2, the axle spring seat, the peripheral side beam and the slot welded part joining them each other, were modeled using the three dimensional elements, *i.e.*, the solid elements ^{*27}, to compose as the two plates were fixed at the slot welded part, same as the actual bogie. The calculated results by the FEM analysis using this model showed that the stress was generated as to concentrate to the back boundary of the slot welded part and the generated stress was higher compared to its periphery as shown in Figure 8.

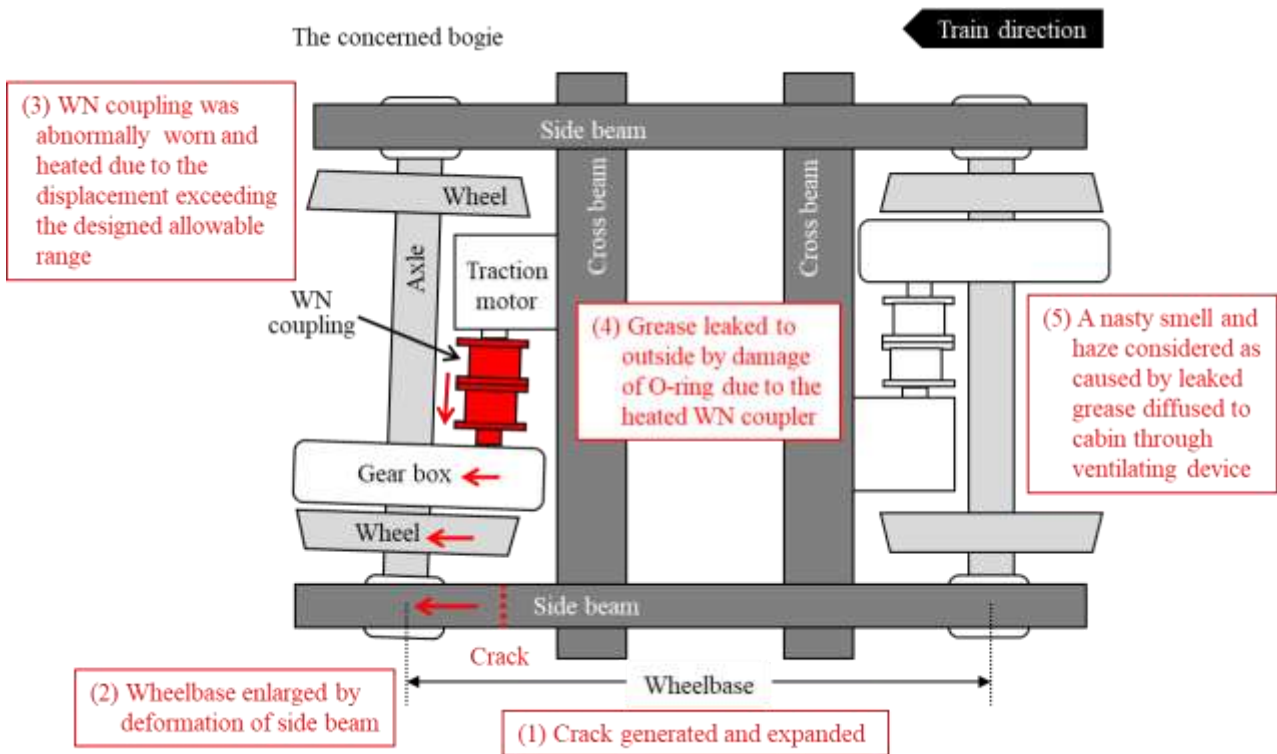
Figure 13. Process to generate the abnormal sound and the nasty smell, etc.

(2) The relative displacement between the traction motor and the gear device had increased.

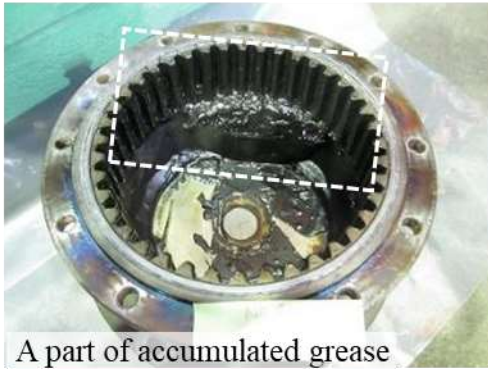
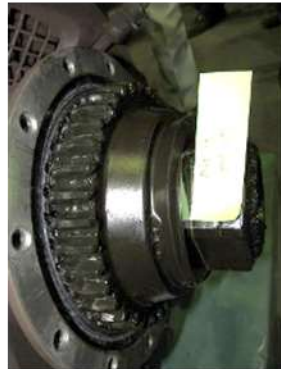
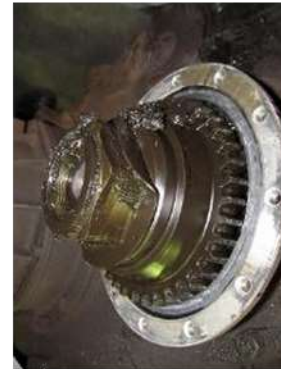
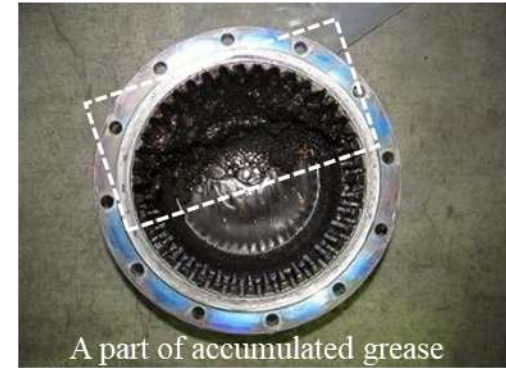
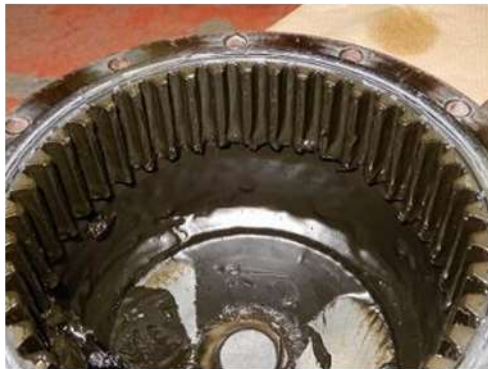
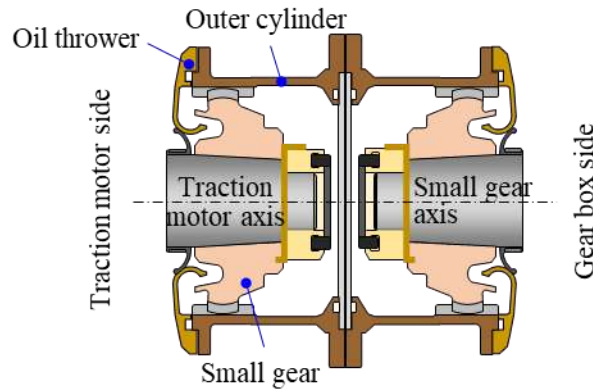
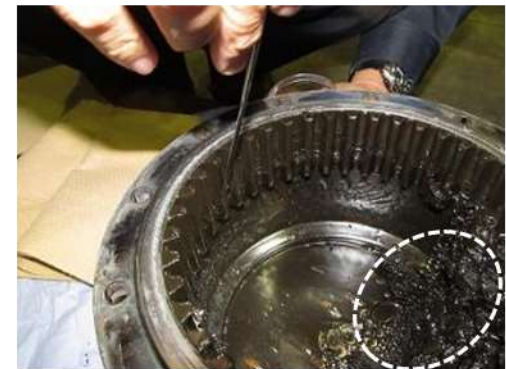
Attached Figure 5. Status of Grease inside the Concerned WN Coupling

Partly bubbled and hardened as sponge

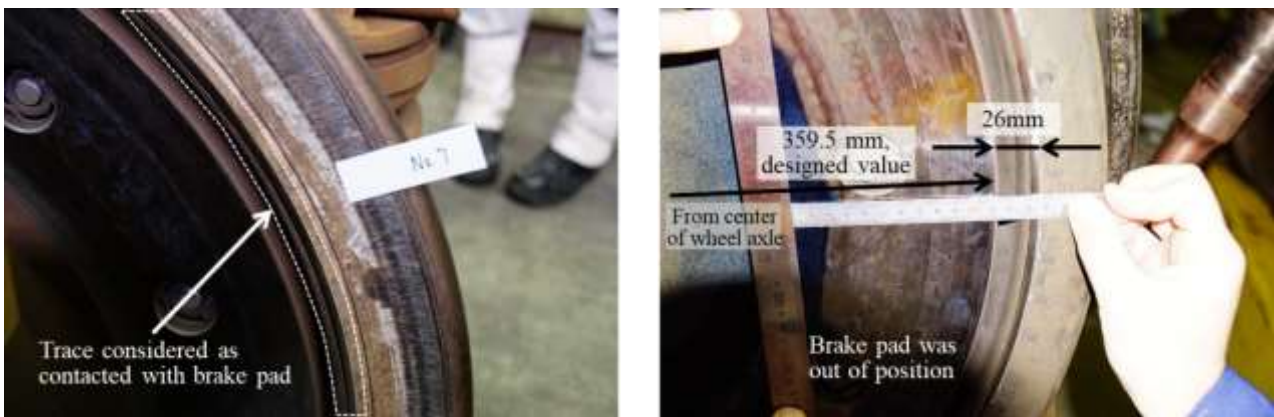
Attached Figure 6. The Traces in the Rim Surface of the Wheels

(a) The backside surface of the rim

(b) The right side surface of the rim
