~ Railway serious incident that the door opened while the train was running ~

Railway operator : Nishi-Nippon Railroad Co., Ltd.  
Serious incident type : Vehicle damage  
Date and time : At about 16:49, May 15, 2018  
Location : At Shirakibaru station, Tenjin Omuta Line, Onojo City, Fukuoka Prefecture.

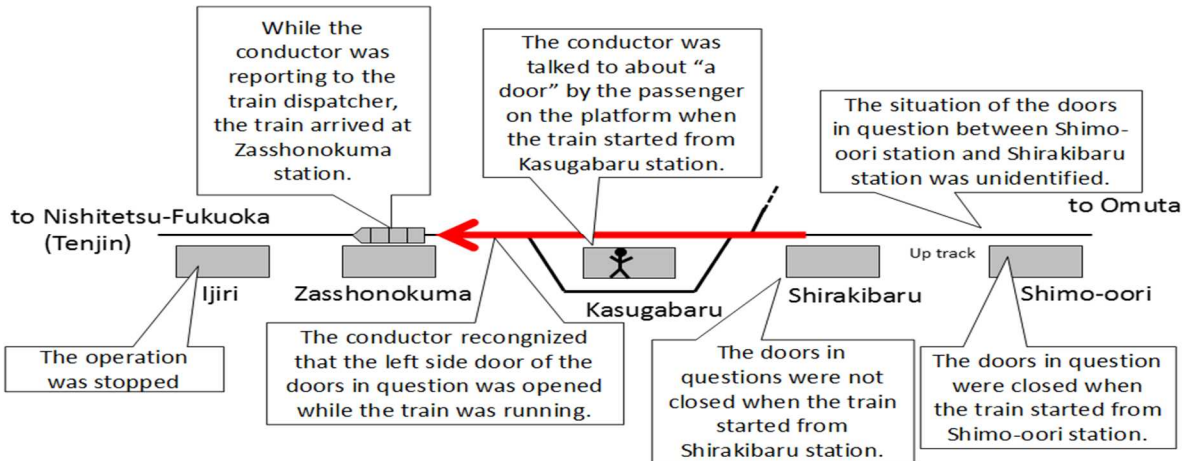
- (1) When the train departed from Shirakibaru station, the concerned door became in the status that it had not been closed certainly.
- (2) While the train was running between Shirakibaru station and Kasugabaru station, the concerned door became in the status to repeat opening and closing actions responding the jolts of the train and sometimes in the status as fully opened.

- (3) When the train was departing from Kasugabaru station, the concerned conductor was talked by the passenger on the platform about the door as it was not clear, then the concerned conductor checked the doors while the train was running, and found that the rear door of the concerned door was opening by about 40 cm. Here, the concerned door could not be move by hand at that moment.

- (4) After the train arrived at Zasshonokuma station, the concerned door was locked.
- (5) The operation of the concerned train was cancelled at Ijiri station.

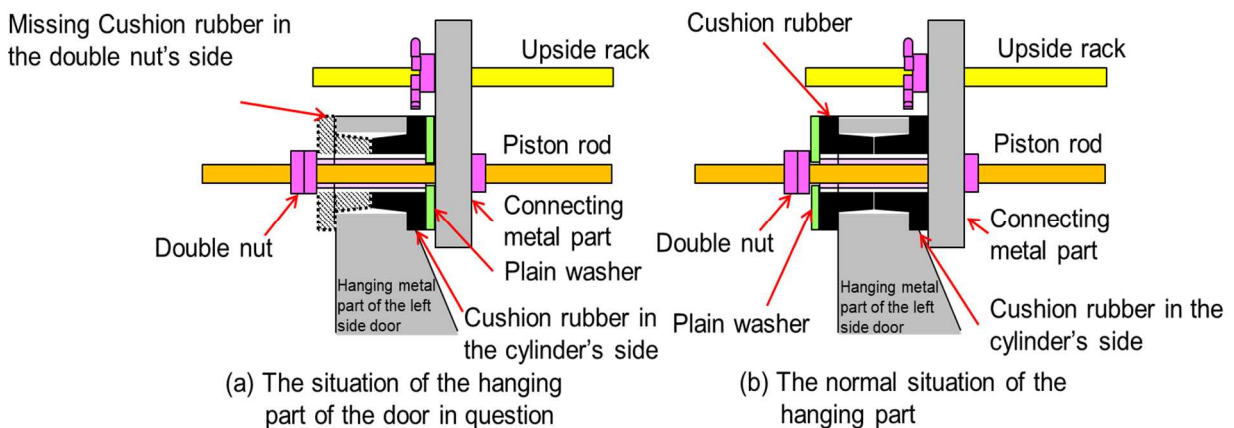
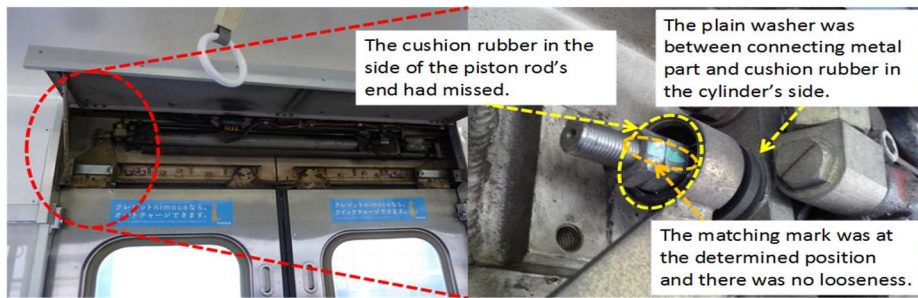
It is probable that the concerned serious incident was caused as the door did not close certainly when the closing door operation was implemented, because the hanging device of the door and the piston rod transferring the force to open and close operation of the doors were disconnected and became not to work as linking each other as the buffer rubber of the hanging part for a door in the double door of the vehicle had fallen away, in addition, the train operation was continued in the status that the opening door could not be detected.

It is probable that the buffer rubber in the hanging part of the door had fallen away in the following process, *i.e.*, the nut of the piston rod and the buffer rubber had been in the status as contacted directly with each other due to mistaking the attached position of the plain washer in the fastening works of the hanging parts in the important parts inspection of the vehicle, the doors had been operated to open and close actions repeatedly in this status, then, the nut continued to cut into the hole part of the buffer rubber to cause the removal of the buffer rubber.

It is probable that the situation of the opening door could not be detected because the opened door could not be detected by the door control switch, as the door was in the opening status even though the piston rod was in the close position, because the piston rod and the door had become not to work as linking with each other due to the fallen away buffer rubber.

Notes : It is probable that the mistake of the attached position of the plain washer could not be found in the visual inspection of the concerned door in the monthly inspections implemented after the important parts inspection.

As for the works using the common parts and the works having a possibility to mistake the attached position, etc., such as the fastening works of the hanging parts of the concerned door, it is considered that it is effective to implement synthetically the measures for the improvement conformed to the contents and the environment of the works, by studying the following measures : to secure the certainty of the works by making the procedures of the works clear and implementing educations and noticing them to the workers, to improve the contents of the works that would be hard to cause mistakes, *i.e.*, to contrive shapes or colors of the parts, to set the parts to be assembled beforehand, etc., to improve the ability to detect the abnormal situation when the results of the works are checked, *i.e.*, the double check implemented by the workers and the checking staffs independently, or the preparation of the check list, etc.

In addition, it is considered that it is effective to implement the reviews of the check items according to the necessity, including the attached position of the important parts as well as the check marks, by investigating thoroughly again on the items to be inspected mandatory, even in the visual inspection of the doors in the monthly inspection.
