~ Railway serious incident that the signal column collapsed and hindered the railway track ~

Railway operator : Hokkaido Railway Company
 Incident type : Facilities damage
 Date and time : At about 12:40, November 9, 2018
 Location : In the premises of Shin-Sapporo station, Chitose Line, Sapporo City, Hokkaido

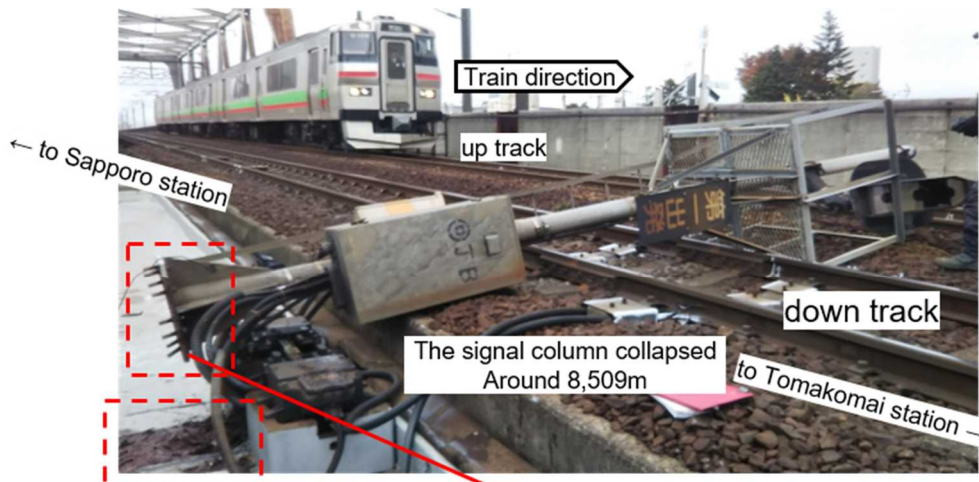
<The situation that the signal column collapsed>

At about 12:40, Friday, November 9, 2018, while the inbound 2760M train, composed of 3 vehicles started from Sapporo station bound for Tomakomai station of Hokkaido Railway Company, was running between Heiwa station and Shin-Sapporo station at a velocity of about 50 km/h, the driver of the train checked the indication of the caution signal in the No.2 home signal of Shin-Sapporo station in order to stop at the station, after that, he found that the column of the No.1 starting signal, planted in the opposite track side, had collapsed and hindered the up and down tracks, from about 200 m before the No.1 starting signal.

Therefore, it is somewhat likely that the signal column had collapsed because the external force exceeded the tolerance of the metal extension anchor fixing the signal column of the home signal, as the anchor of the metal extension anchor was loosening gradually, caused by vibration due to running trains on the viaduct in addition to the effects of the external force such as windstorm, earthquake, etc., in the period of about 38 years from planting, in the status that the metal extension anchor supporting the signal column had been insufficient endurance against tensile force, in cooperation with the wind pressure of about 20 m/s instantaneous wind speed on the collapsed day.

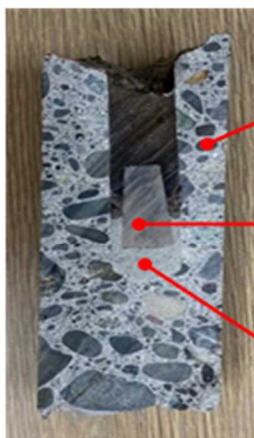
The situation of the hole's inside and the cone

Solidified particulate matter had remained in the hole.
The ingredient of the particulate matter was the same as that of concrete around the hole.

The cone had remained in the hole for inserting a metallic expansion anchor and its cone.

It is probable that the concerned serious incident had occurred because there was the inferior construction work as the insufficient cleaning in the hole after drilled into concrete body in the construction work of the metal extension anchor based on the "after constructing anchor method", in the planting work of the down line No.1 starting signal column.

It is probable that the metal extension anchor was in the status as insufficient tolerance against tensile force because the cone of the metal extension anchor had not expanded the swelling part of the anchor due to the inferior construction work when the signal column had been planted.

- (1) Implement the construction works certainly satisfying the conditions[#] described in the guidebook, etc., such as the "guide for design and construction of the after constructing anchor", published by the Railway Technical Research Institute, when the heavy structure such as the signal column, etc. are fixed by the "after constructing anchor method", because it is difficult to find out the malfunctions in the periodic inspection, etc., after constructed by the "after constructing anchor method". In addition, the workers who has the license of the works should implement the construction works and store the records.

- (2) Implement the additional reinforcing works in the place where there is high risk as to contact with the train if the signal column etc. fall down, in the places where the metal extension anchor has been used, similar to the concerned signal column, and the place where there is no record to check the contents of the construction works, etc., in the places where the heavy structure such as the signal column, etc., was fixed by the "after constructing anchor method".
