"The railway serious incident that the situation as the entrance door for passengers in the cabin opened while the train was running, *i.e.*, Dangerous trouble in vehicle"

Railway operator : West Japan Railway Company
 Incident type : Dangerous trouble in vehicle
 Date and time : About 19:01, December 30, 2020
 Location : In the premises of Hommataga station, Yamaguchi Line, Masuda City, Shimane Prefecture

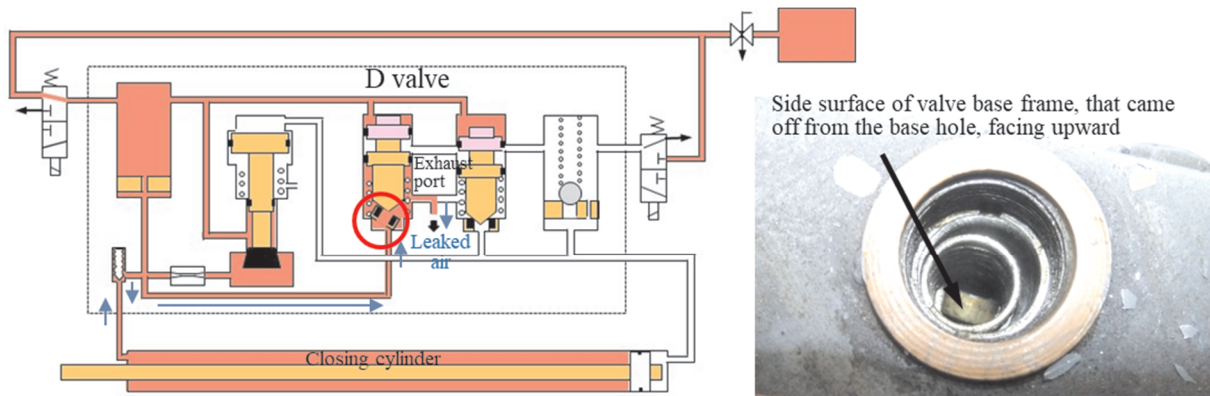
<Flew out route of compressed air in closing cylinder, left, and valve base frame of the D valve came off from counterbore, right>

The JTTSB concludes that the probable cause of this serious incident was highly probable that the force pushing the slide door had decreased and became smaller than the inertial force caused by the braking operation, because the valve base frame which was press fitted to the counterbore had come off, in the D valve in the valve cabinet of the door operating equipment, which opened while the train was running, and consequently the compressed air in the closing cylinder of the door operating equipment flew out to the air.

It is probable that the valve base frame, which had been press fitted to the counterbore, came off from the counterbore related with the following situations.

1. There was the possibility that the upward force by the restoring force of the spring had acted to the switching valve A, and the upward force had also acted to the valve base frame indirectly, when there is no compressed air in the closing cylinder of the door operating equipment. The friction force of the side surface of the counterbore of the D valve and the side surface of the valve base frame was small compared in the status when press fitted as usual, and the valve base frame had been in the status to be risen easily.

2. The valve base frame had been in the status that the unexpected force acted to rise the valve base frame in the undersurface of the valve base frame, while the vehicle was operating and the doors were closed (there was the compressed air in the closing cylinder of the door operating equipment) because there was the space between the undersurface of the valve base frame and bottom surface of the counterbore.

3. There was the possibility that the switching valve A and the valve base frame were strongly pressed and adhered, because the unexpected force had been acted for a long period to the contacted part between the switching valve A and the valve base frame.

4. As the results of the above situations 1 to 3, there was the space that the valve base frame could pass through inside of the spring when the valve base frame was rising in the counterbore, and, at the same time, the valve base frame could rise to the upper edge of the counterbore between the undersurface of the screw cock and the upper edge of the switching valve B.

It is likely that the valve base frame settled in the inside of the counterbore in the status as the side surface was in the upside, because the situations of the above 1 to 3 had been repeated for a long period, the undersurface of the valve base frame, which rose gradually inside the counterbore, got over the upper edge of the counterbore when the serious incident occurred, that caused the leakage of the compressed air in the closing cylinder of the door operating equipment, and resulted that the valve base frame fell when the pressed and adhered valve base frame and the switching valve A were released by the wind pressure of the air stream.

It is necessary to implement the visual inspection of the valve cabinet that has been currently implemented in the periodic inspection especially focus on the valve base frame, check whether the valve base frame is rising or not by pushing the valve base frame, etc., and

implement the exchange, etc., promptly when the same incident as the concerned serious incident or its signs were found.

It is desirable to check thoroughly on the mother material of the valve cabinet when the parts were delivered, and to increase the numbers of the sampling check for the other parts in order to reduce the delivered poor products, from now on, because the manufacturing of the TK105 type door operating equipment is continued even at present.

In addition, as for the press fitting works of the valve base frame, it is necessary to implement thoroughly the certain works considering that it is the part which could not be adjusted after shipping, and might influence badly for the long term resulted by the uncertain works.
