"The railway serious incident that the situation the door opened in the deck for entraining and detraining passengers while the train was running (vehicle damage)"

Railway operator : Kintetsu Railway Co., Ltd.  
 Serious incident type : Vehicle damage  
 Date and time : About 18:50, November 23, 2021  
 Location : In the premises of Ise-Asahi station, Nagoya Line, Asahi Town, Mie Prefecture.

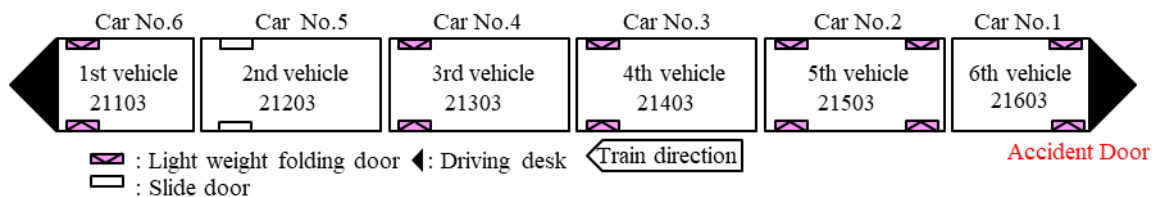
Formation of the accident train

On Tuesday, November 23, 2021, the conductor charged in passengers of the Limited Express 0168 Train, composed of 6 vehicles started from Kintetsu Nagoya station bound for Osaka Namba station, of Kintetsu Railway Co., Ltd., noticed that the left door for entraining and detraining passengers in the rearmost of the train had been opened at around Ise-Asahi station, and communicated to the driver to stop the train. The driver, as received the communication, operated the brake to stop the train.

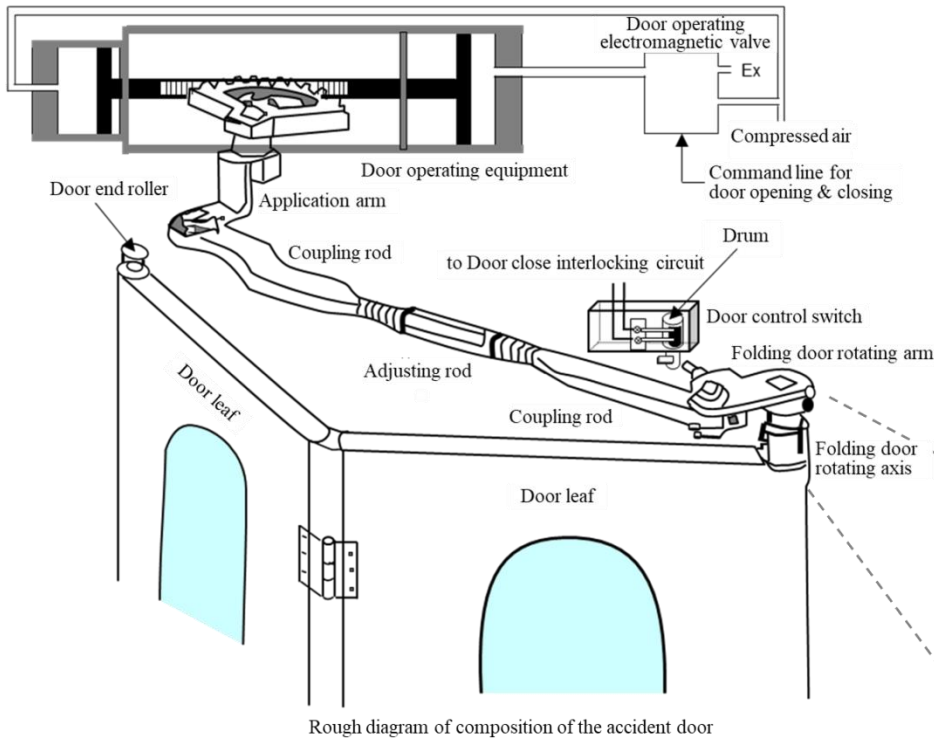
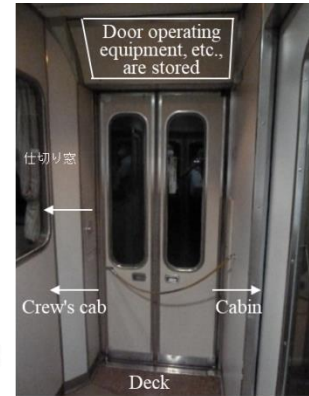
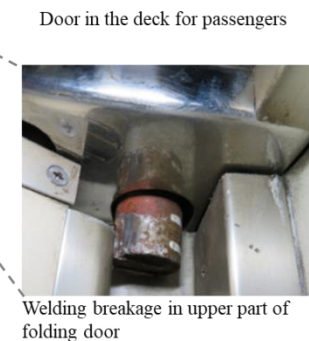
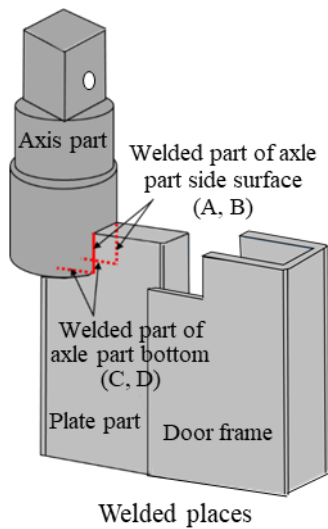
Broken surface A1, B1, C1, D1 : Rotating axis of folding door, axis part

Broken surface A2, B2, C2, D2 : Rotating axis of folding door, plate part

It is probable that the welded part between the axis part and the plate part of the rotating axis

of the folding door was broken, because, it is probable that the strength had been lacked due to the poor welding when manufactured the folding door due to the existence of the poor fusion penetration in the welding as the grooving works had not been implemented obeying to the design drawings when implemented the welding works, besides, the proper treatment had not been taken before broke, since the welded status of the rotating axis of the folding door had not been checked visually, as the welded part had been covered by the door frames, the outer boards and the ornamental boards, etc., in the periodic inspection by the operators implemented after that. However, it is considered that there was no problem in the designed strength of the welding of the rotating axis of the folding door.

It is necessary to increase the weld strength of the rotating axis of the folding door at present, by increased the volume of the welding when implemented the general inspection, for the rotating axis of folding door of all welding types, because there is the possibility that the weld strength decreased by the implementing status of welding works.

Since there is the possibility that the crack cannot be found visually in the general inspection and the critical parts inspection, the magnetic particle test shall be implemented to the welded places in the rotation axis of all folding doors, and the investigation on the causes should be implemented and the measures should be taken not only implement the repair or the replacement when abnormality is found in the welded place.
