# FLANGE-CLIMB DERAILMENTS OF FREIGHT TRAINS ON CURVED TRACKS DUE TO ROLLING

Akira MATSUMOTO<sup>1</sup> and Yohei MICHITSUJI<sup>2</sup>

<sup>1</sup> Japan Transport Safety Board (JTSB)  
2-1-2 Kasumigaseki, Chiyoda-ku, Tokyo, 100-8918 JAPAN

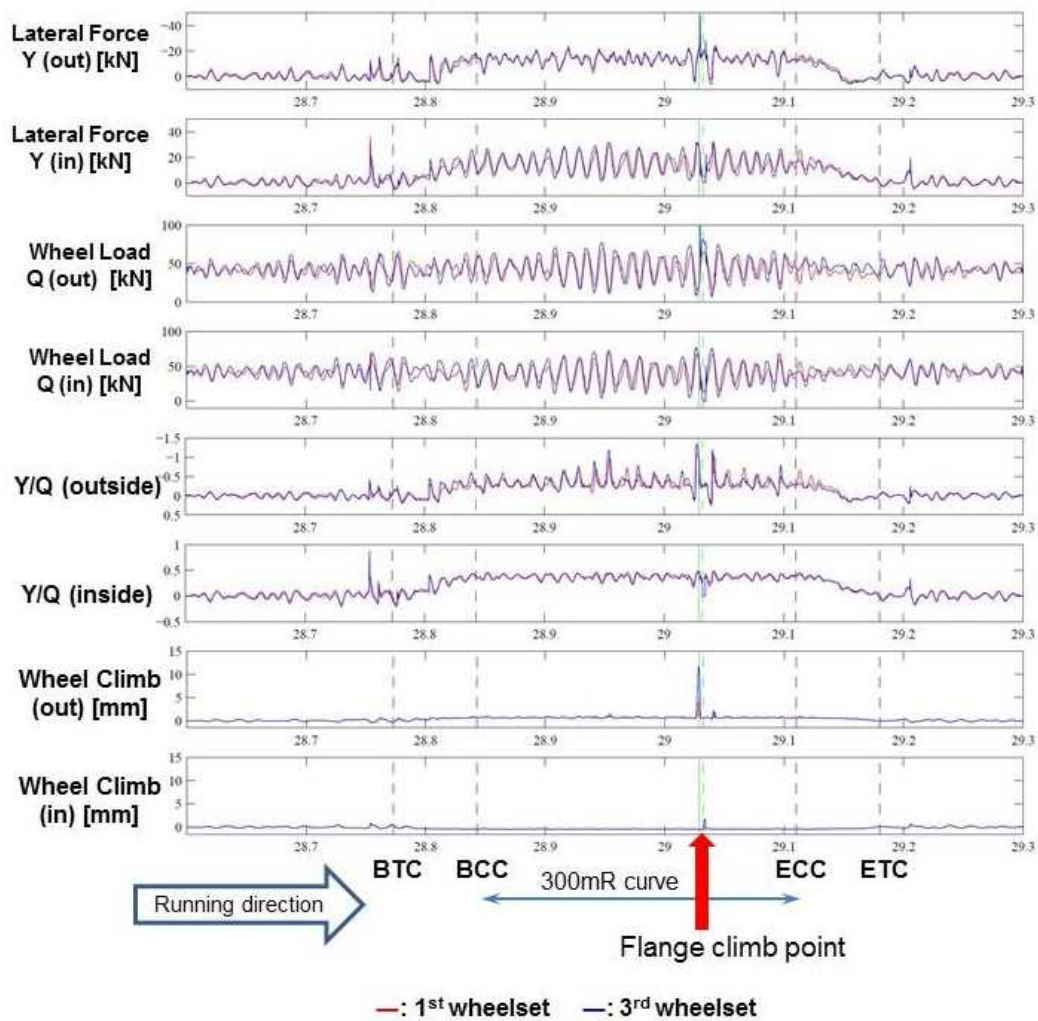
Fig. 2 Simulation result

Fig.2 shows the results of SIMPACK simulation around the accident No.2 site. The continuous rolling oscillation was produced in 300m radius curved section, and the outside wheel of 3<sup>rd</sup> axle is climb up just at the accident site. At this point the derailment coefficient  $Y/Q$  is also increased up to around 1.5.

- The outside wheel of 3<sup>rd</sup> axle (= front axle of rear bogie) climbing up just at the accident No.2 site on 300mR curved track -

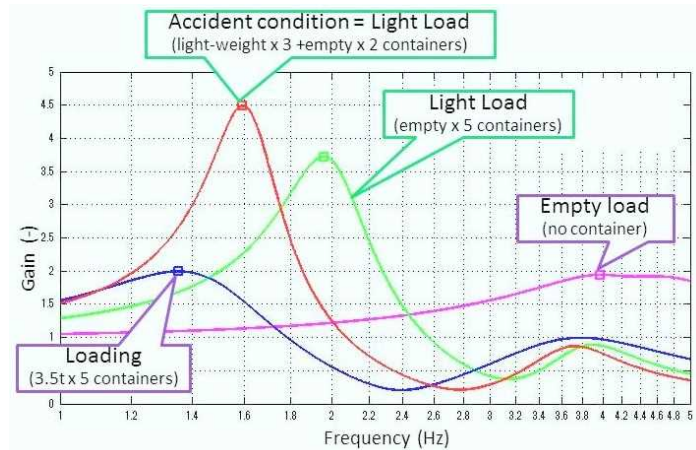
The rolling oscillation is produced by insufficient damping of vertical dampers, whose damping factor is different between “loaded condition” and “empty condition”. So in the case of light loaded condition, such as the accident No.2 condition, large rolling oscillation may be produced, compared with “loaded” or “empty” conditions, as shown Fig.3.

Fig.3 Response amplitude of body-rolling oscillation against track twist irregularity input
