AIRCRAFT ACCIDENT INVESTIGATION REPORT DAMAGE FROM BELLY LANDING HONDA AIRWAYS CO., LTD. HAWKER BEECHCRAFT G58, JA51HA ON THE RUNWAY AT OITA AIRPORT

AT 10:27 JST, AUGUST 14, 2023

JANUARY 24, 2025

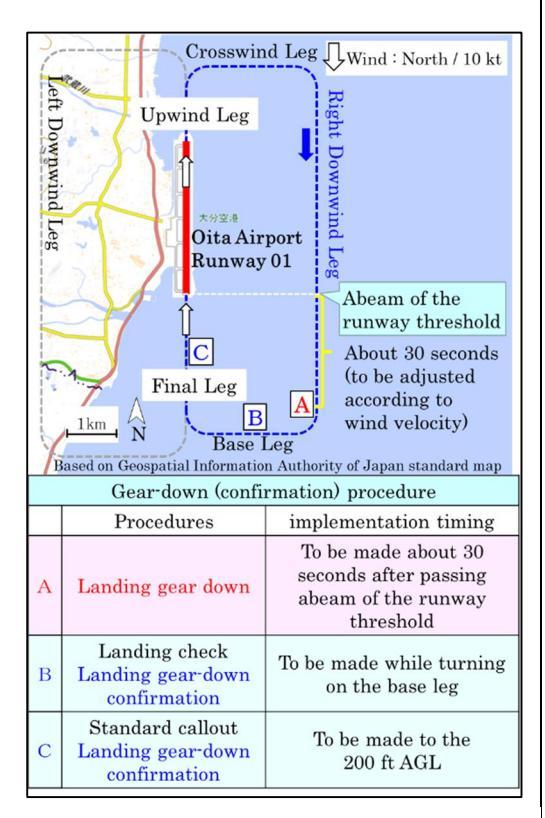
Figure 1: Traffic Pattern and Timing for Gear Down and Others

Figure 1 shows the traffic pattern around the airport, and the implementation timing for performing a landing gear down and confirming the landing gear down status described in the company's training manual for G58 (see "2.7 (5) Landing Gear Down Operation and Confirmation of Landing Gear Down Status" later).

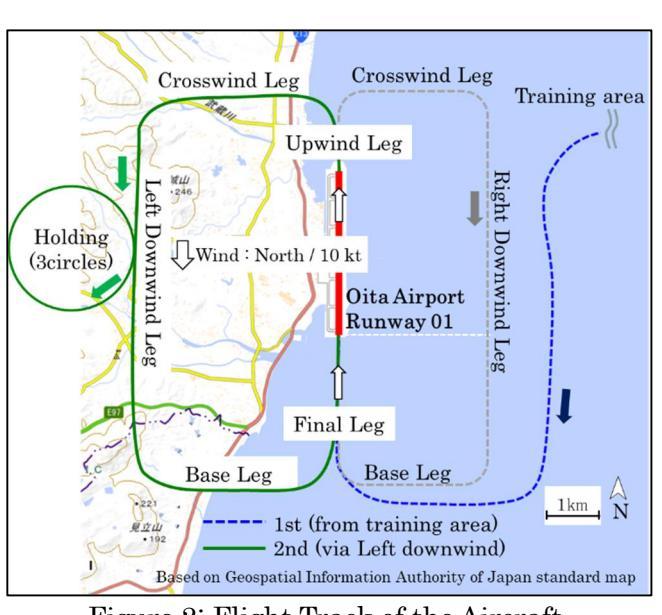
Figure 2: Flight Track of the Aircraft (1st and 2nd TGLs)

(1) 1st and 2nd TGLs At about 10:01, the aircraft requested the clearance for the 1st TGL from Oita Tower on the right downwind leg (see Figure 2). Oita Tower issued a TGL clearance to the aircraft instructed and the aircraft to report again at the time of entering the right downwind leg after TGL (CLEARED TOUCH AND GO. WIND 350 AT 10.

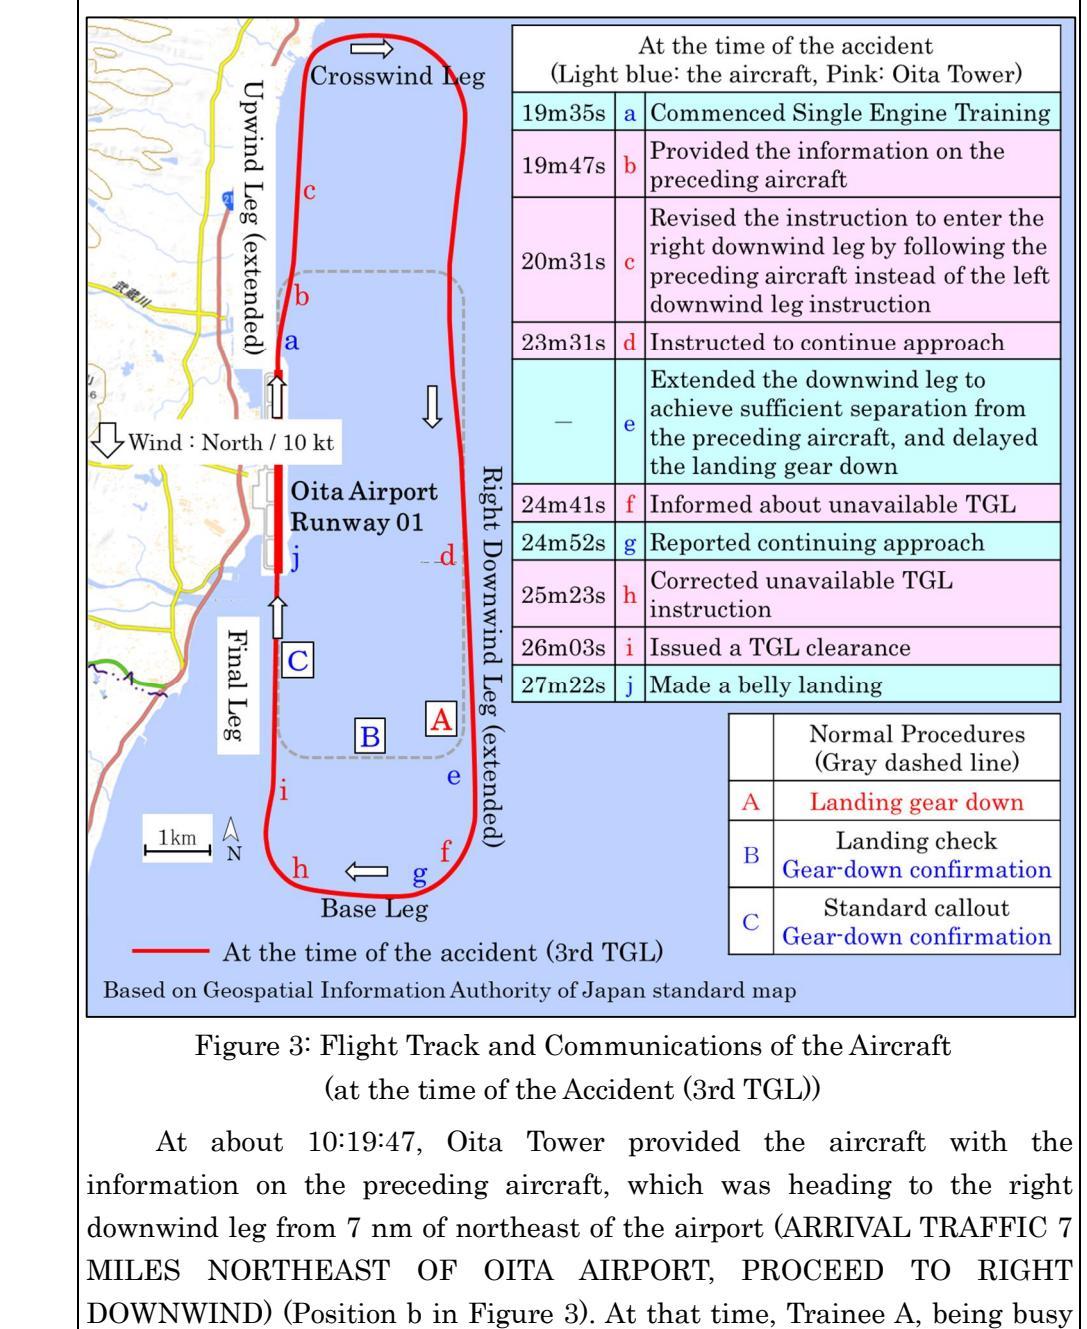
At 10:19:35, on the upwind leg of the 3rd TGL, the Instructor pulled the right engine throttle to the idle position to begin Single Engine Training during take-off (Position at a in Figure 3). Trainee A started the initial action for Single Engine Training, but mistakenly applied the right rudder pedal that was opposite to the pedal that should have been applied, resulting in a large right yaw and nose-down attitude of the aircraft, forcing Trainee A to be occupied with the corrective operations. In addition, according to the flight data, at this time, the aircraft was flying with the maximum changes in aircraft attitude such as a heading of approximately 19° to the right, a roll angle of approximately 17° to the right, and a pitch angle of approximately 13° down.

Trainee A was confused and upset due to the reasons as follows: Trainee A made a mistake about the initial action for Single Engine Training; along with this the instructor made a communication to Oita Tower that Trainee A should have made; and the instruction to enter the left downwind leg was revised to follow the preceding aircraft entering the right downwind leg. In addition to these, although the aircraft was instructed to report to Oita Tower if it entered the right downwind leg, Trainee A forgot it. Therefore, the instructor urged Trainee A to do so, and Trainee A reported to Oita Tower that they had entered the right downwind leg at about 10:23 and requested a TGL clearance. Oita Tower instructed the aircraft to continue onto Runway 01. (Position d in Figure 3).

At about 10:24:41, as the aircraft began its base turn, Oita Tower informed the aircraft that it would be unable to TGL due to wake turbulence from the preceding aircraft, but that a low approach (to fly over a runway at low altitude) was available, and asked for its intention (THIS TIME UNABLE TOUCH AND GO DUE TO WAKE TURBULENCE FROM ARRIVAL TRAFFIC, LOW APPROACH IS AVAILABLE, REQUEST INTENTION.) (Position f in Figure 3) This was the first time Trainee A had received this type of instruction, and Trainee A had ever been instructed to "CONTINUE APPROACH" but did not know what to do with his head going blank when Trainee A heard the instruction to "UNABLE TOUCH AND GO DUE TO WAKE TURBULENCE". The instructor advised Trainee A that a low approach would be good, as Trainee A did not seem to understand how to respond to the notification that a low approach would be available at this timing. At 10:24:52, Trainee A reported to Oita Tower that the aircraft would continue its approach (Position g in Figure 3).

At 10:26:03, Oita Tower issued a TGL clearance (CLEARED TOUCH AND GO, AFTER TOUCH AND GO, REPORT RIGHT DOWNWIND RUNWAY 01) (Position i in Figure 3). After reading back to Oita Tower, "Runway 01 Cleared Touch and Go" Trainee A said to the Instructor that "Runway 01 Cleared Touch and Go", and the Instructor also returned to Trainee A with confirmation "Runway 01 Cleared Touch and Go".

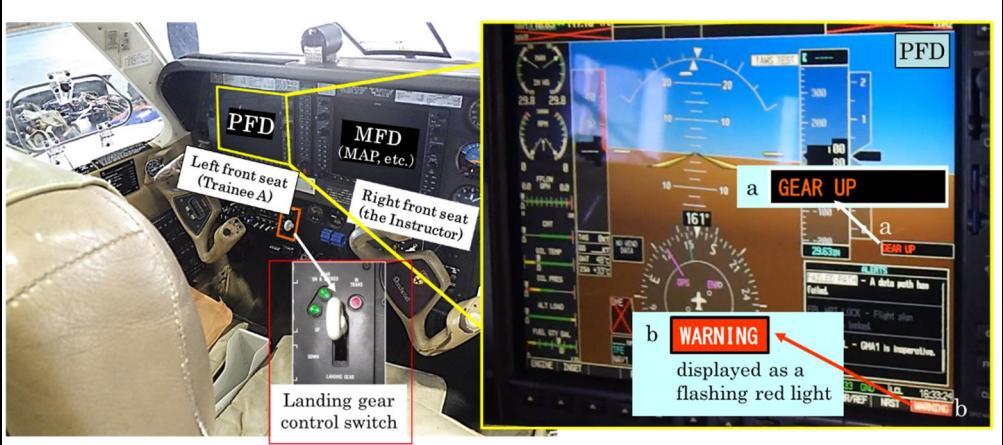
Figure 9: Indication Status of Landing Gear Warning Systems at the time of confirming the operation (the Aircraft)

(b) Warning label: A	A red "GEAR U	P" warning displayed	l in the
	6	annunciator wi	indow of the PFD	(Primary Flight
	1	Display) locate	d in front of the lef	ft pilot seat (see
]	Figure 9. a).		-

(c) Alert soft key: A flashing red "WARNING" alert displayed on the alert soft key of the PFD (see Figure 9, b).

Examination of the Landing Gear Warning Systems conducted in the hanger where the aircraft was brought in after the accident revealed that all the Landing Gear Warning Systems were normally activated (displayed).

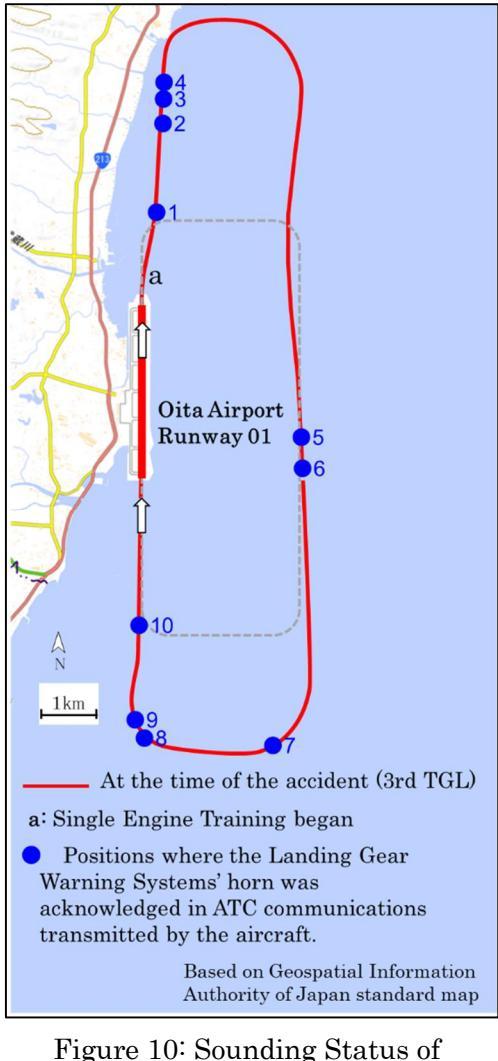
Figure 10: Sounding Status of Landing Gear Warning Systems' Horn

As a result, it was analyzed that in all the ten positions (Positions marked with " \bullet " in Figure 10) where the aircraft had transmitted communications while flying on the traffic pattern at the time of the accident, the frequency matched some of the characteristics of the sample audio source of the Landing Gear Warning Systems' horn.

c. Based on frequency analysis of ATC communications transmitted by the aircraft, after Single Engine Training commenced during the 3rd TGL, the aircraft transmitted ATC communications, whose all frequency most likely matched some of the characteristics of the horn of the Landing Gear Warning System output through the aircraft's in-flight speaker.
