# AIRCRAFT SERIOUS INCIDENT INVESTIGATION REPORT

Company	Shin Nihon Helicopter Co., Ltd.	
Туре,	Aerospatiale AS332L1, JA6686	
Registration		
Mark		
Incident Class	Case where a slung load, any other load carried external to the aircraft, was	
	released unintentionally	
	Article 166-4, Item (xvi), of the Regulation for Enforcement of the Civil	
	Aeronautics Act of Japan.	
Date and Time of	At about 10:36 Japan Standard Time (JST: UTC+9 hours), July 3, 2023	
the Occurrence		
Site of the	At an altitude of about 150 m over the Kamiochiai area, Aoi Ward, Shizuoka	
Incident	City, Shizuoka Prefecture	
	(35° 10' 30" N, 138° 18' 36" E).

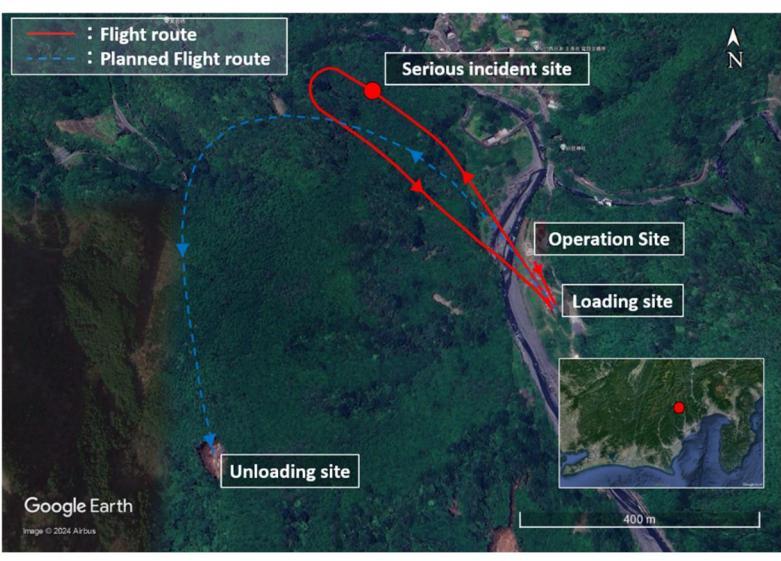
Figure 1: Estimated Flight Route

On the day of the serious incident, the helicopter was scheduled to transport cargo for the construction of transmission line pylons 16 times from a loading site adjacent to the operation site (see Figure 1) to an unloading site approximately 560 m from the loading site. On board the helicopter, the Captain sat in the right seat in the cockpit, and two of Onboard Mechanic A and B in charge of monitoring sat on the left side of the cabin. Onboard Mechanic A was in the training for onboard mechanic operations and undergoing an assessment review by Onboard Mechanic B on the day of the serious incident. Three ground operators were deployed at the loading site, including Ground Operator C who was responsible for hooking external cargo onto the cargo hook.

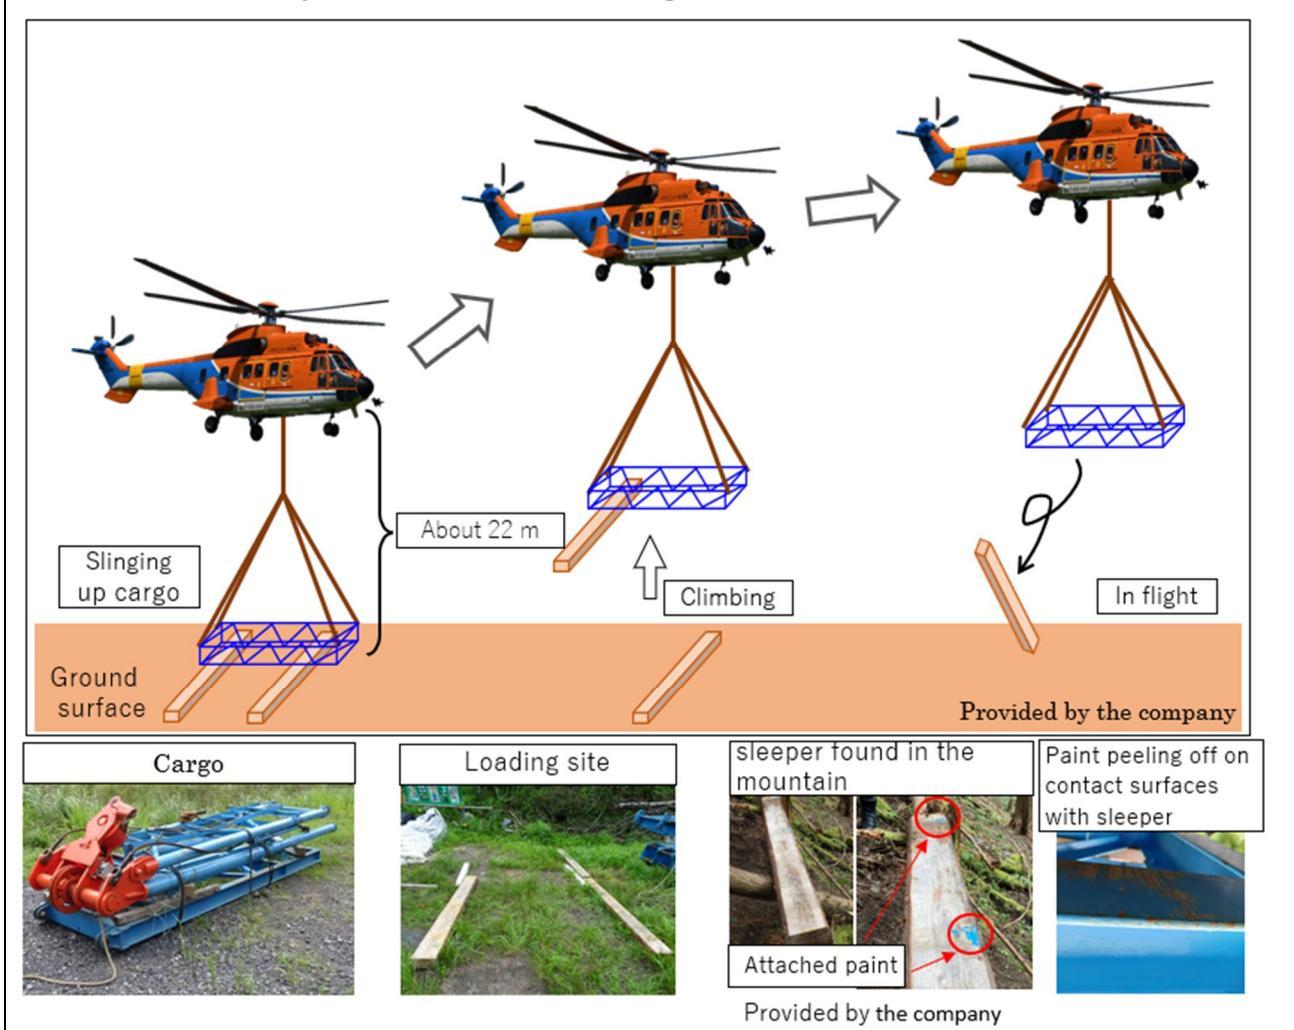
Figure 2: Image of Falling Sleeper and Others

the transport operation for the cargo after this communication with Ground Operator C. At about 10:36, as the helicopter flew along the mountainside at an altitude of about 500 ft (150 m) over the Kamiochiai area, Aoi Ward, the Captain saw the sleeper falling through the cargo mirror and the two onboard mechanics visually confirmed it (see Figure 2). The helicopter returned to the loading site, unloaded the cargo, and then landed at the Operation Site.

approximately 15 kg. The fallen sleeper was found in the mountain below the helicopter's flight route and there were no casualties and the other damages from the fallen sleeper. There was paint from the same color as the cargo in part of the sleeper to which the cargo appeared to be attached. In addition, the paint of the cargo being transported at the time of the serious incident was partially peeled off where it appeared to be in contact with the sleeper.

The JTSB concludes that it was probable that the cargo, weighing approximately 800 kg, was placed on the top of the sleepers for a lengthy period, which caused by the large load on the contact surface, therefore the sleeper was pressed against and crimped to the cargo. When the helicopter lifted the cargo, the sleeper was lifted with it, and the crimping to the cargo was removed by vibration, wind pressure and the weight of the sleeper itself during the flight, most likely causing the sleeper to fall.

The JTSB concludes that the probable cause of this serious incident was that the sleeper, which had been pressed against and crimped to the cargo own weight, lifted with the cargo, when the helicopter went to fly, and then the vibrations and other factors during the flight most likely cause the sleeper to fall.

It is necessary that the captain, onboard mechanics and ground operators should make sure of the items relevant to the underslung cargo and record it in the transport cargo list to make sure of it before the flight, as well as when the cargo is lifted, they should communicate well among themselves to confirm the state of the cargo and stop the transport operation if there is anything abnormal.

- a. The company's training text stipulated that it shall be written in the transport cargo list if sleepers are to be included in the cargo, which was made known to all. (September 21, 2023)
- b. The company regulation was revised as follows: Confirm with ground operators if there is anything abnormal during cargo transport; stop the operations once if unable to confirm with ground operators and unload the cargo on the ground to confirm. (September 21, 2023)
- c. Training has been provided all those involved in the company's cargo transport operations education on the overview of serious incidents and the correct use of headsets when communicating by radio during cargo transport. (July 21, 2023)
