AIRCRAFT SERIOUS INCIDENT INVESTIGATION REPORT

ATTEMPTED LANDING ON A RUNWAY
BEING USED BY OTHER AIRCRAFT
KOHNAN AERODROME,
OKAYAMA CITY, OKAYAMA PREFECTURE
AT AROUND 13:01 JST, JUNE 20, 2023
1. TAKUMI ENTERPRISE CO., LTD.
ROBINSON R44 (HELICOPTER), JA01CG
2. OKAYAMA AIR SERVICE CO., LTD.
CESSNA 172R, JA10AZ

Adopted by the Japan Transport Safety Board

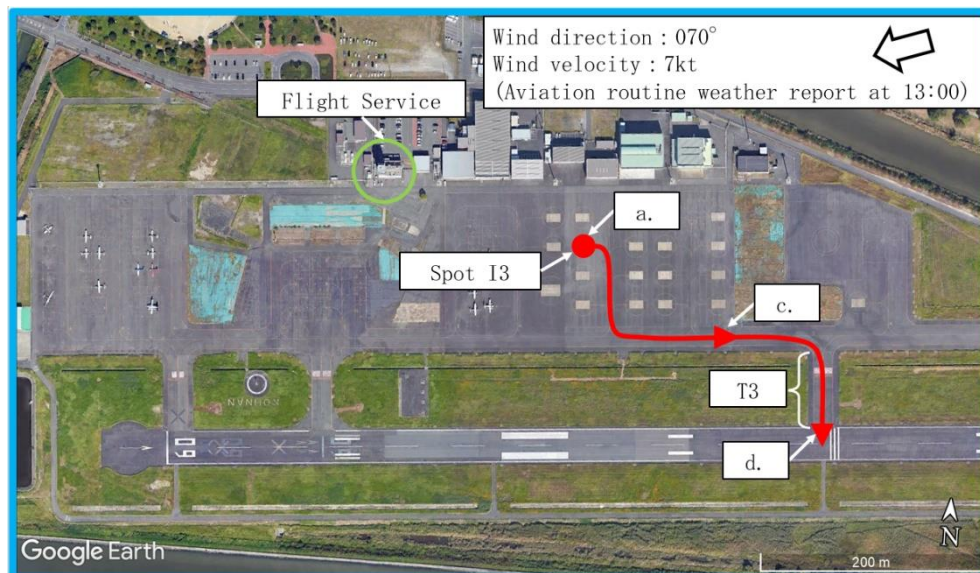
<p>At around 12:53, Aircraft A landed and returned to Spot I3 (Figure 3). Judging that it would be possible for Student Pilot A to fly solo, Captain A disembarked.</p> <p>Aircraft B planned to conduct a total of five touch and goes at the aerodrome. At around 12:54, Aircraft B reported to the Flight Service that it was entering the left downwind leg (orange line in Figure 4) on Runway 09 for the first touch and go. The Flight Service informed Aircraft B that "RUNWAY IS CLEAR." Captain B read it back. At around 12:56, Aircraft B conducted the first touch and go.</p> <p>At around 12:57, Aircraft A requested the Flight Service to provide the information on ground taxiing. (At Position a. in Figure 3) The Flight Service advised Aircraft A to taxi to Taxiway T3. Aircraft A read it back and started air-taxiing^{*3}. According to the statement, student Pilot A was nervous because it was Student Pilot A's first solo flight. In addition, Student Pilot A was concentrating on flying the aircraft to cope with the changes in weight and balance caused by Captain A's disembarkation, and the crosswind during the air-taxiing.</p> <p>At around 12:58, Aircraft B reported to the Flight Service that it was entering the left downwind leg for the second touch and go. (At Position b. in Figure 4) The Flight Service informed Aircraft B that "RUNWAY IS CLEAR." Captain B read it back. Student Pilot A was not aware of this radio communication.</p> <p>At around 12:59, as there was Aircraft B on the base leg which was scheduled to conduct a touch and go, the Flight Service informed Aircraft A that "TRAFFIC ON BASE FOR TOUCH AND GO, ADVISE HOLD SHORT OF RUNWAY." Student Pilot A read back "HOLD SHORT OF RUNWAY." (At Position c. in Figure 3) Student Pilot A misunderstood "HOLD SHORT OF RUNWAY" for "LINE UP AND WAIT".</p> <p>Student Pilot A visually checked the base leg and final leg before entering the runway, but could not visually see any traffic, thus Aircraft A entered the runway.</p> <p>At around 13:01, the Flight Service checked again for birds and other obstructions on the runway before Aircraft B conducted a touch and go and visually recognized that Aircraft A had entered the runway. (At Position d. in Figure 3)</p> <p>Aircraft A entered the runway, therefore the Flight Service advised Aircraft B to "GO AROUND."</p> <p>Aircraft B made a go-around immediately after entering the final leg. (Altitude: about 500 ft) (At Position e. in Figure 4)</p> <p>The Flight Service again confirmed with Aircraft A concerning the holding short advice that the Flight Service had already given.</p>

Student Pilot A reported to the Flight Service to the effect that Student Pilot A had entered the runway by mistake and Aircraft A returned to Taxiway T3.

Figure 3: Estimated Taxiing Route of Aircraft A
(based on the statements)

to conduct touch and go, Aircraft A, which had been advised to hold short of the runway, entered the runway by mistake. Aircraft A entered the runway by mistake most likely because Student Pilot A misunderstood the hold short of runway advice from Flight Service for the line up and wait advice.

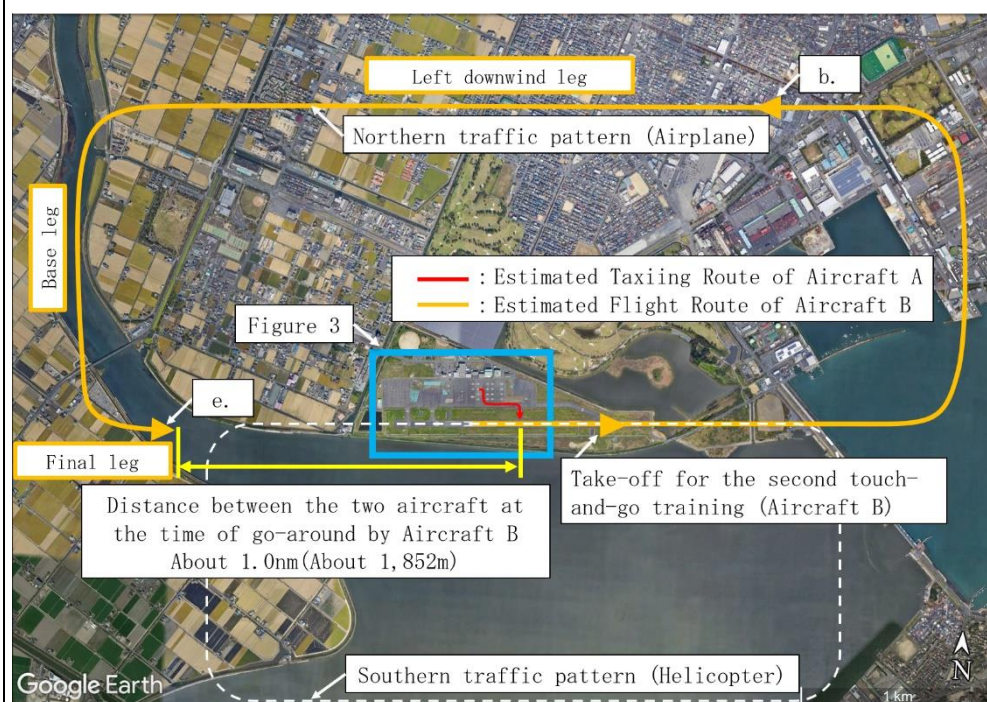
Aircraft B climbed to an altitude of about 800 ft near the runway threshold and passed over the runway, maintaining that altitude.

Figure 4: Estimated Flight Route of Aircraft B and Distance between the Two Aircraft at the time of Go-around by Aircraft B
(based on statements)

The JTSB concludes that the distance between the two aircraft when Aircraft B executed a go-around was probably about 1.0 nm (about 1.9 km). And the serious incident certainly falls under the severity classification of Category C (An incident characterized by ample time and/or distance to avoid a collision) of "Manual on the Prevention of Runway Incursions" of ICAO with classification tools provided by ICAO. (See Attachment "Severity Classifications of Runway Incursions").
