**MARINE ACCIDENT  
INVESTIGATION REPORT**

Vessel type and name: Container ship CARINA STAR

Vessel type and name: Destroyer KURAMA

Accident type: Collision

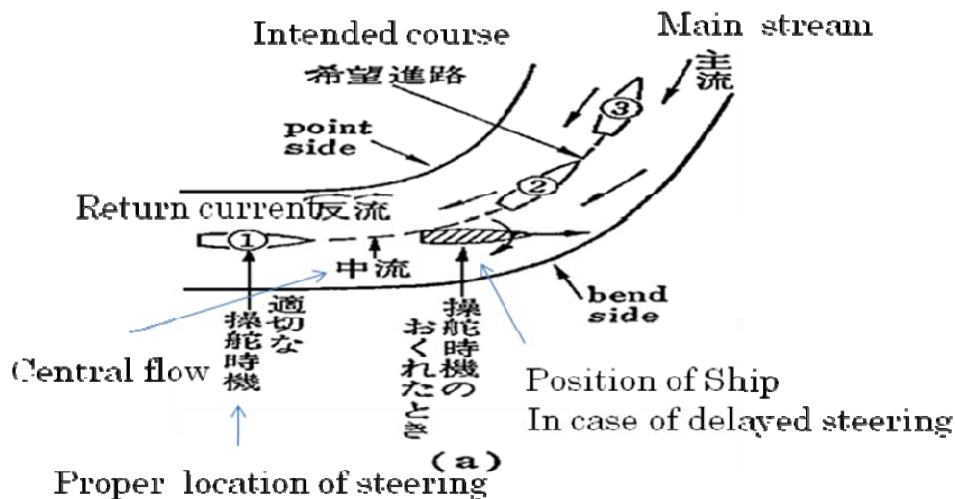
*The flow at a bend in a narrow channel such as a river or canal, as shown in the diagram below, generates a strong stream at the bend side, a weak stream at the point side and return streams locally in various places. In such waters, there is the possibility, as illustrated graphically in the diagram below, that a ship would be likely in danger depending on the course which is selected by the ship.*

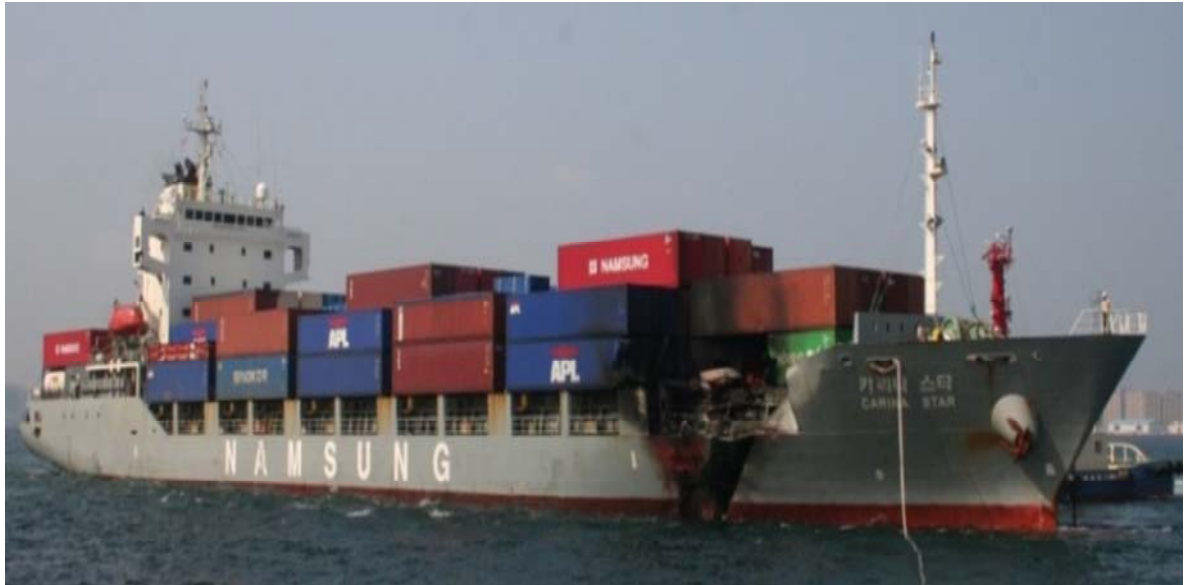
Photo 1: Situation of Ship A

Ship A suffered damage on the starboard bow outer-plate in the form of an open crack.

{2} Several containers on board were broken, and the wooden dunnage in the broken containers caught fire due to the flames on Ship B. The fire of Ship A was extinguished by the crewmembers of Ship A.

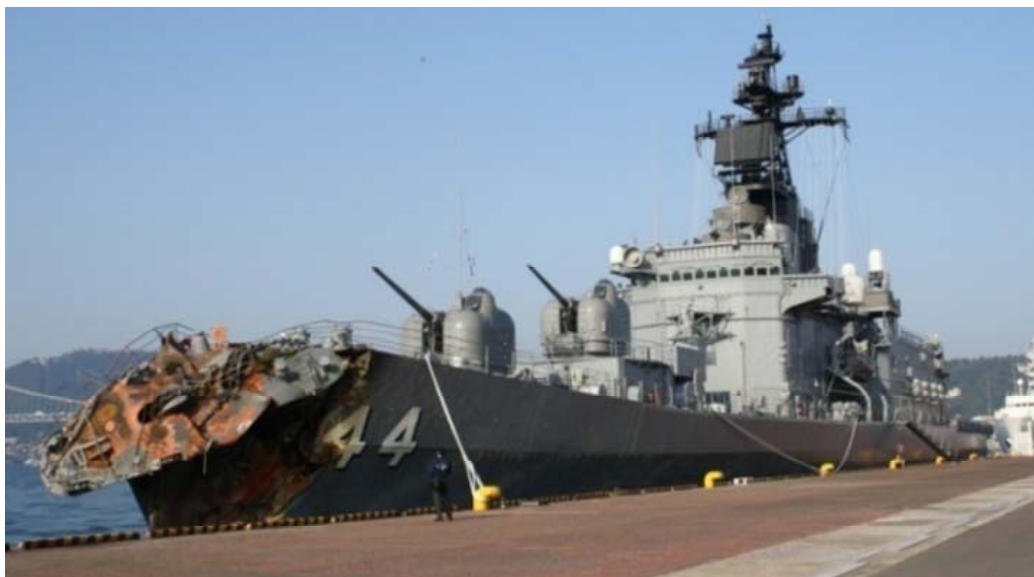
Photo 2: Situation of Ship B

Ship B suffered damage on the bow in the form of crushing.

It was considered highly probable that the fire was caused by ignition, due to sparks generated by the hard contact of the steel hulls, of the flammable mixture of gas generated from the petroleum No.1 thinner cans in the bow storage room of Ship B, which were broken by the collision between Ship A and Ship B.
