3. Characteristics of the accidents and incidents under focus and their investigation cases

(1) Train derailment accidents caused by compacted snow at level crossings

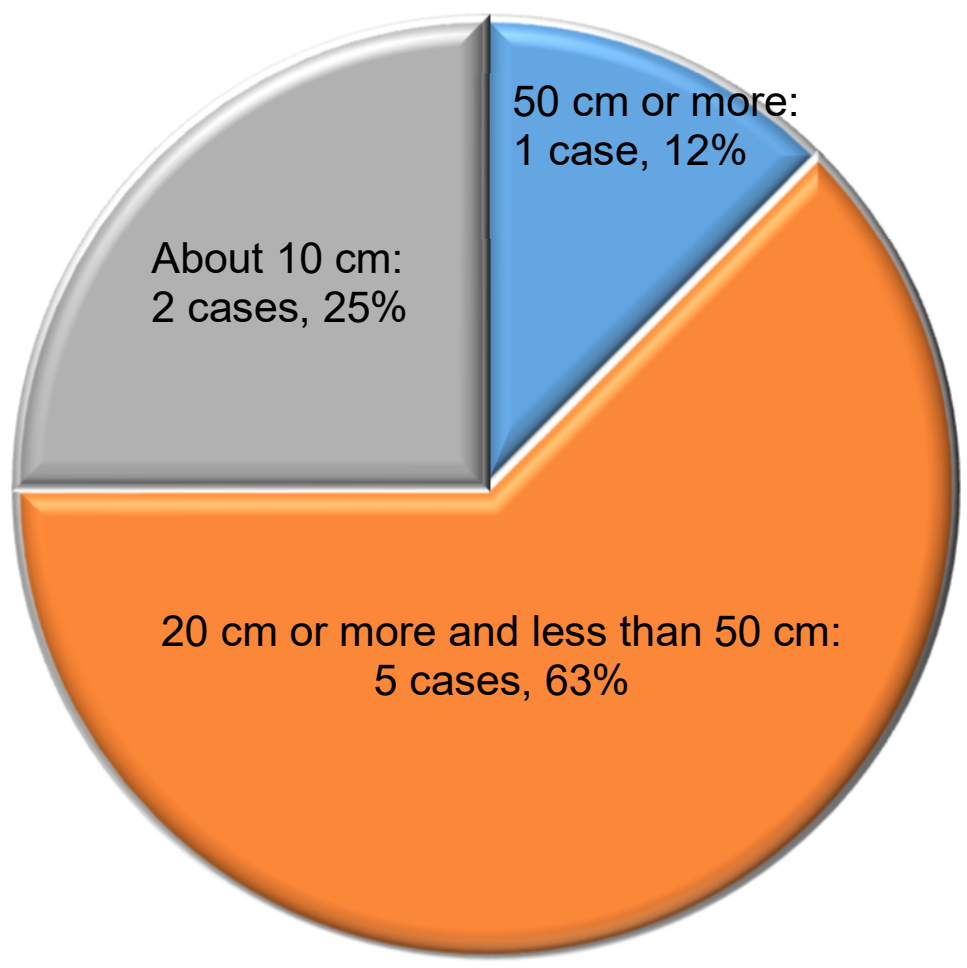
If there has been snowfall from the day before to the day of the accident, the newly accumulated snow is compacted by vehicles, which becomes compacted snow. In many cases the snowfall from the day before amounted to 20 cm or more (Figure 9), and there were cases where snowdrifts had formed. In addition, because of train service cancellations, operation controls, etc., in six cases there was an interval of 10 hours or more after the previous train that passed the level crossing (Figure 10). In the two remaining cases, snowdrifts formed rapidly because of heavy snowfall.

Figure 9: Snowfall from the day before (compacted snow at level crossings)

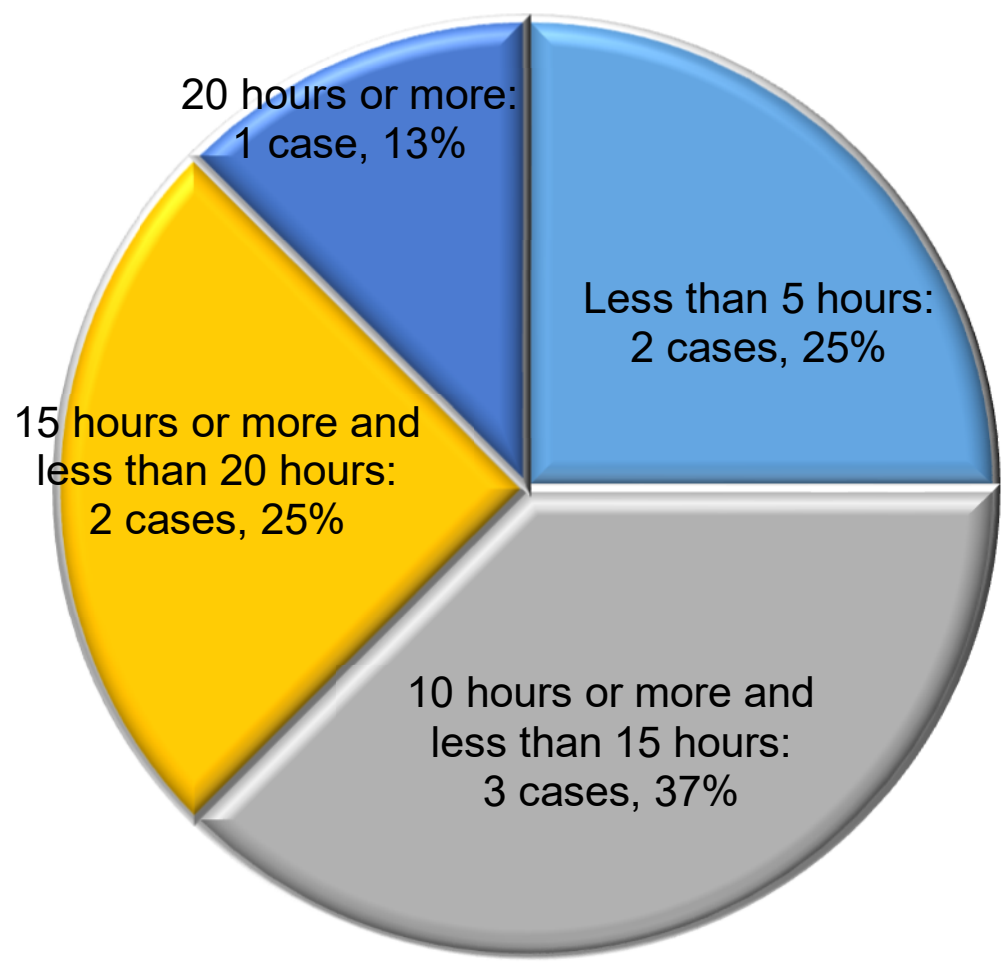
Figure 10: Interval after the previous train

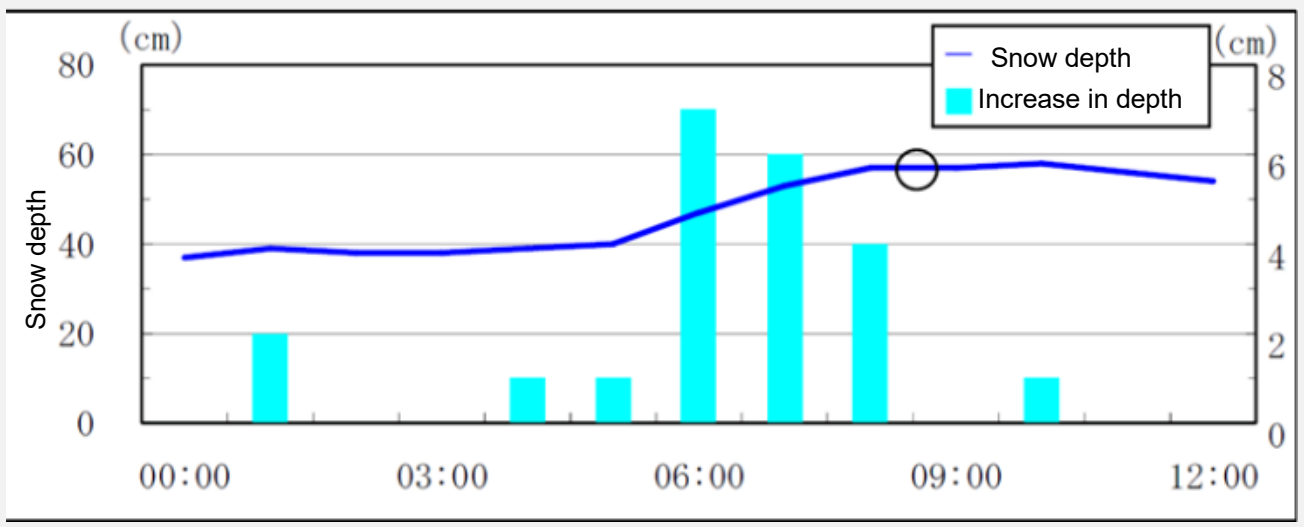
Figure 11: Snow depth and increase near the accident site (the circle indicates the time when the accident occurred.)

As for the occurrence of the accident, it is possible that the rapid formation of compacted snow due to a combination of the following factors was involved: strong winds from the direction unobstructed near the accident site caused a snowdrift to grow quickly at the level crossing, which, together with snowfall earlier in the period before the accident, led to snow accumulating enough to bury the rails at the crossing; and many heavy vehicles passed over the crossing and compacted the accumulated snow in a short time.

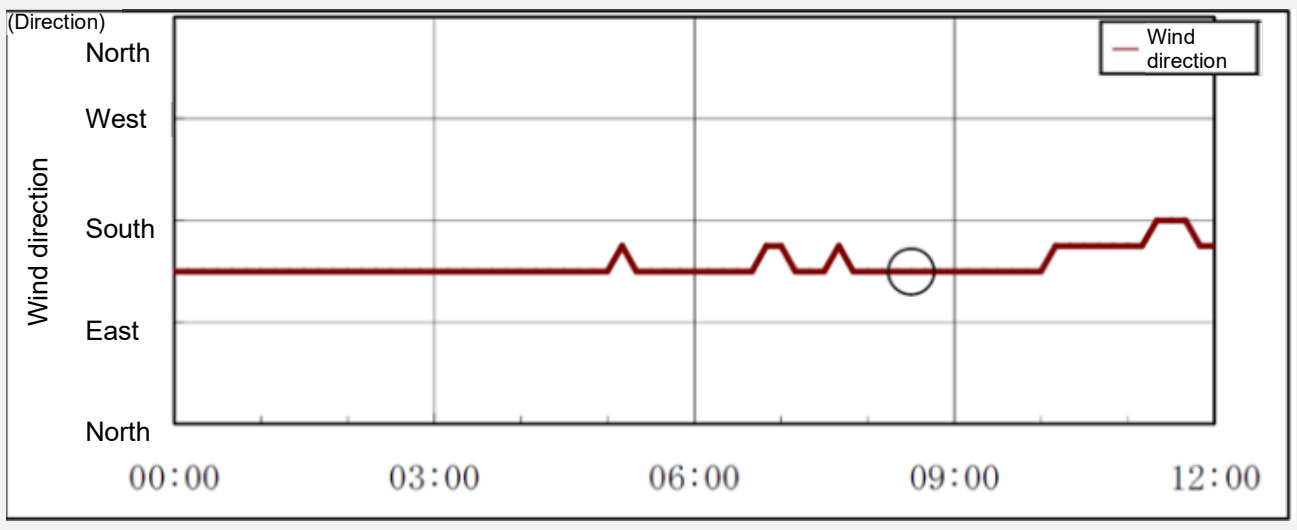
Figure 12: Wind direction near the accident site (the circle indicates the time when the accident occurred.)

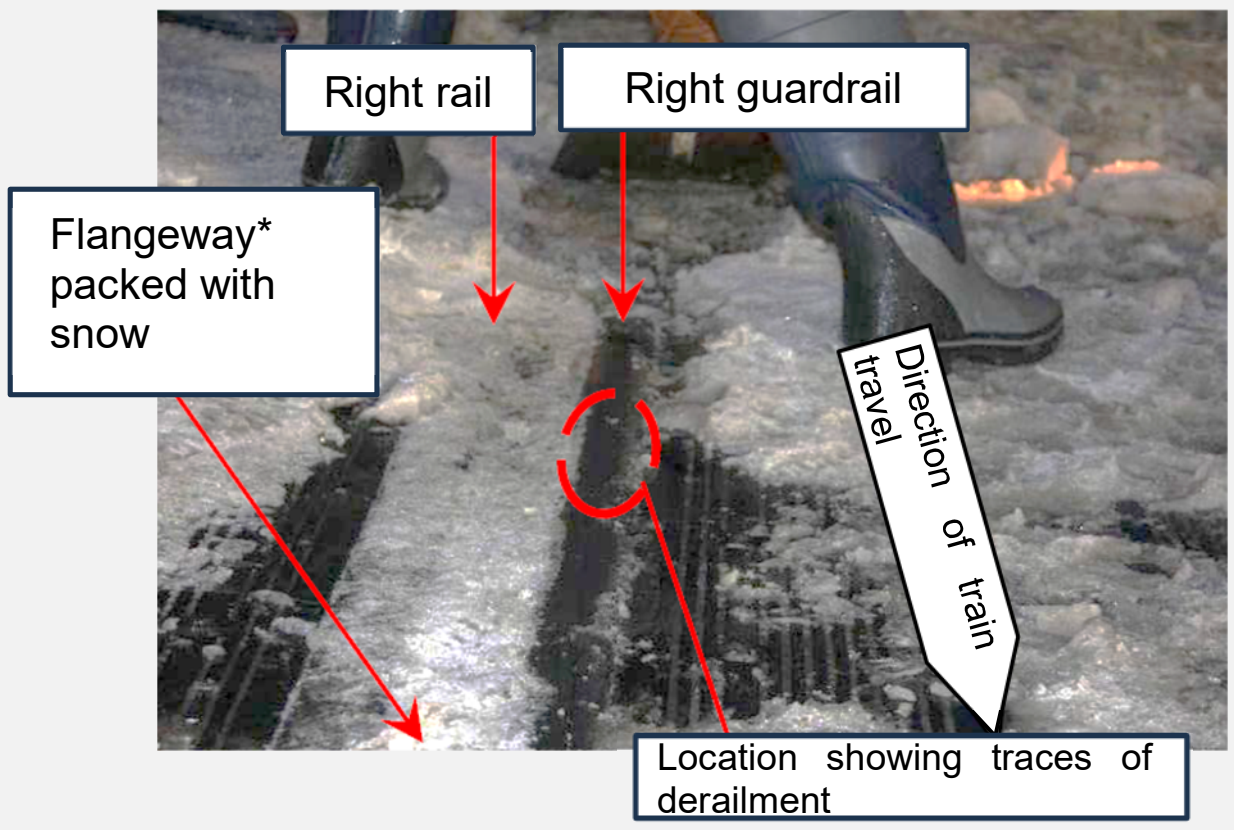
Figure 14: Condition of the level crossing where the accident occurred (photographed after removing snow at the location on the evening of the day of the accident)
* At the level crossing, although there is filler rubber at the bottom, it is not visible.

Probable causes: The JTSB concludes that it is probable that the accident was caused as the train climbed up onto compacted snow formed in the flangeways and on the rail surfaces at the level crossing and then moved to the left, resulting in a derailment.

(3) Efforts were continuously made to appropriately ascertain snowfall and accumulation conditions, and snow removal was carried out. In addition, for level crossings equipped with filler rubber, visual inspections and checks using a hammer, for example, were conducted to investigate whether soil and sand had accumulated in the hollow sections of the filler rubber. The operator has decided to check the conditions of filler rubber, remove soil and sand when necessary, and take measures to prevent the ingress of soil and sand before the winter season and, for locations where ingress is observed, to further strengthen the monitoring system.

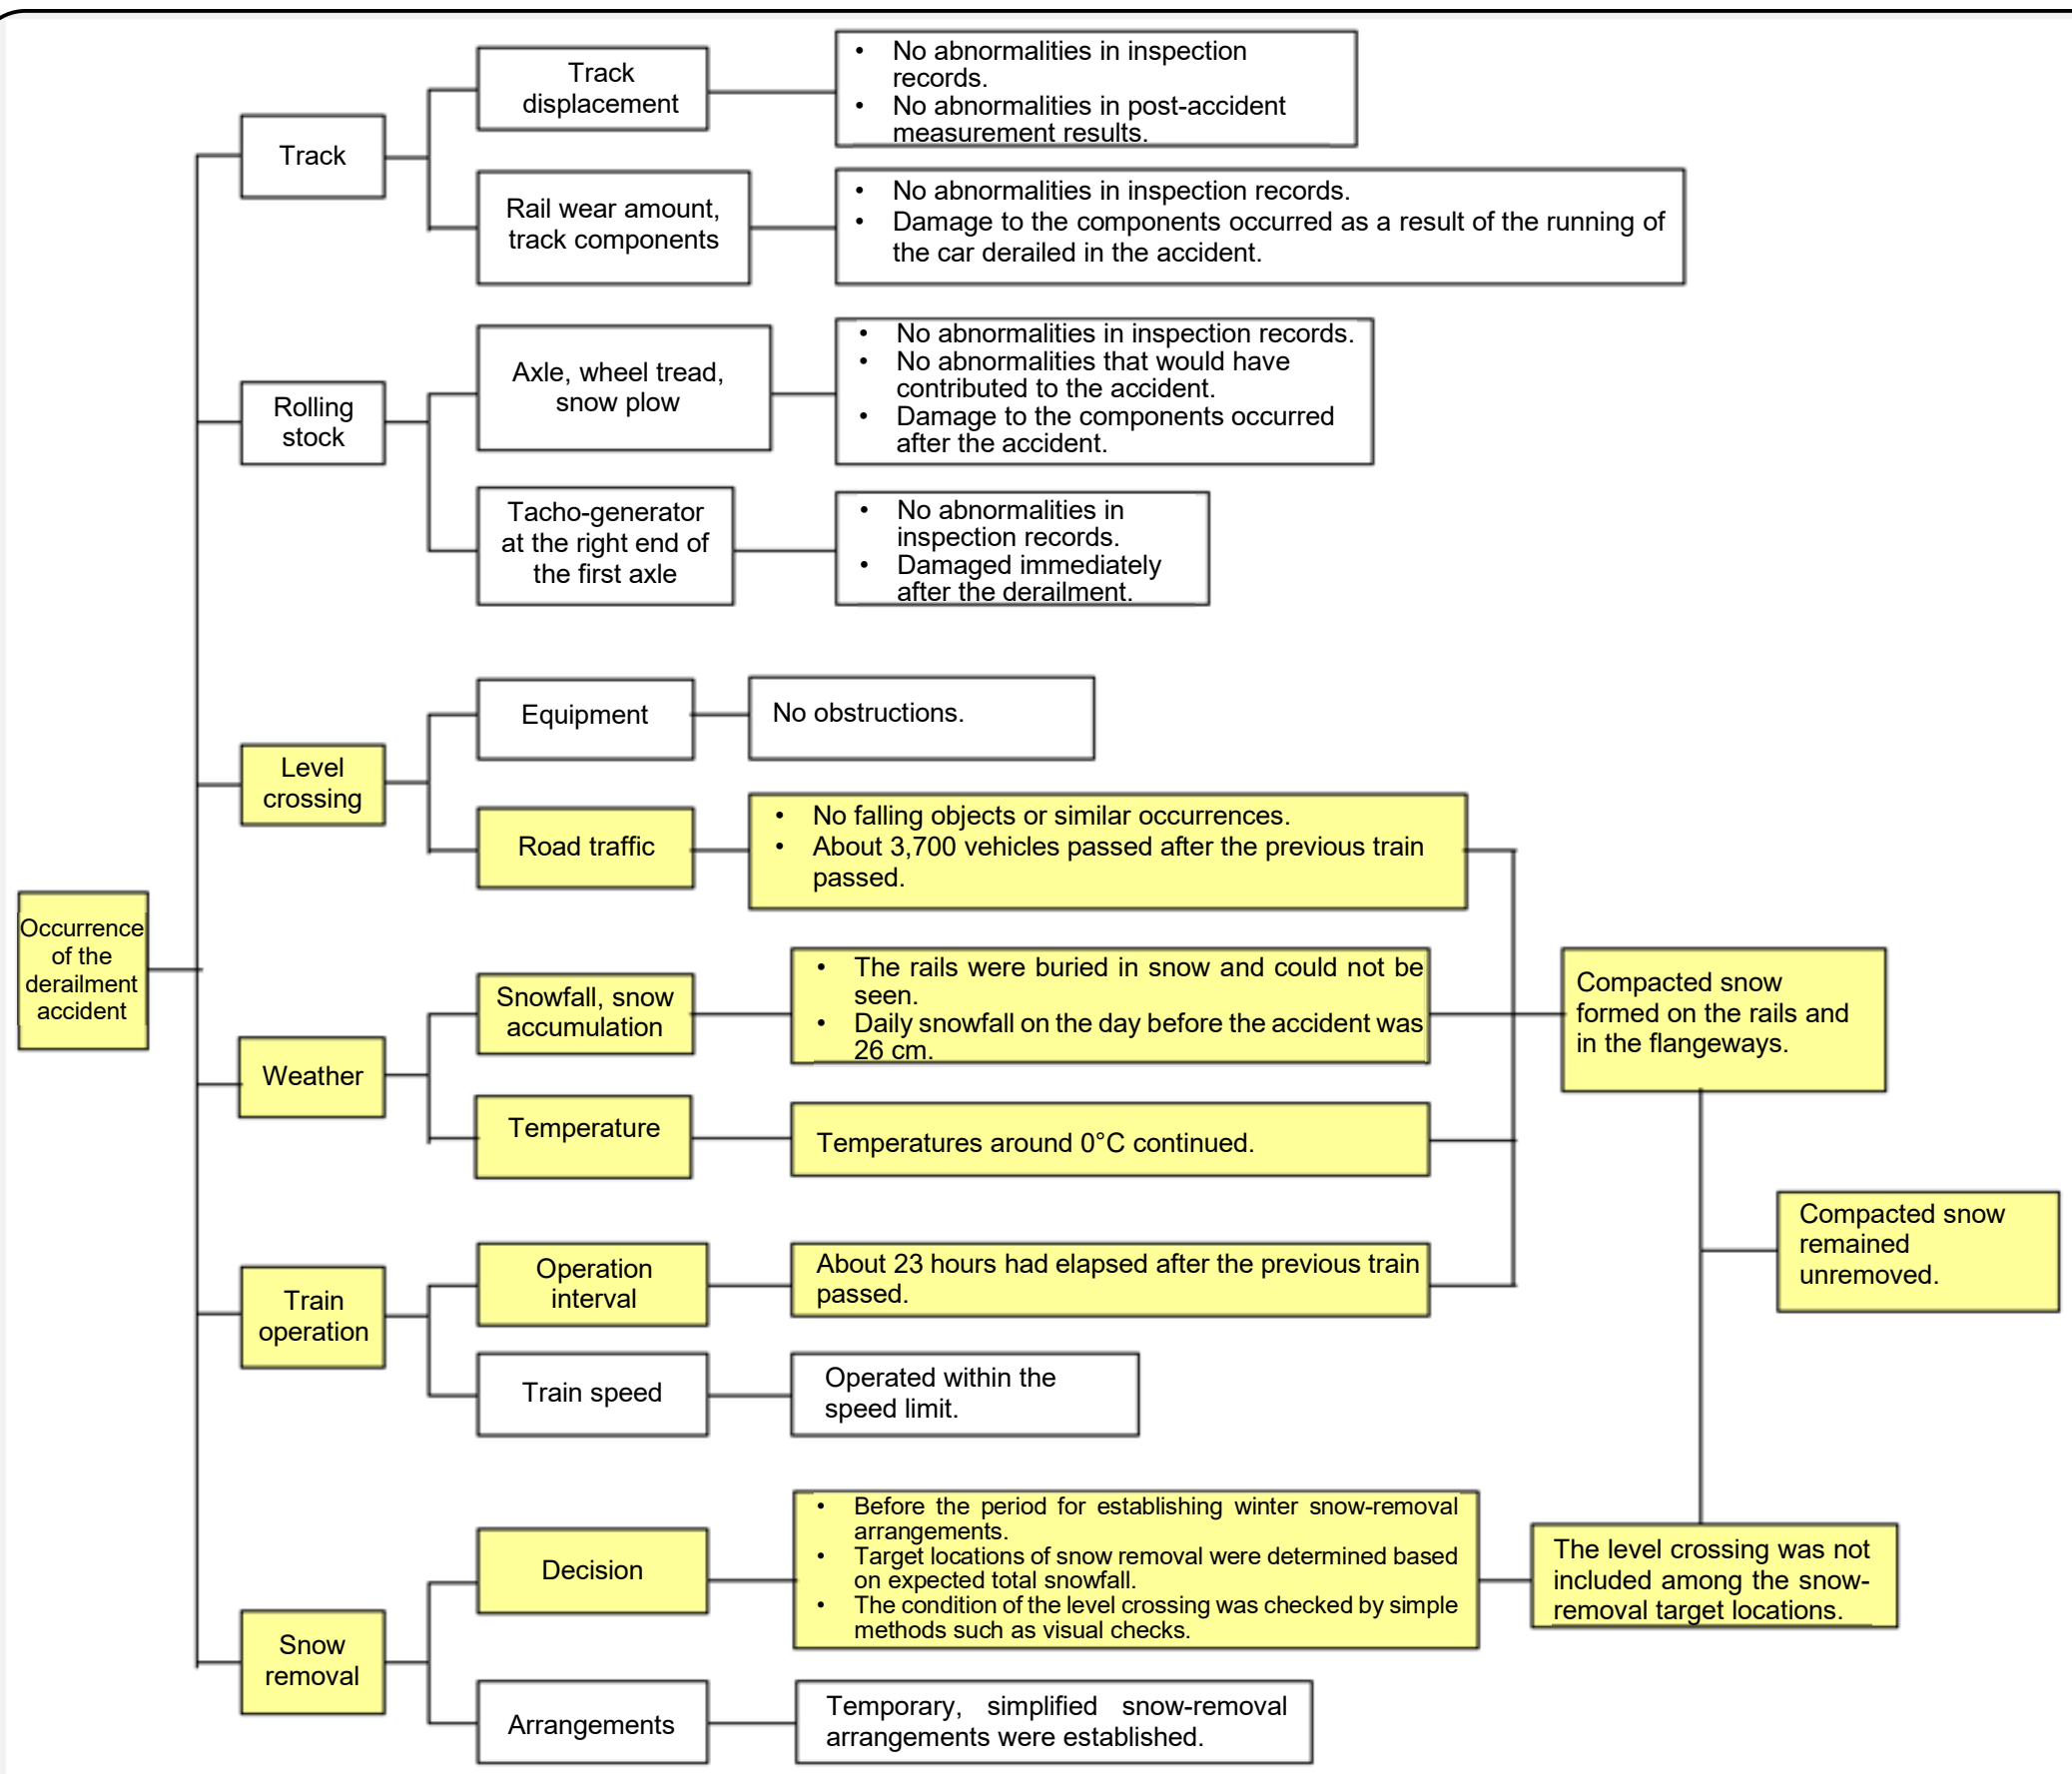
Figure 15: Factors involved in the train derailment accident (yellow boxes indicate factors that may have been involved in the occurrence of the accident.)

Probable causes: The JTSB concludes that the probable cause of the accident was, when the train was passing the level crossing located on the right-hand curve of the siding for inbound and outbound lines, which had not been used frequently, on the station premises, the left wheel of the first axle of the leading car's bogie climbed up onto the left rail (outer rail), resulting in a derailment to the left.

As for the derailment, it is possible that the wheel flange climbed up onto the compacted snow that existed on the rails and in the flangeways at the level crossing.

As for the presence of compacted snow at the level crossing, it is possible that heavy snowfall on the day before the accident, under the condition where temperatures around 0°C continued, and the continued compaction of snow by vehicles passing over the crossing during the long interval after the previous train contributed to its presence. In addition, it is possible that the compacted snow formed on the rails and in the flangeways remained unremoved, because no snow removal was performed up to when the train passed the crossing. As for the lack of snow removal, it is possible that the following factors were involved: it was before the period for establishing winter snow-removal arrangements; the condition of the level crossing was checked by simple methods such as visual checks; and the operation interval was not sufficiently considered in on-site checks and decisions about snow removal.

(1) Appropriate snow-removal arrangements and designation of snow-removal target locations according to the situation

In the cases where a day with heavy snowfall, the passage of strong cold air at night, or other weather conditions requiring caution are expected, it is desirable to flexibly increase snow-removal personnel according to the situation even outside the planned period for the winter snow-removal arrangements. Furthermore, it is desirable to further enhance snow removal at level crossings depending on snowfall and accumulation conditions by, for example, appropriately designating snow-removal target locations taking into account the conditions of compacted snow ascertained through on-site checks and environment of the level crossings, such as train operation intervals and vehicular traffic volumes.

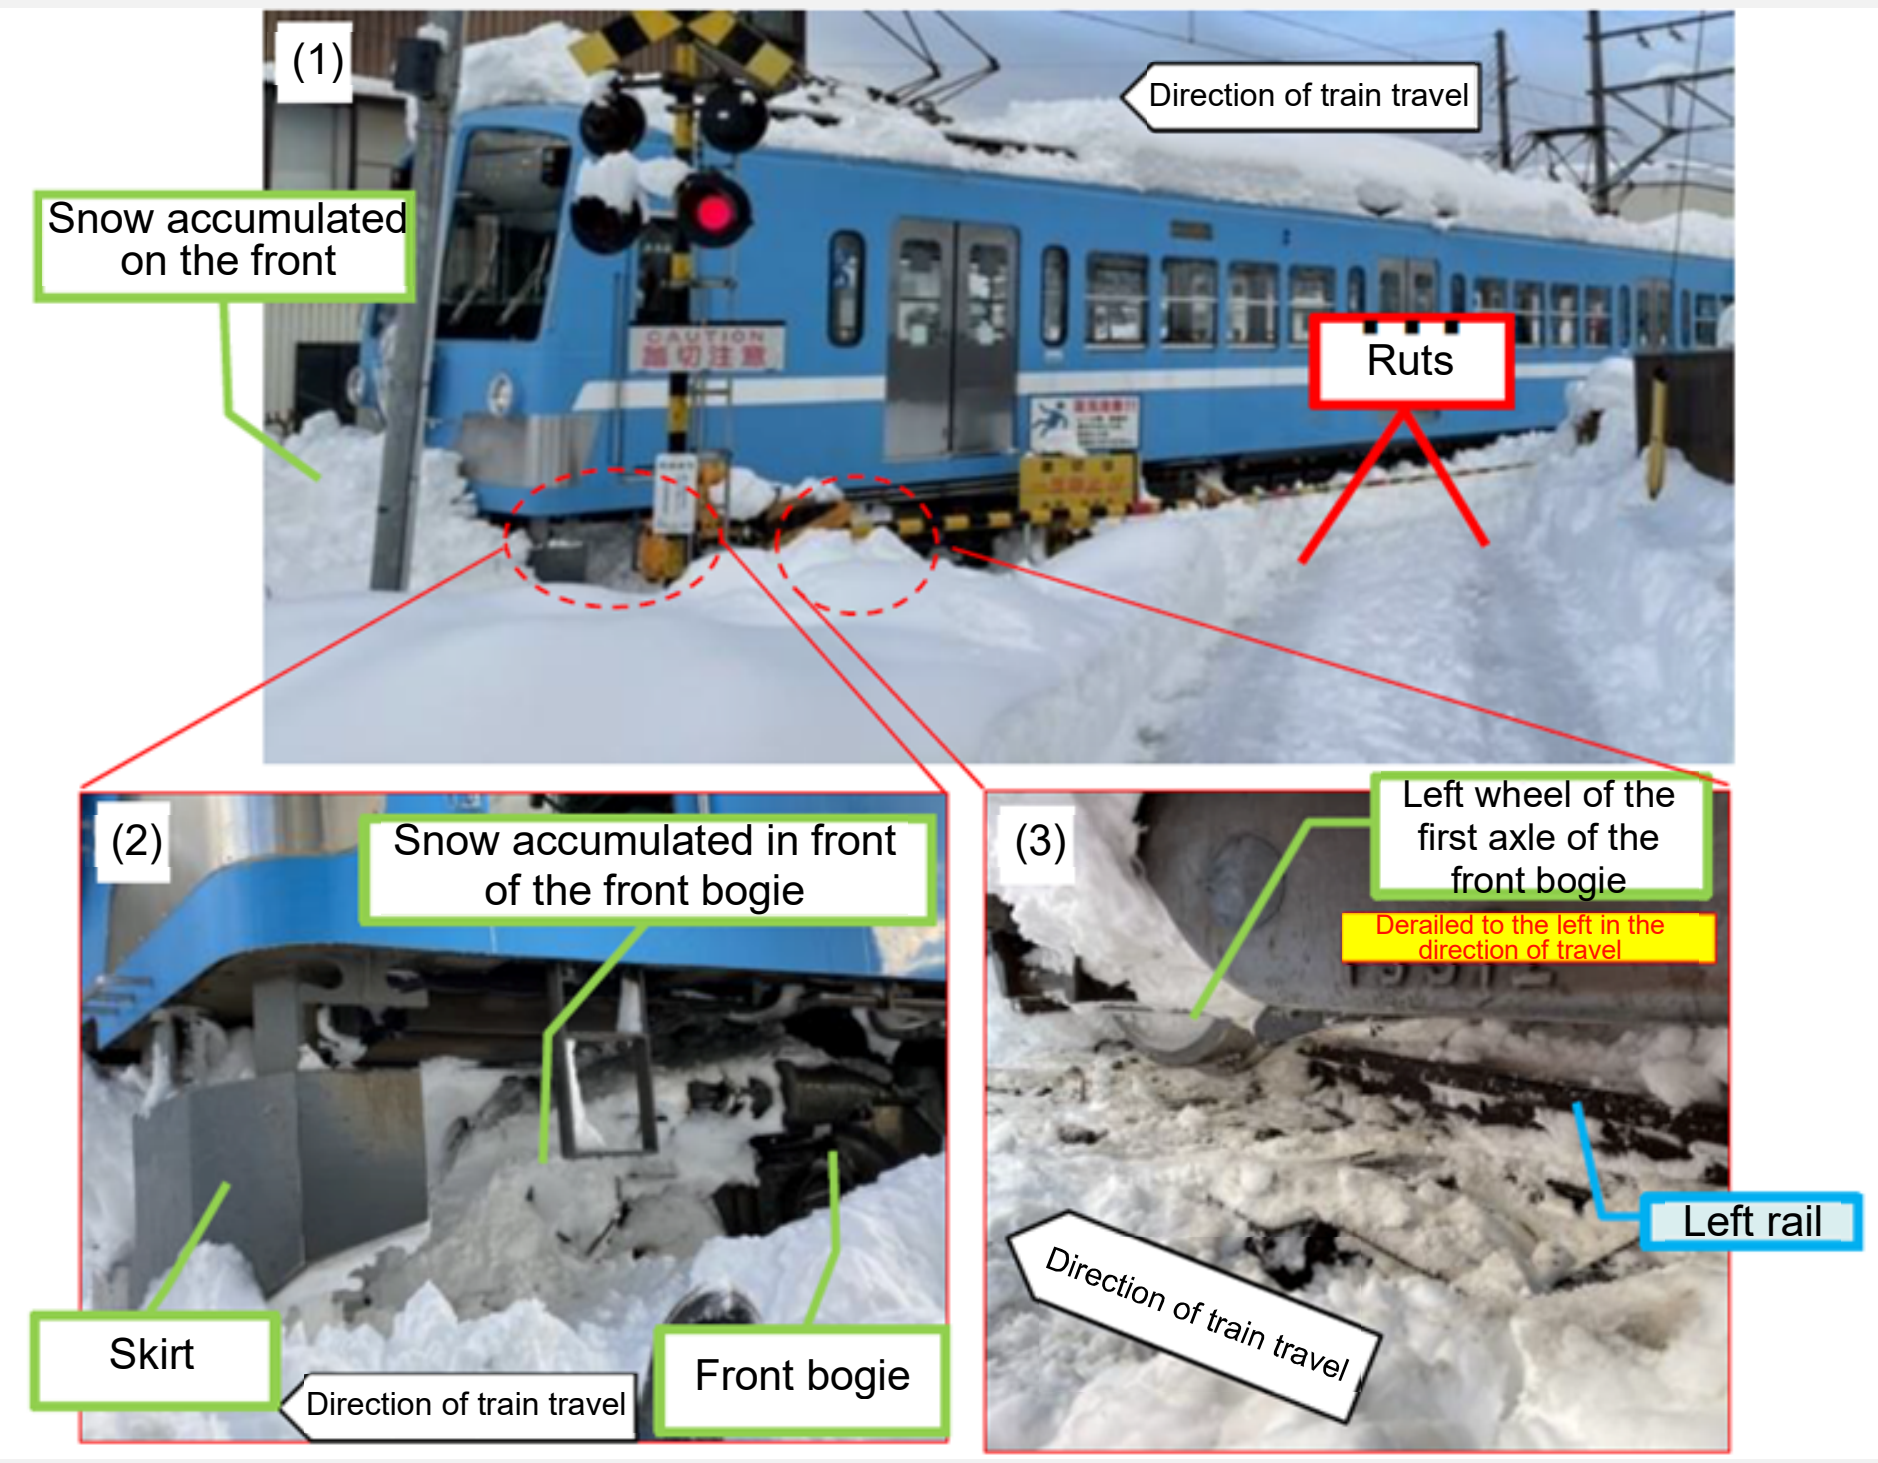
Figure 18: Conditions at the accident site

Probable causes: The JTSB concludes that it is possible that the accident occurred because the wheel load of the front bogie of the leading car decreased, and while the train was running with that bogie turned to the left, the first axle of the bogie climbed up onto compacted snow that was on the rails and in the flangeways at the level crossing, causing a derailment.

As for the decrease in wheel load on the front bogie of the leading car, it is possible that when the train ran while pushing aside a large amount of snow on the track, the volume of snow that had entered from below and above the skirt increased, causing an upward load to be applied to the leading car's front bogie.

Regarding the front bogie's turning to the left, it is possible that snow accumulated on the front of the leading car's carbody and front bogie pushed the front of the carbody and the front bogie.

It is necessary to clarify objective standards and conditions for determining the necessity of removal of snow on tracks and at level crossings, the use of cars with a snow plow, and the possibility of operations after collecting accurate information on the conditions of snowfall, snow accumulation, and compacted snow, for example.

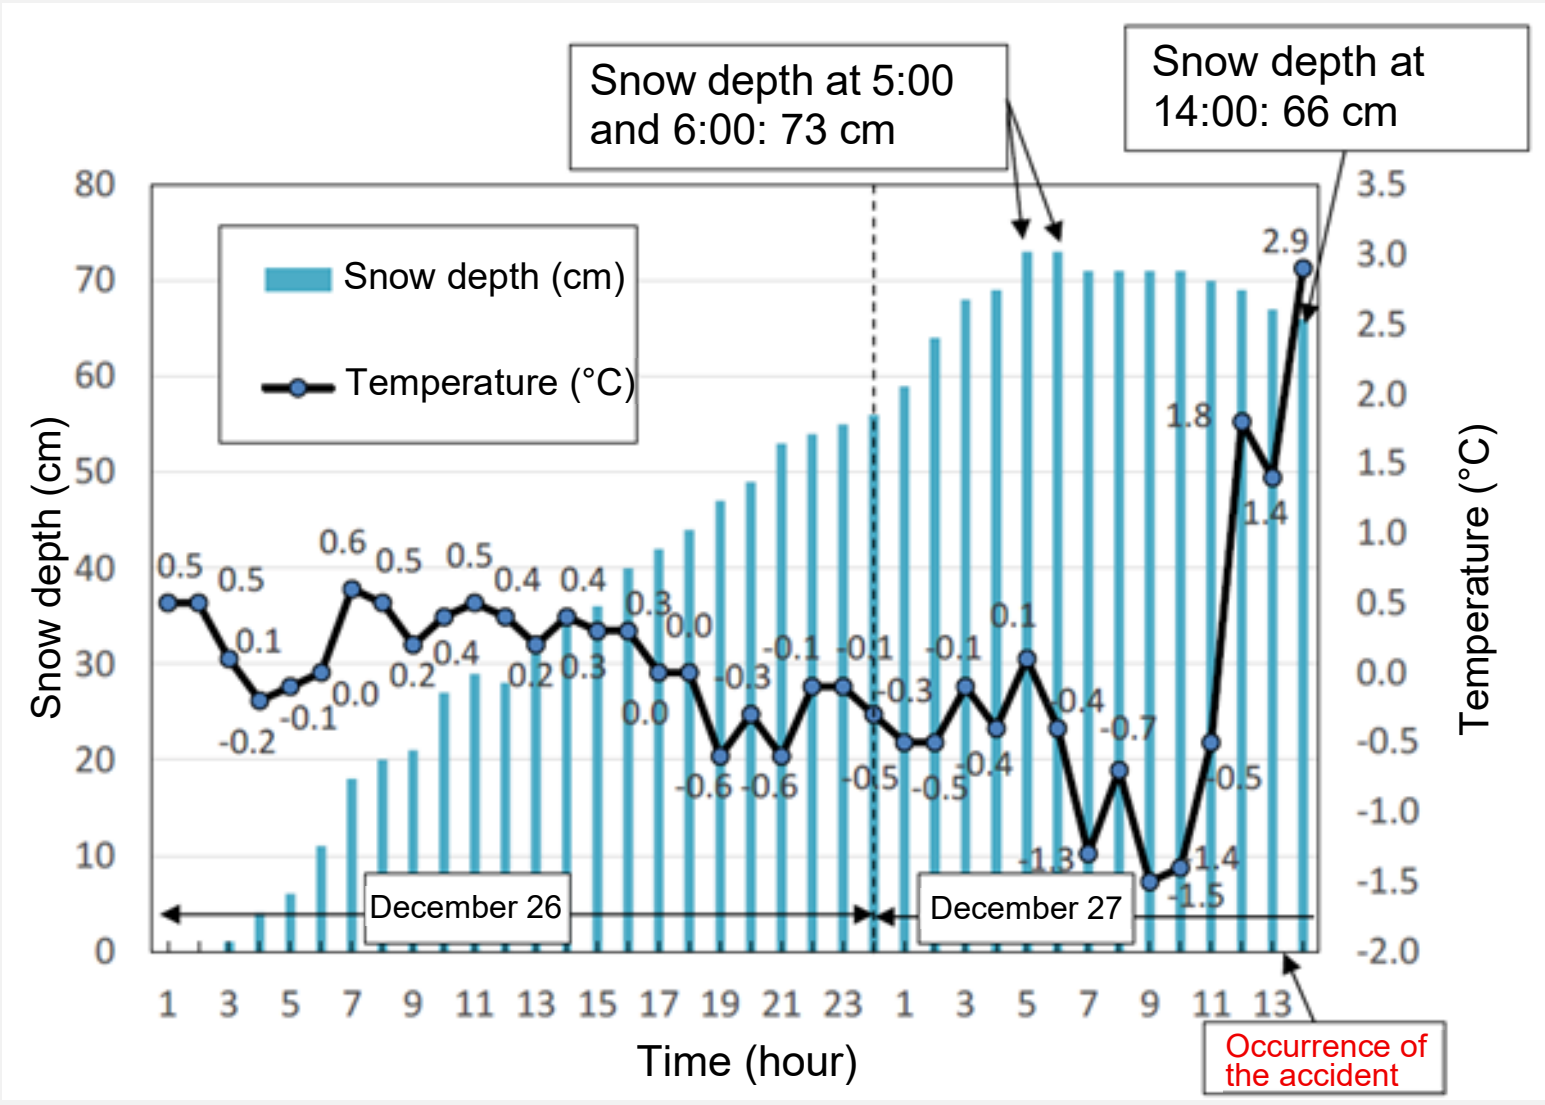
Figure 19: Trends in snow depth and temperature near the accident site

As for the presence of a large amount of snow on the track, it is possible that under conditions of low temperature and heavy snowfall, in addition to the snow that was on the track when the last train passed the level crossing on the previous day, much of the snow that fell before the train ran had not melted and therefore remained.

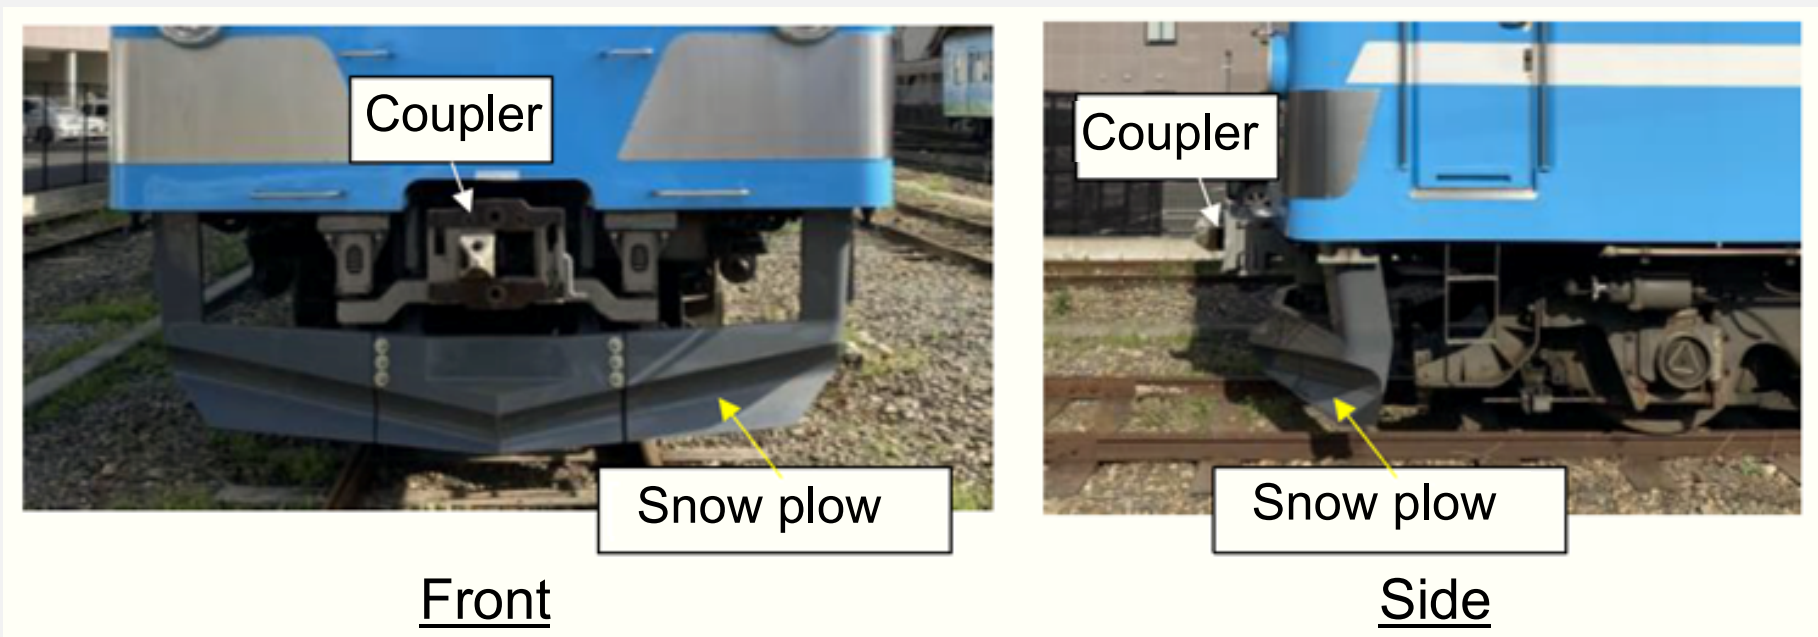
Figure 21: Example of a car equipped with a snow plow

As for the operation of the train that did not use cars equipped with a snow plow without performing snow removal, it is probable that, although the conditions of snow accumulated on the track and compacted snow at the level crossing were presumed to differ between the previous day when trains were operated and the day of the accident, the chief safety management officer thought that the conditions of snow accumulated on the track and compacted snow at the crossing on the previous day were the same as those on the day of the accident, and finally determined the necessity of snow removal and the possibility of operations based on the past instance in which trains ran without problems. Furthermore, it is possible that the following factors were involved: the operator's internal regulations, etc., contained no objective standards and conditions that enable the determination of the necessity of snow removal, the use of cars with a snow plow, and the possibility of operations based on the conditions of snow accumulation and compacted snow, for example; and information gathering for determining the necessity of snow removal and the possibility of operations was insufficient because the operator had not checked the condition of compacted snow at the level crossing.

It was stipulated that snow removal on tracks is to be carried out by running an inspection vehicle equipped with a snow plow after removing snow from the rails and flangeways at level crossings that are the target of snow removal. The inspection vehicle is to be operated when snowfall of 20 cm or more above the rail head is observed during the period from the last train to the first train, or where train operations are canceled, and will not be operated if snowfall exceeds 35 cm above the rail head and 50 cm above the top of the sleepers. In addition, when operating an inspection vehicle, the track will be closed.
