**航空事故調査報告書**  
**ノースウェスト航空会社所属**  
**ボーイング式747-251B型N637US**  
**新東京国際空港**  
**平成6年（1994年）3月1日**

平成8年11月7日

航空事故調査委員会議決

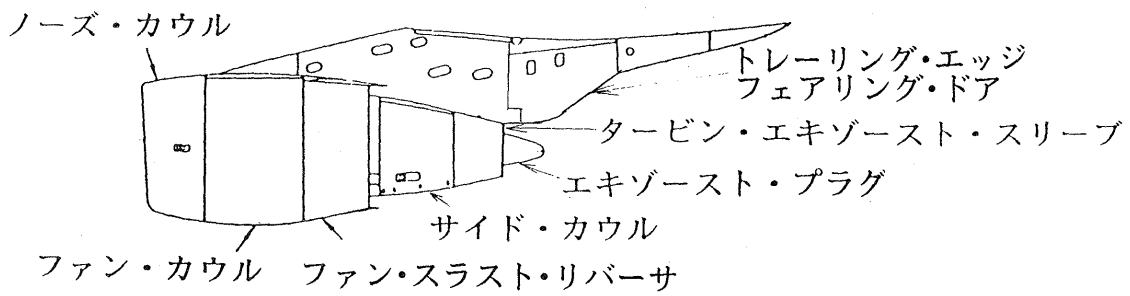
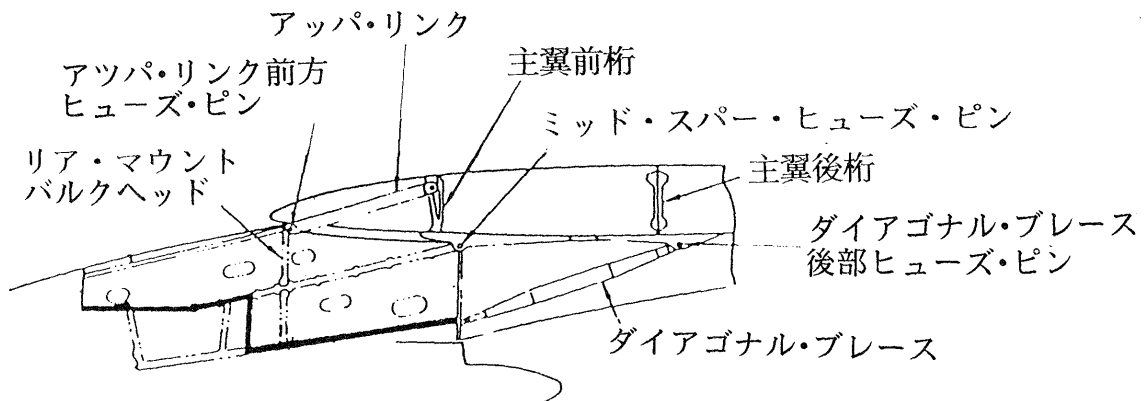
付図6-1 No.1エンジン・ナセル・ストラット部の概要図

### 2.14.1 ナセル・ストラット (付図6 参照)

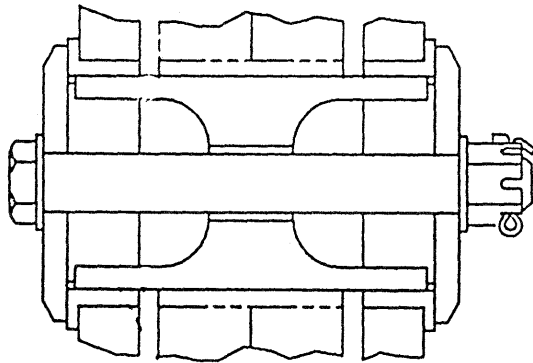
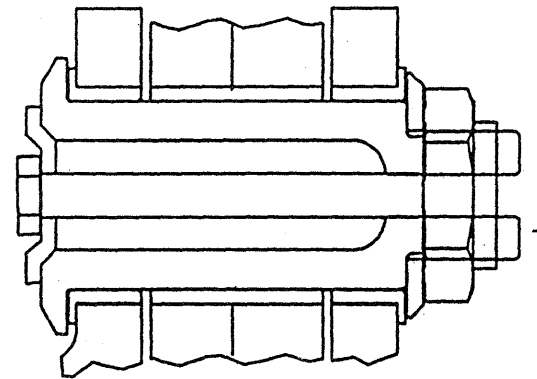
付図7 ヒューズ・ピンの形状図

同型機のヒューズ・ピンについては、当時、高張力鋼製のバルクヘッド型ヒューズ・ピンから、ステンレス鋼で、かつ、形状も変更し、強度を増加させたサード・ジェネレーション・ストレート・ボア型ヒューズ・ピンへの改修が実施中であった。（付図7 参照）

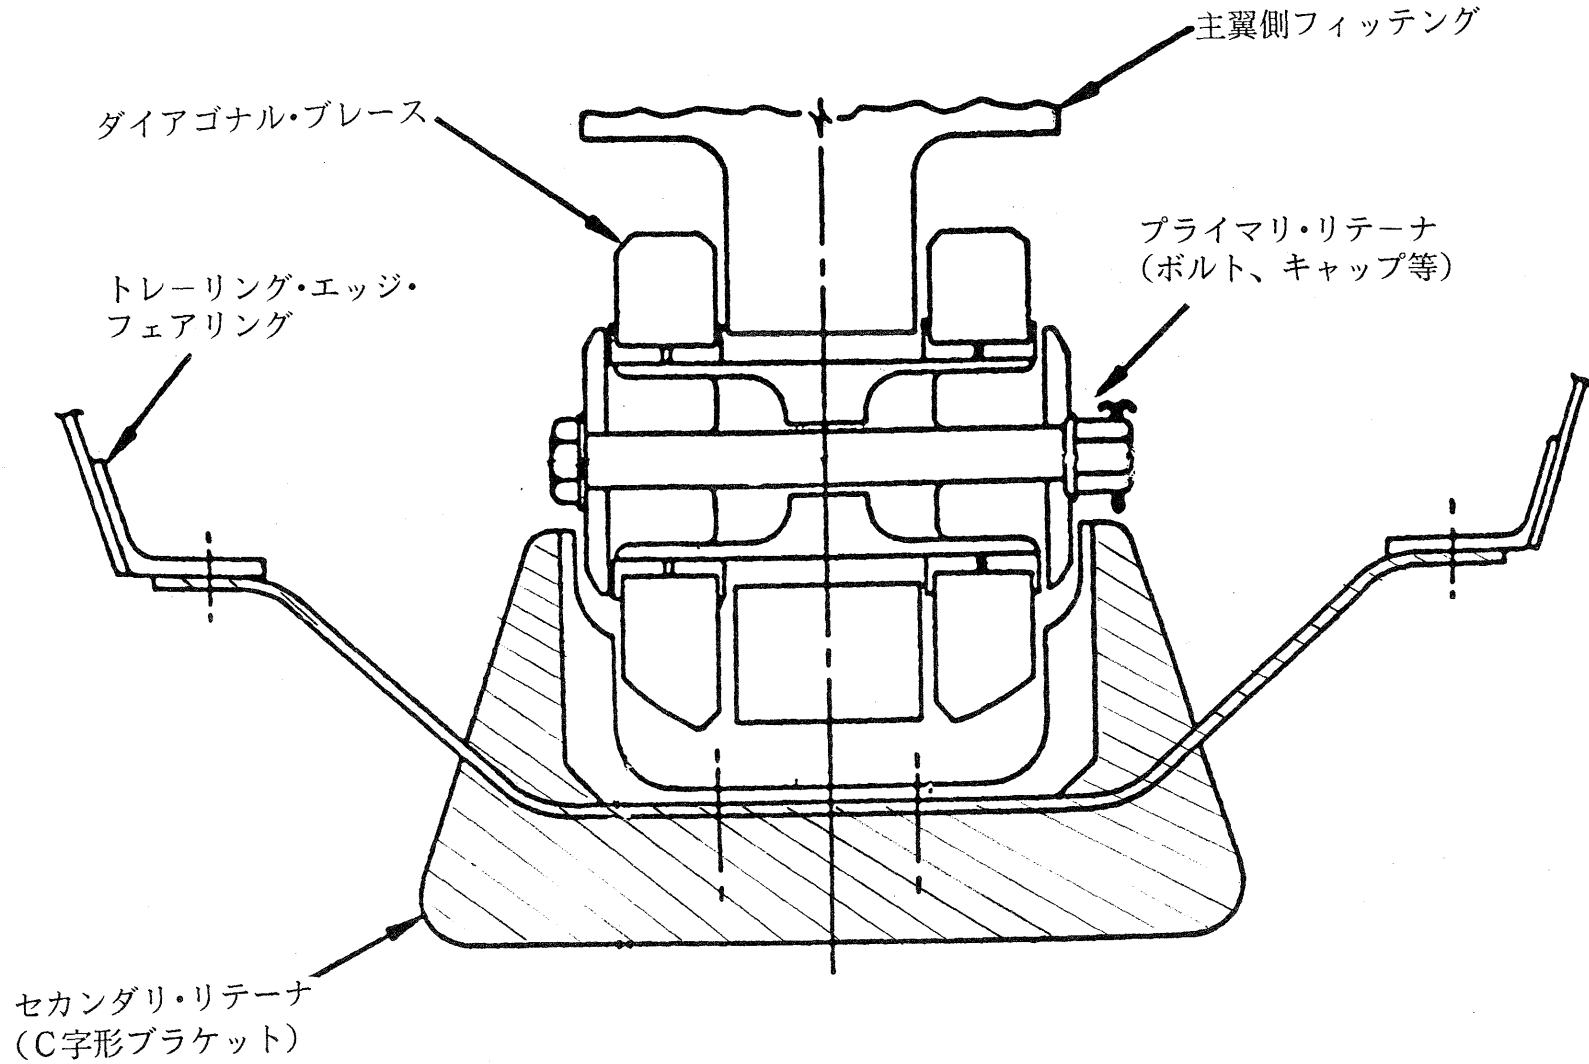
付図8 ダイアゴナル・ブレース後方ヒューズ・ピン・セカンダリ・リテーナ概要図

ヒューズ・ピンには、抜け出しを防止するためのリテーナを装着するが、バルクヘッド型ヒューズ・ピンには、プライマリ・リテーナ及びセカンダリ・リテーナを装着する。プライマリ・リテーナは、2個のキャップ、1本のボルト、1個のナット及び2個のワッシャーが一組となったもので、セカンダリ・リテーナはC字形ブラケットを取付けるものである。（付図8及び写真8 参照）

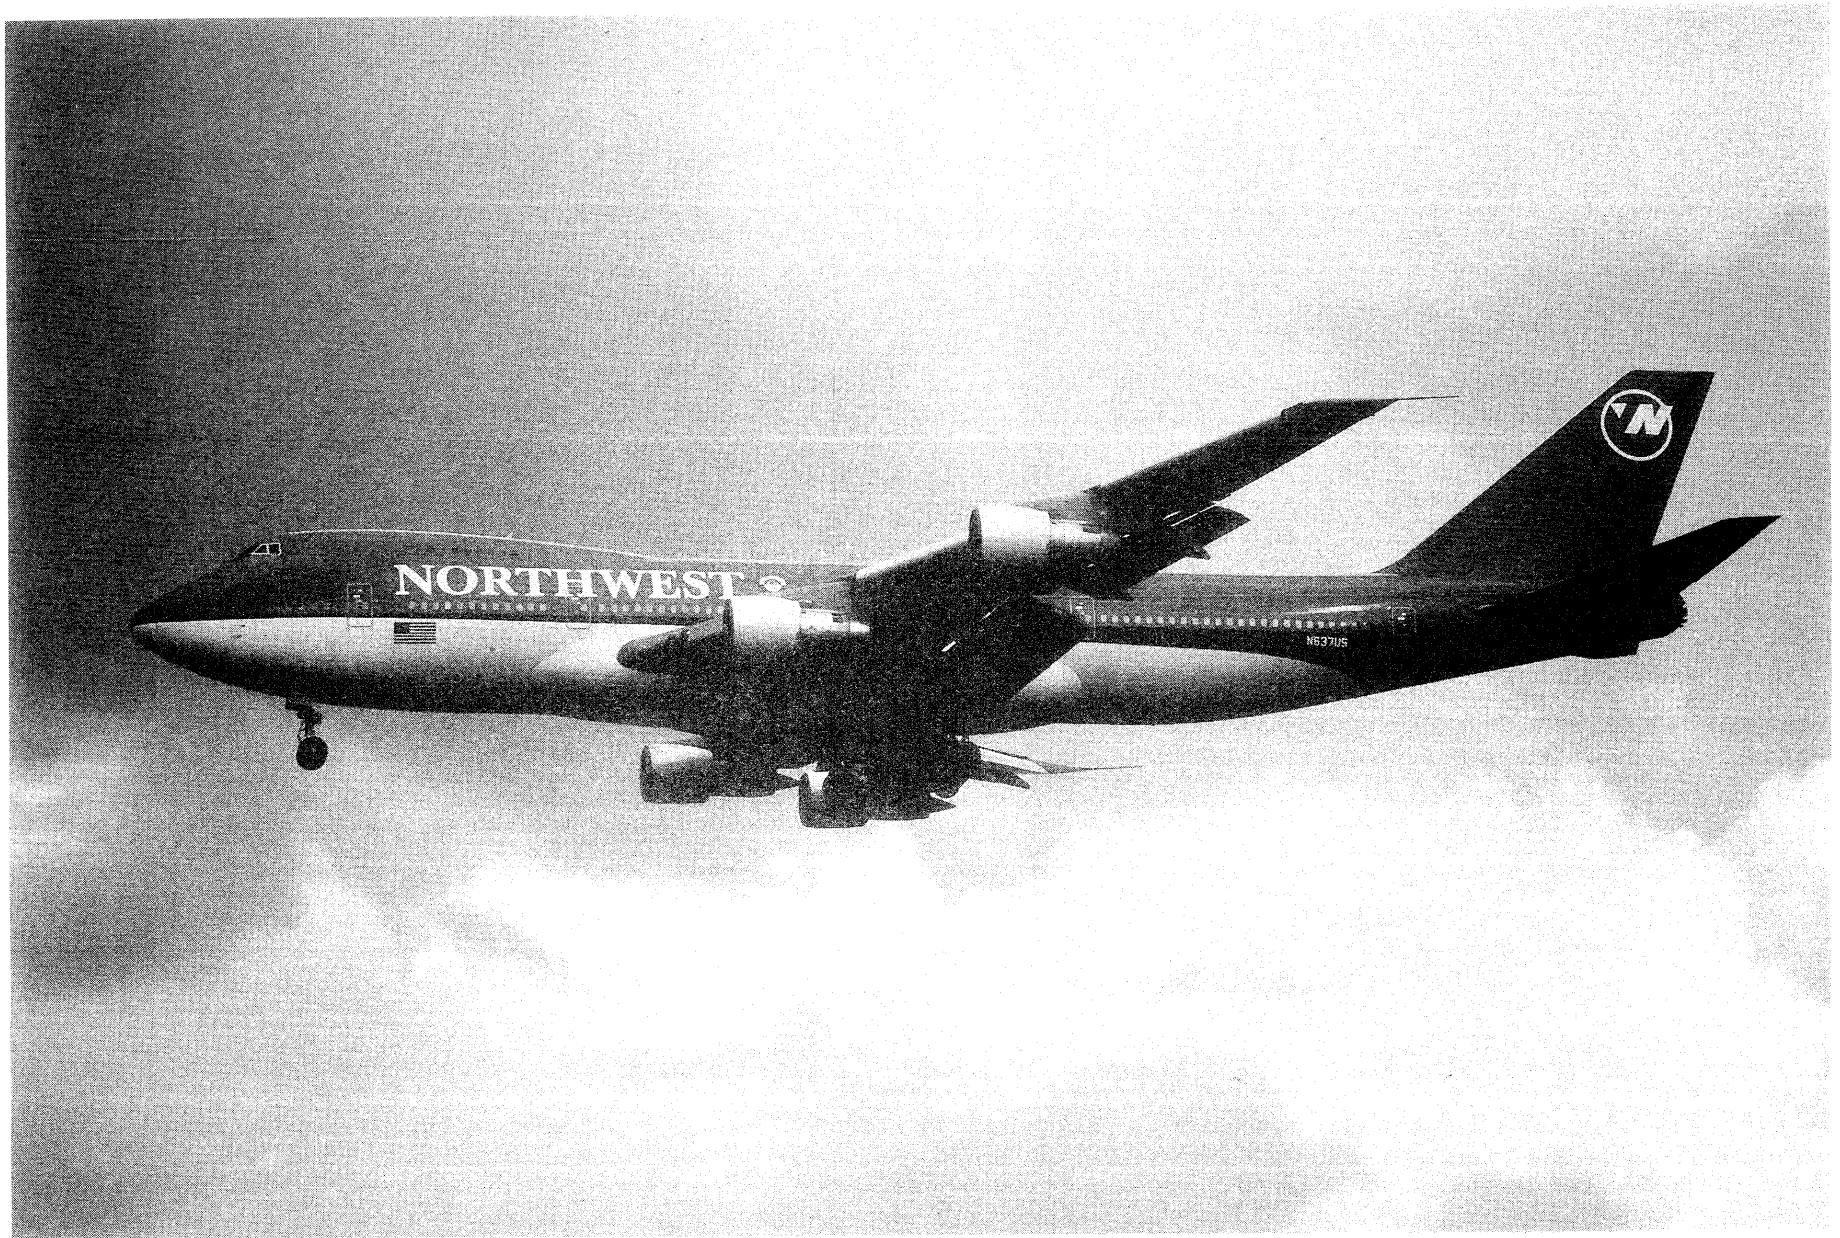
写真7 成田空港に着陸進入中の同機

着陸前の進入中の同機を目撃者した者によれば、その時点では、同機は外観上は異常は認められなかったとのことであり、その際、撮影された同機の写真からも、同機のNo. 1エンジン等に異常は認められない。(写真7 参照)

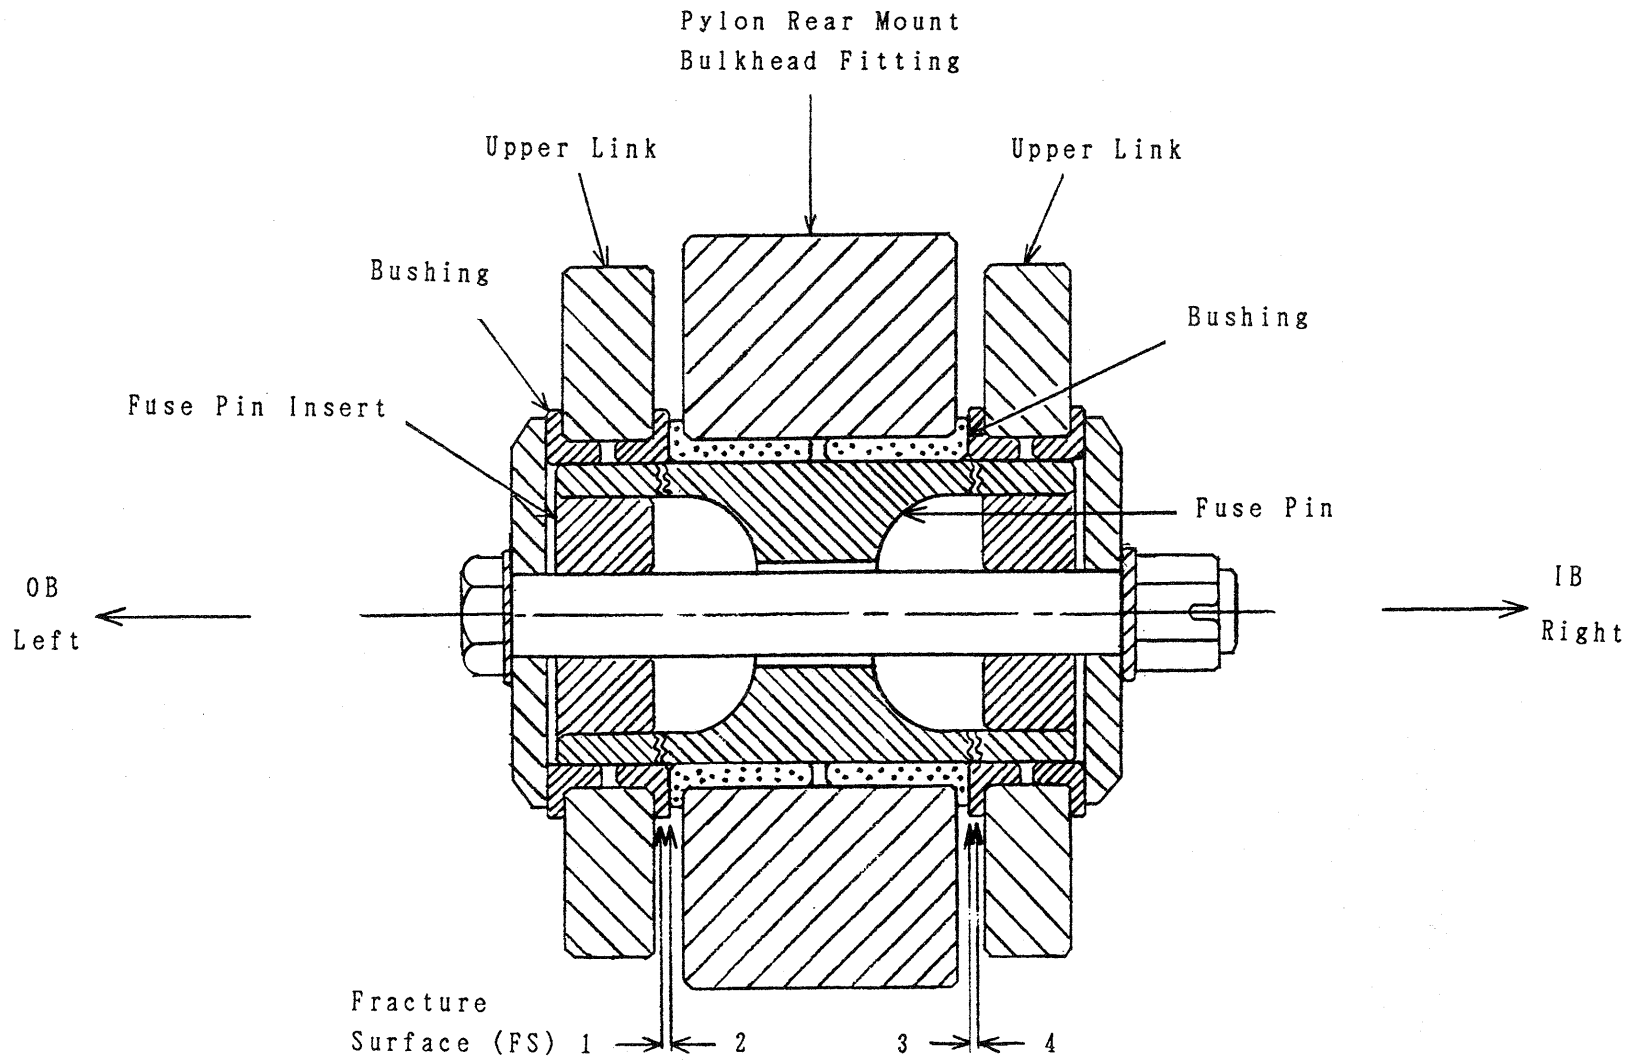
図3. Upper Link FWD Fuse Pin 取付け部のA-A断面図と破壊箇所

ヒューズ・ピンは、フィッティングとアップパ・リンクの間で破断し、3つの破片に分かれていた。

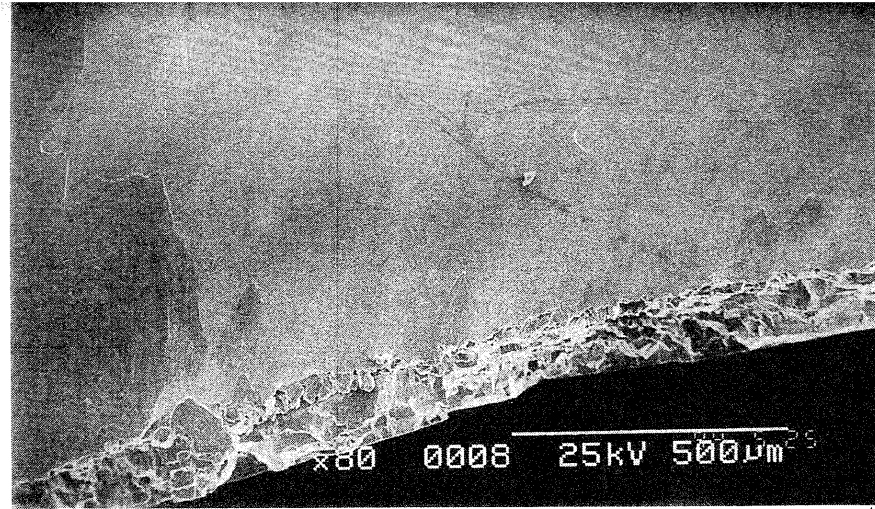
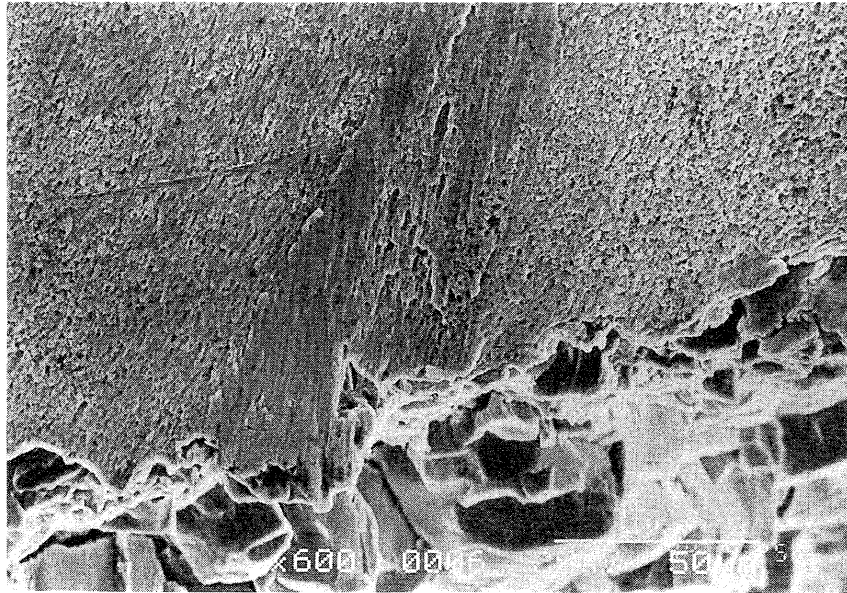
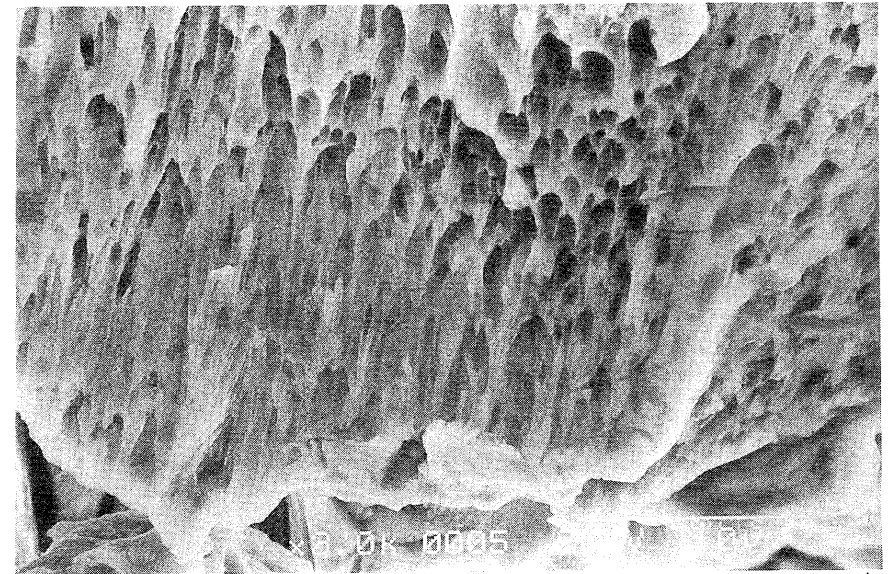
図8. Upper Link FWD Fuse Pin ミクロ破面におけるディンプル例  
(その1、FS2、 $\theta = 0^\circ$ 、外側)

各破面は、何れも0°と180°を中心とするほぼ±60°の範囲では、剪断破壊の特徴である伸長ディンプルが多く認められた。

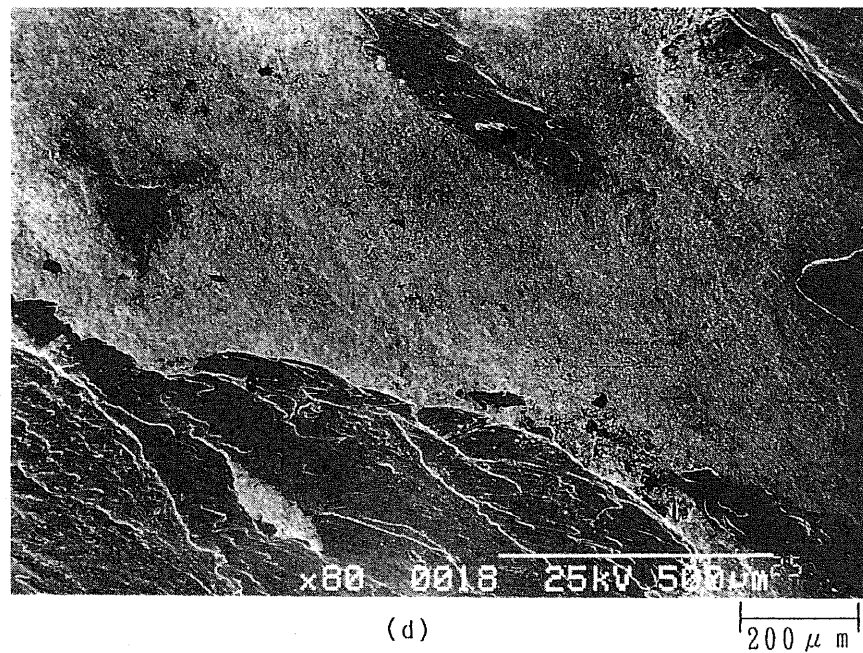
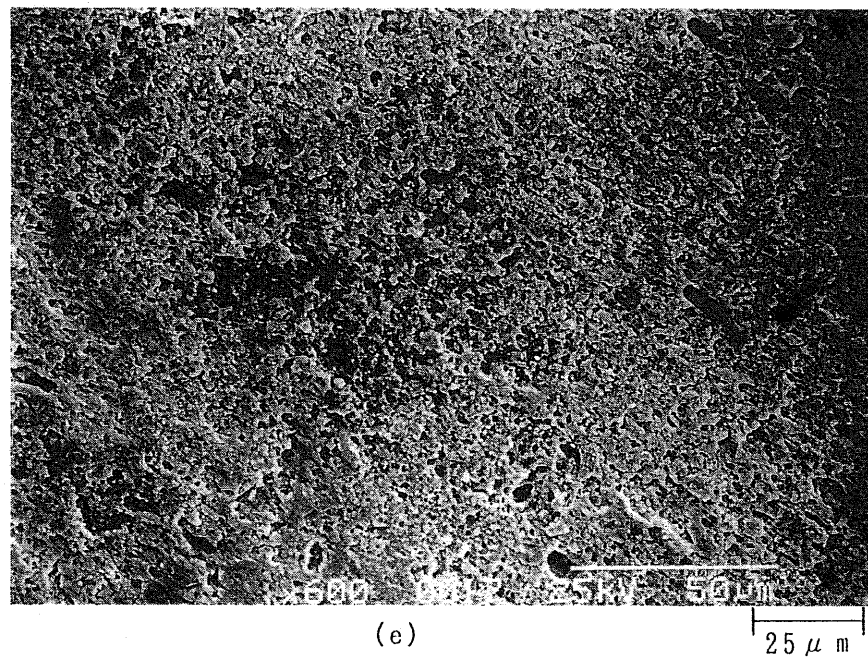
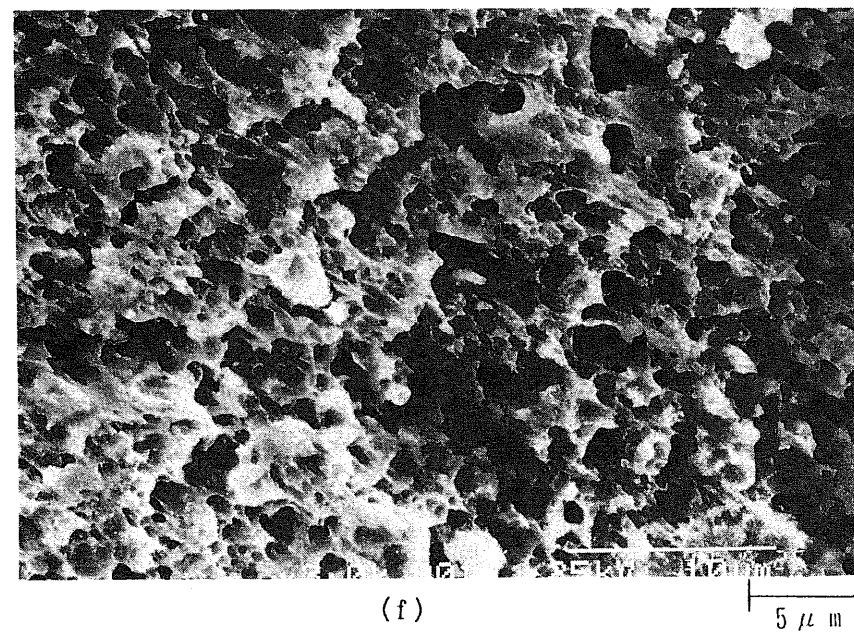
図8. Upper Link FWD Fuse Pin ミクロ破面におけるディンプル例  
(その2、FS2、 $\theta = 90^\circ$ 、中央)

各破面の90°と270°を中心とする約±30°の範囲では、ディンプルの長さは短くなり、引張り破壊の特徴である等軸ディンプルも部分的に認められた。

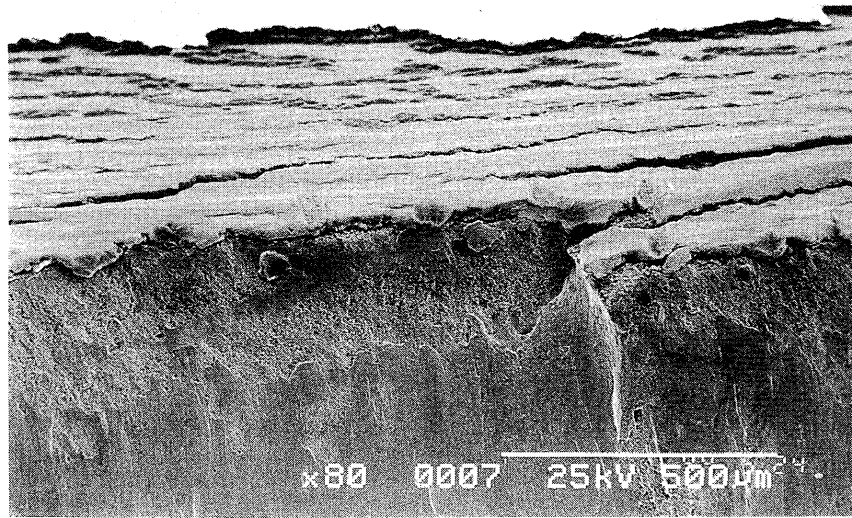
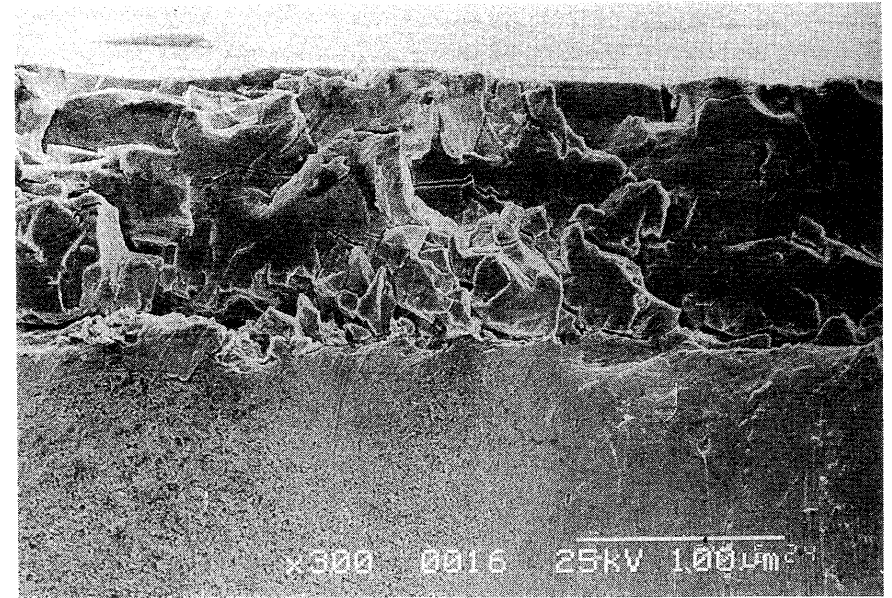
図9. Upper Link FWD Fuse Pin のカドミウム塗料と  
クロムメッキ層のマイクロ観察例

疲労の痕跡は認められず、材料傷、腐食、メッキ不良などの異常は見いだせなかった。

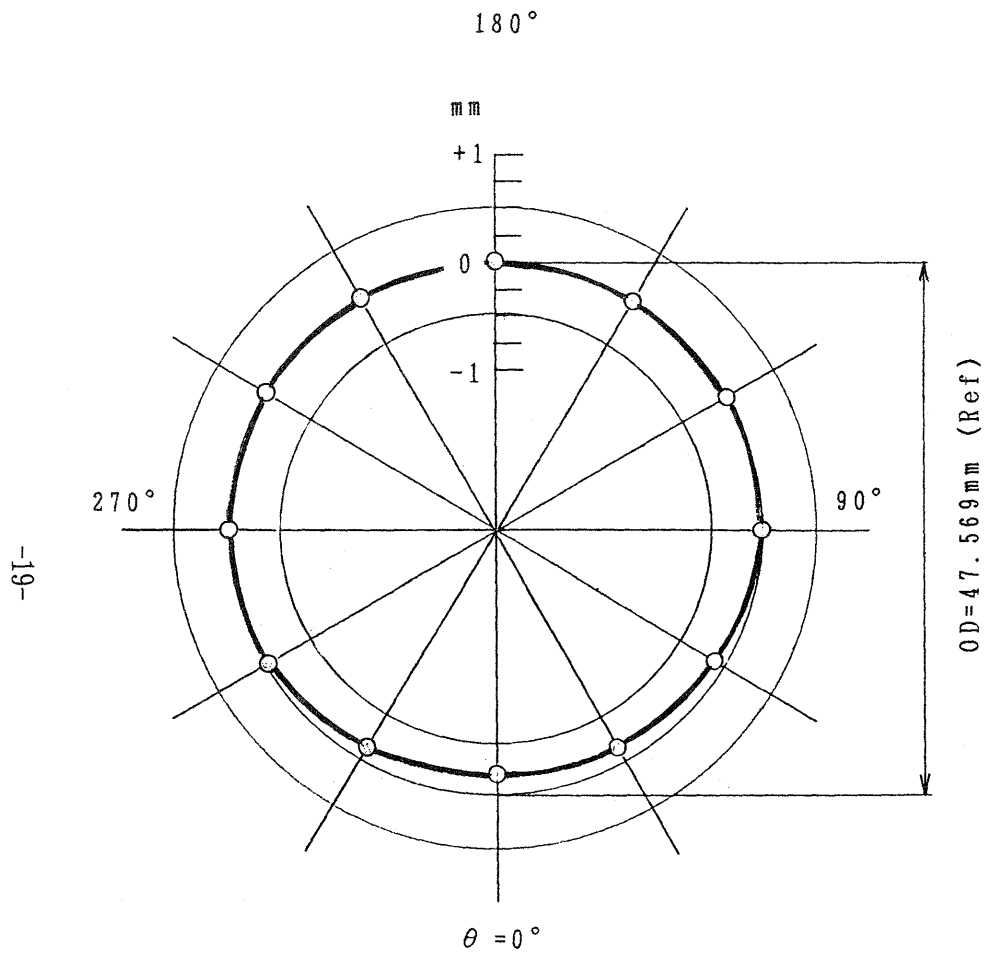
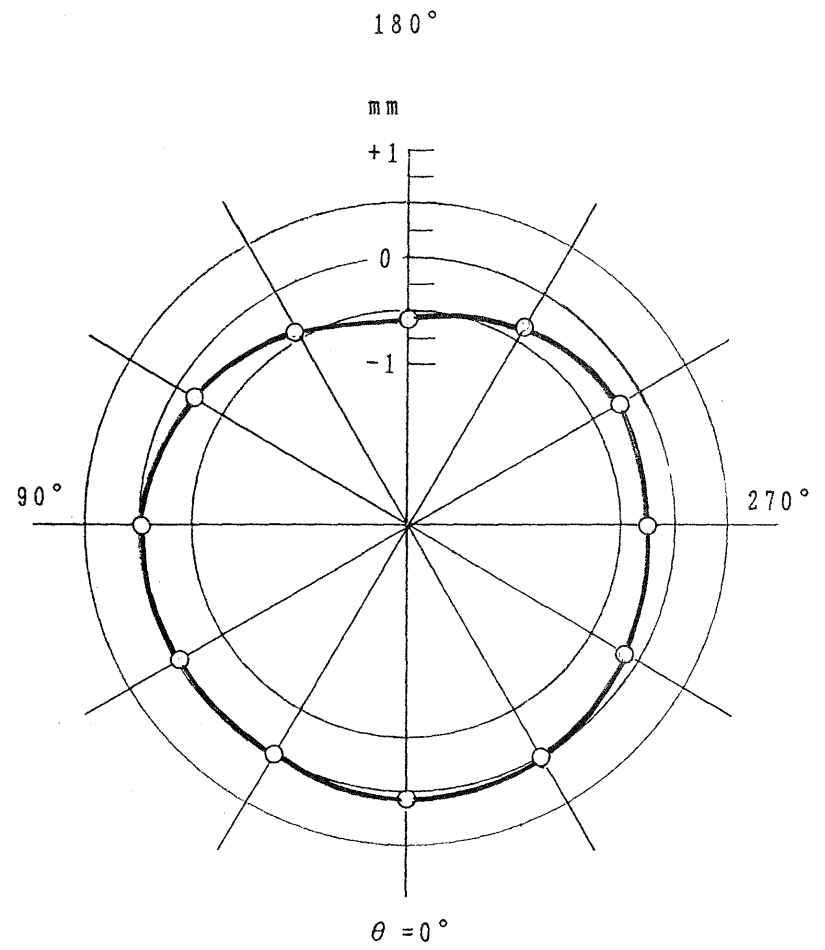
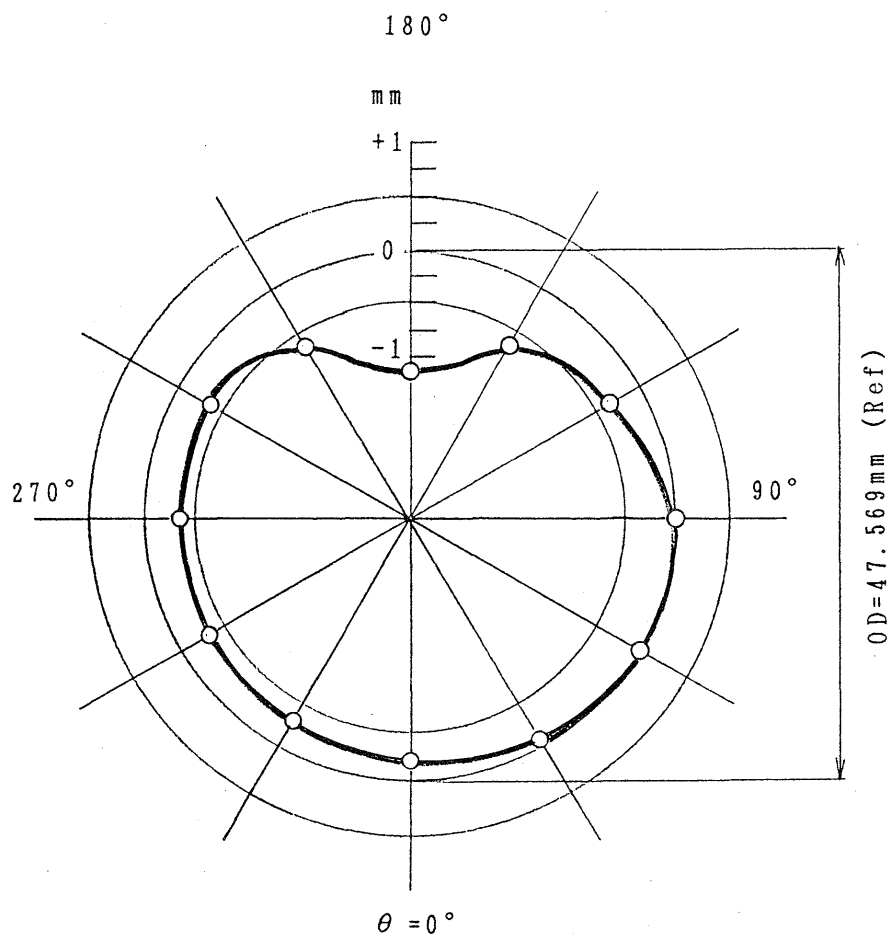
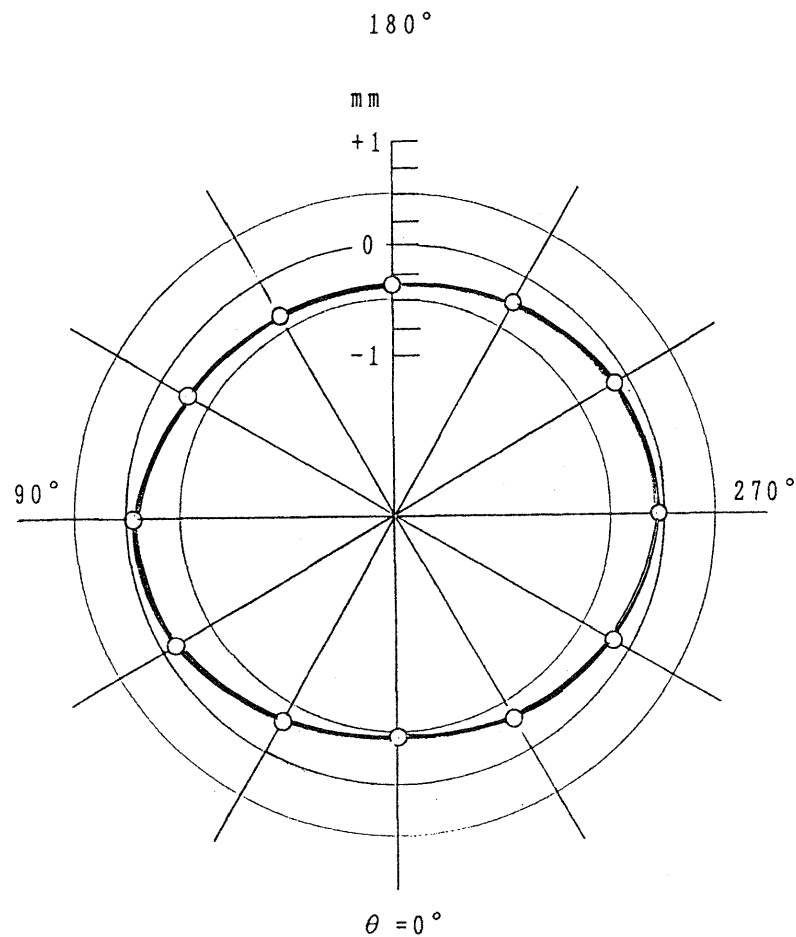
図13. Upper Link FWD Fuse Pin の外径変化(その1、FS1と2)

- (1) Fuse Pinの外径変化は破面1、4側で小さく、破面2、3側で大きくなった。これは破面1、4側では外側はUpper Link、内側はInsertによって拘束されていたが、破面2、3側では内側が空洞であったことによると考えられる。
- (2) Fuse Pinの破壊は次の順序で起こったと考えられる。
- $\theta = 0^\circ$ 、 $180^\circ$  の付近から伸長ディンプルを伴うせん断破壊が始まる。
  - 残った $90^\circ$ 、 $270^\circ$ の部分では、曲げ荷重が生じるため、等軸ディンプルに近づき、先に $90^\circ$ 付近で破断する。
  - 最後に、 $270^\circ$ 付近で破断するが、この時はねじり荷重も加わり、ディンプルは外径側と内径側で逆になる。

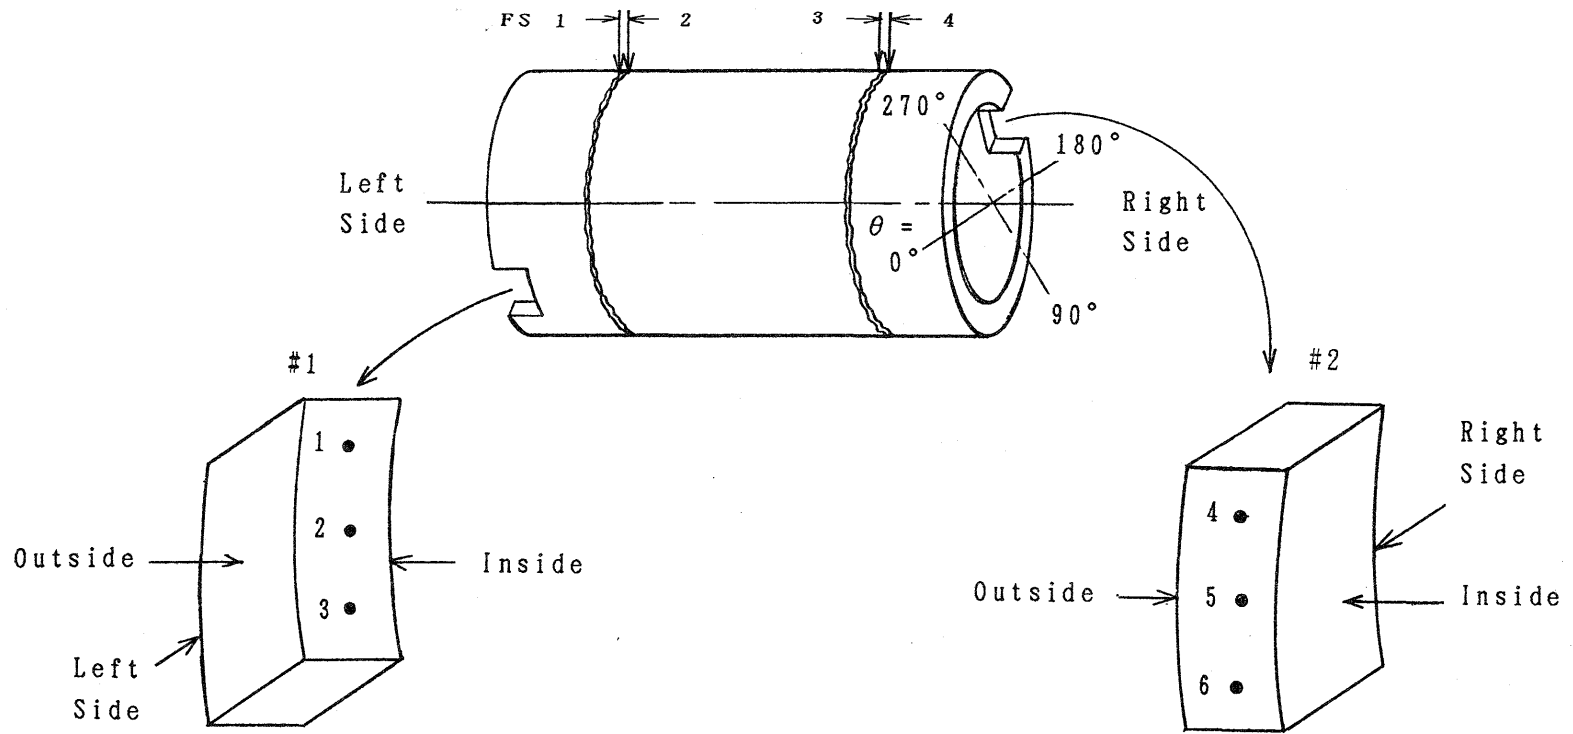
- 2 破断したピンの両端部から各1つの試料を切り出し、ピン横断面について金属組織調査及びビッカース硬さ試験(HV20)を行った。

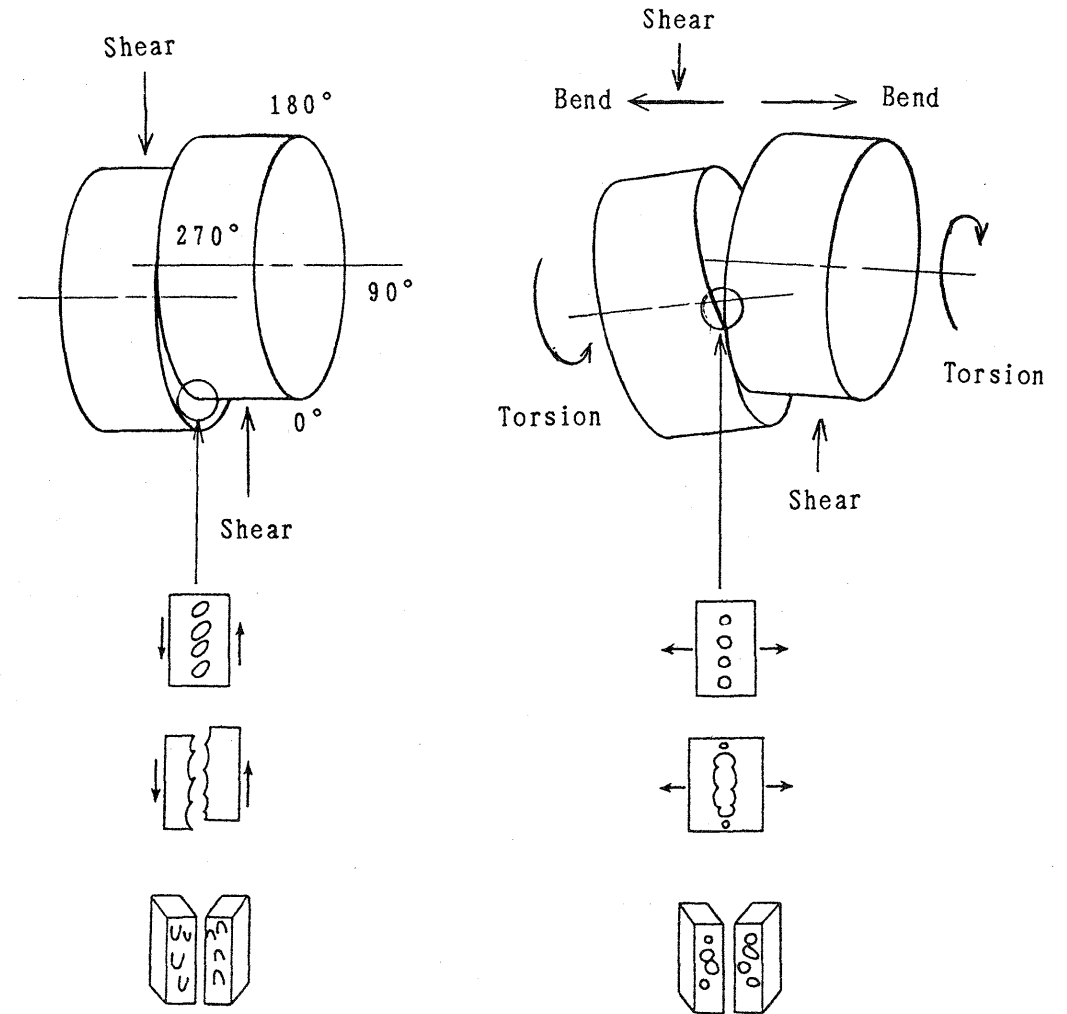
(a) 初期、伸長ディンプル

(b) 後期、等軸ディンプル

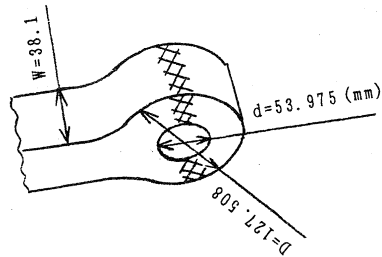
図(a) Pylon Rear Mount Bulkhead Fittingの設計寸法

$$F \geq A_1 \times \sigma_y = 1003 \text{ kN} \quad \dots\dots\dots (1)$$

(A<sub>1</sub> : Fittingの面積、図(a)の設計寸法による。)

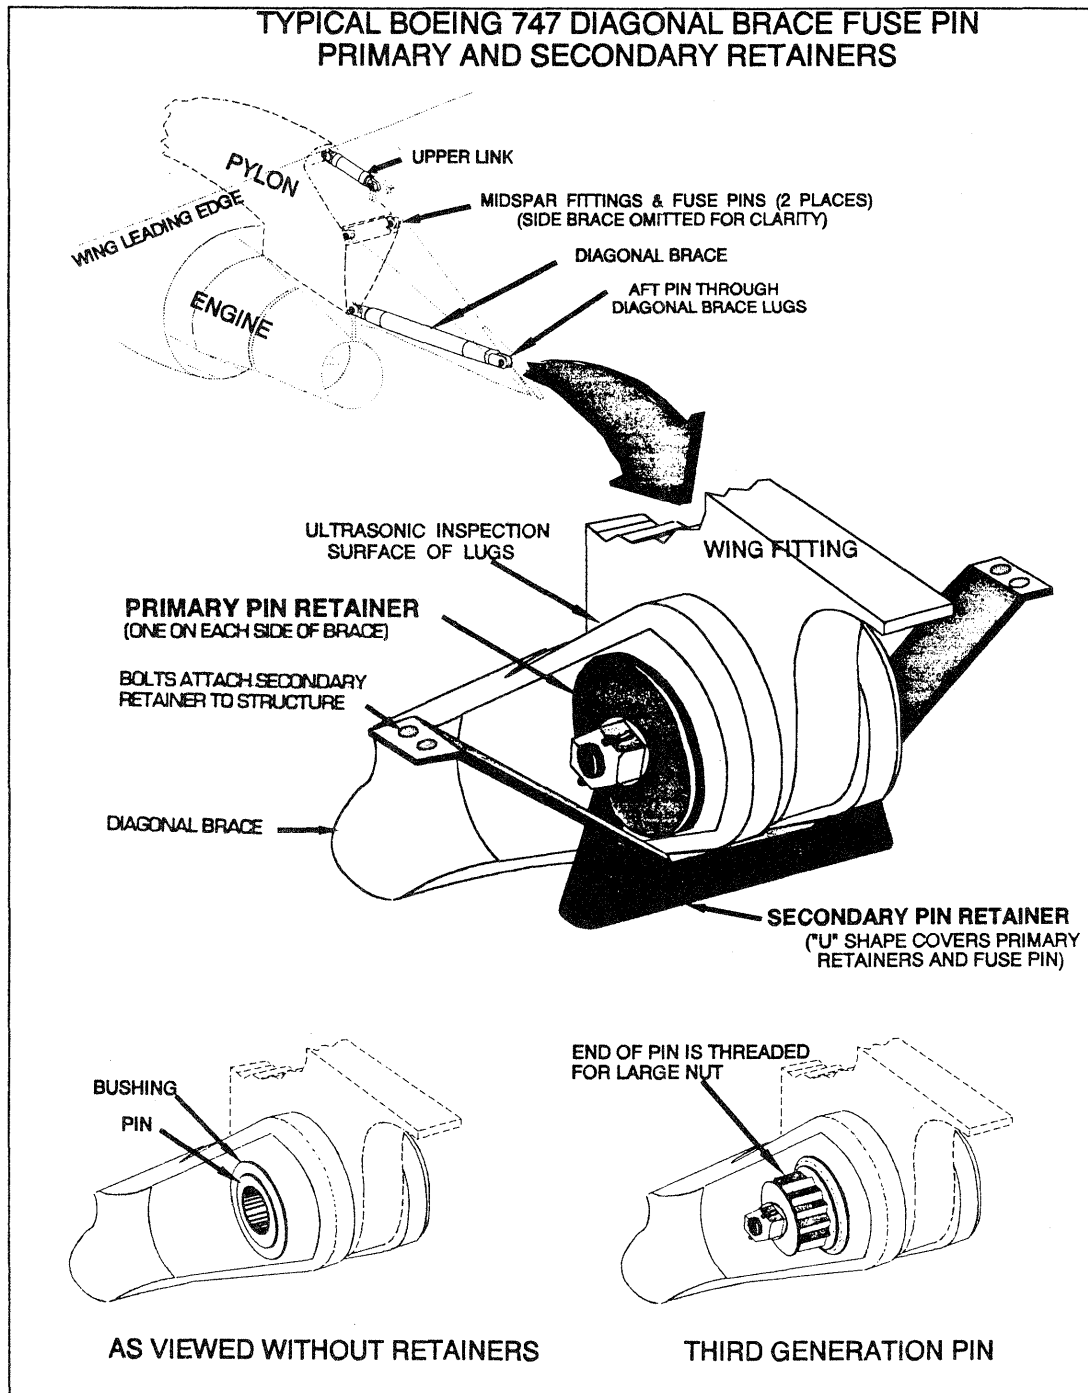
Figure 2.--Diagonal brace attachment details.

Prior to this landing, at some unknown time, the aft fuse pin on the pylon diagonal brace had migrated out of its fitting. The pin was found loose in the pylon structure. It was intact, undamaged, and had no evidence of preexisting defects. The aft diagonal brace fuse pin is normally retained by both a primary retainer (two washer-like retainer caps and a through bolt) and a secondary retention clip (a bolt-on C-shaped bracket). (See figure 2). However, a search of the airplane pylon and engine area, as well as the runway surface at Narita, revealed neither the aft diagonal brace fuse pin primary nor secondary retaining devices.

The March 1, 1994, NWA Fleet Information Register indicates that the airline operates 41 B-747 airplanes of various models. NWA officials stated that 7 airplanes, numbers 6631, 6632, 6636, 6637 (the accident airplane), 6638, 6739 and 6740, of its 31 B-747 aircraft, have the secondary retainers installed on the aft diagonal braces, unless the third generation of pins had been installed. Third generation pins required no secondary retaining devices. (See figures 2 and 3).<sup>1</sup>

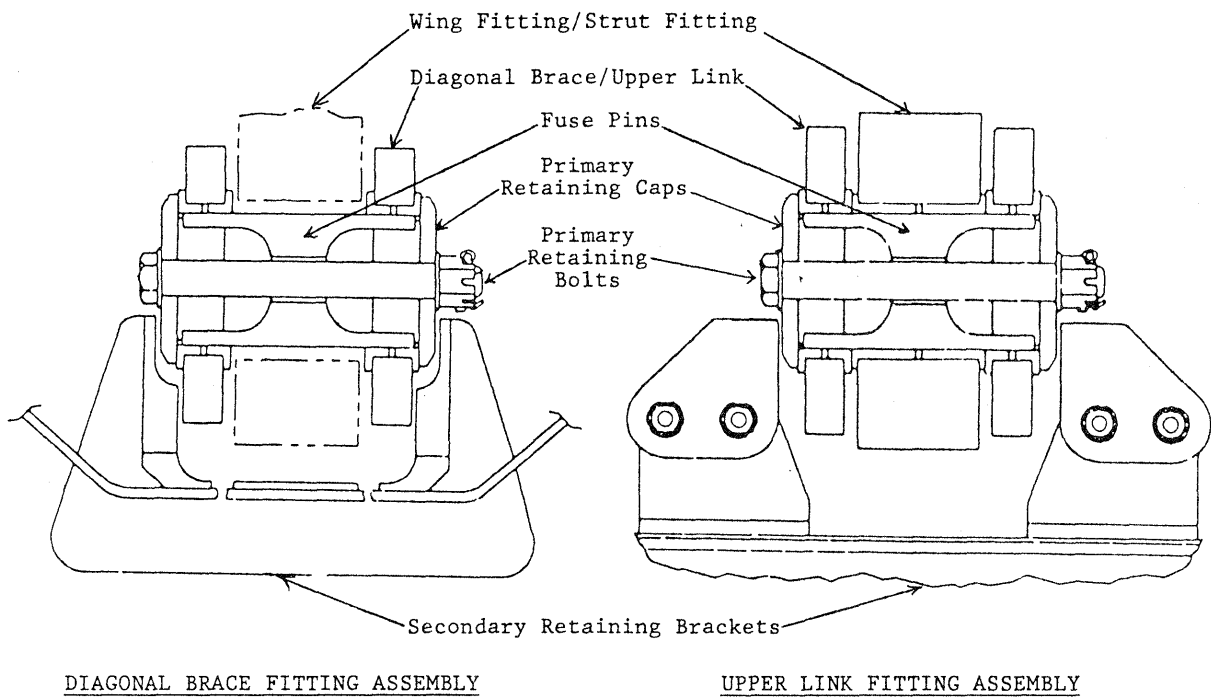
Figure 3.--Diagonal brace and upper link fitting assemblies.

The fractured forward upper link fuse pin from the No. 1 pylon was recovered in three pieces and was retained by the JAAIC for metallurgical examination. Examination of the pin revealed that it fractured in static overload and that there was no evidence of preexisting fatigue.
