Chapter 1 Aircraft accident and serious incident investigation

1. Summary of major investigation report

Aircraft 1 The tail rotor became uncontrollable while the aircraft was flying, and the aircraft rapidly lost its altitude and crashed into terrain.
 (All Nippon Helicopter Co., Ltd. Eurocopter EC135T2, registered JA31NH)
 Full text of the investigation report : http://www.mlit.go.jp/jtsb/eng-air_report/JA31NH.pdf

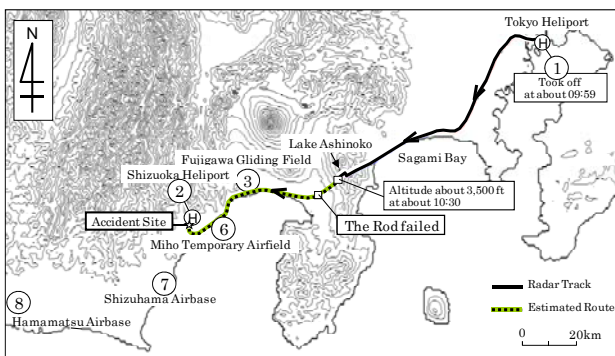
Estimated flight route

A Eurocopter EC135T2 (Rotorcraft), operated by All Nippon Helicopter Co., Ltd. took off from Tokyo Heliport for a ferry flight. While flying to Shizuoka Heliport, the aircraft crashed in Minami-Numagami, Aoi-Ku, Shizuoka City, Shizuoka Prefecture, at about 10:53 Japan Standard Time.

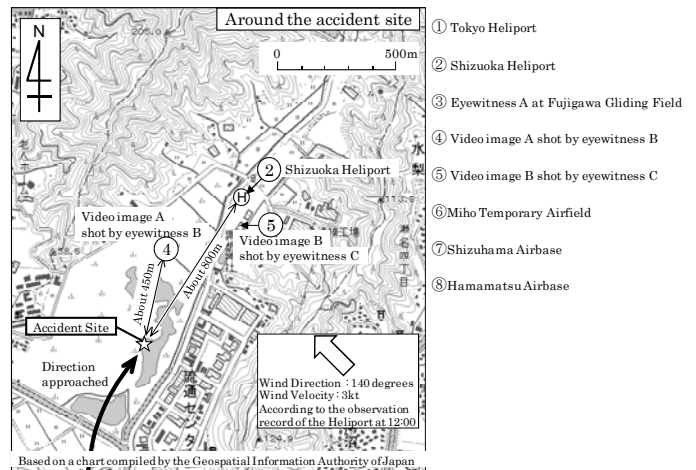
Around the accident site

- a. Because the aircraft crashed on a marsh with its landing gear first hitting the ground, it is highly probable that the impact to the aircraft was smaller than that of crashing on a hard ground.
- b. The cause of the captain's death was the heart damage. It is highly probable that because the captain was not fastening his shoulder harness at the time of the accident, his body bent forward due to the impact at the time of the crash and his chest hit against the cyclic stick. The mechanic on board with the shoulder harness fastened sustained serious injuries.

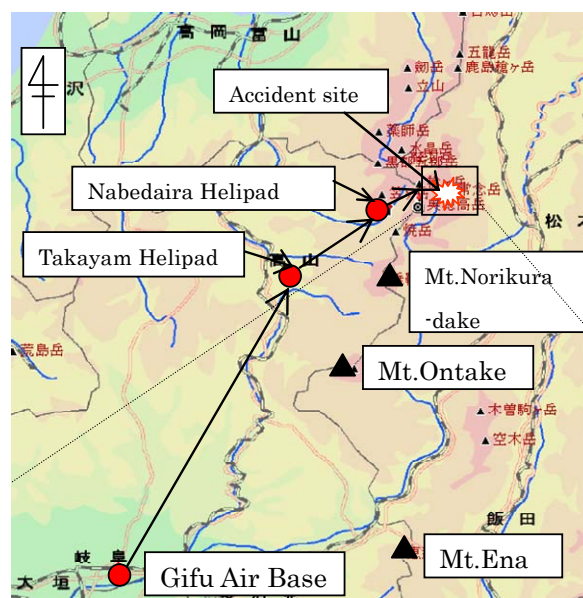
Estimated flight route

- b. It is highly probable that the aircraft was receiving cross wind from the left. But, because the aircraft had been operated by a single pilot, it is probable that the captain had given priority to keeping a watch at rock walls as obstacles and securing an emergency breakaway route over stabilizing the aircraft with its heading facing the wind. It is probable that when the aircraft started hovering before the lifting at the rescue site, the captain initially tried to keep its altitude at around 80 ft. But it is probable that the captain raised its hovering altitude to around the same height as the top of Roba-no-mimi to avoid a rock wall running north and south and a rock wall running east and west (which was in the pilot's blind spot).

c. It is somewhat likely that the aircraft's altitude was suddenly lowered while it was hovering because of the influence of complex air currents typical of higher mountainous areas and when the aircraft moved backward with its altitude lowered, it became difficult for the captain to maintain the position of the aircraft relative to the mountain across the valley, which he had identified during the initial hovering, and that this made it difficult for him to precisely adjust the position and altitude of the aircraft and as a result, the aircraft moved backward and its main rotor blade (MRB) hit one of the rock walls.

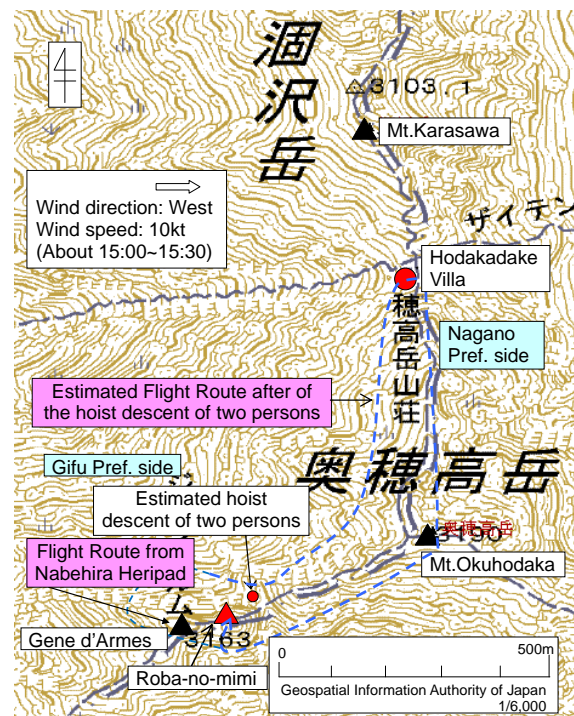
**Estimated flight route
(Around accident site)**

- d. It is probable that the downwash generated by the aircraft converged toward the valley on the northern side to create an even stronger current without dispersing due to the geographical features around the accident site. It is probable that the hoist cable and the hook of the aircraft had been swayed toward the valley in the stream of the downwash. Because the aircraft raised its altitude, the length of the hoist cable wound out became about 48 m (including the surplus length), which was more than twice as long as the usual training length (about 21 m), it is probable that the cable started swinging even more erratically, requiring a longer time for rescue personnel on the ground to catch the hook.
- e. During the hovering, the captain raised the aircraft to an altitude around the top of Roba-no-mimi in order to avoid the rock wall running north and south and the rock wall

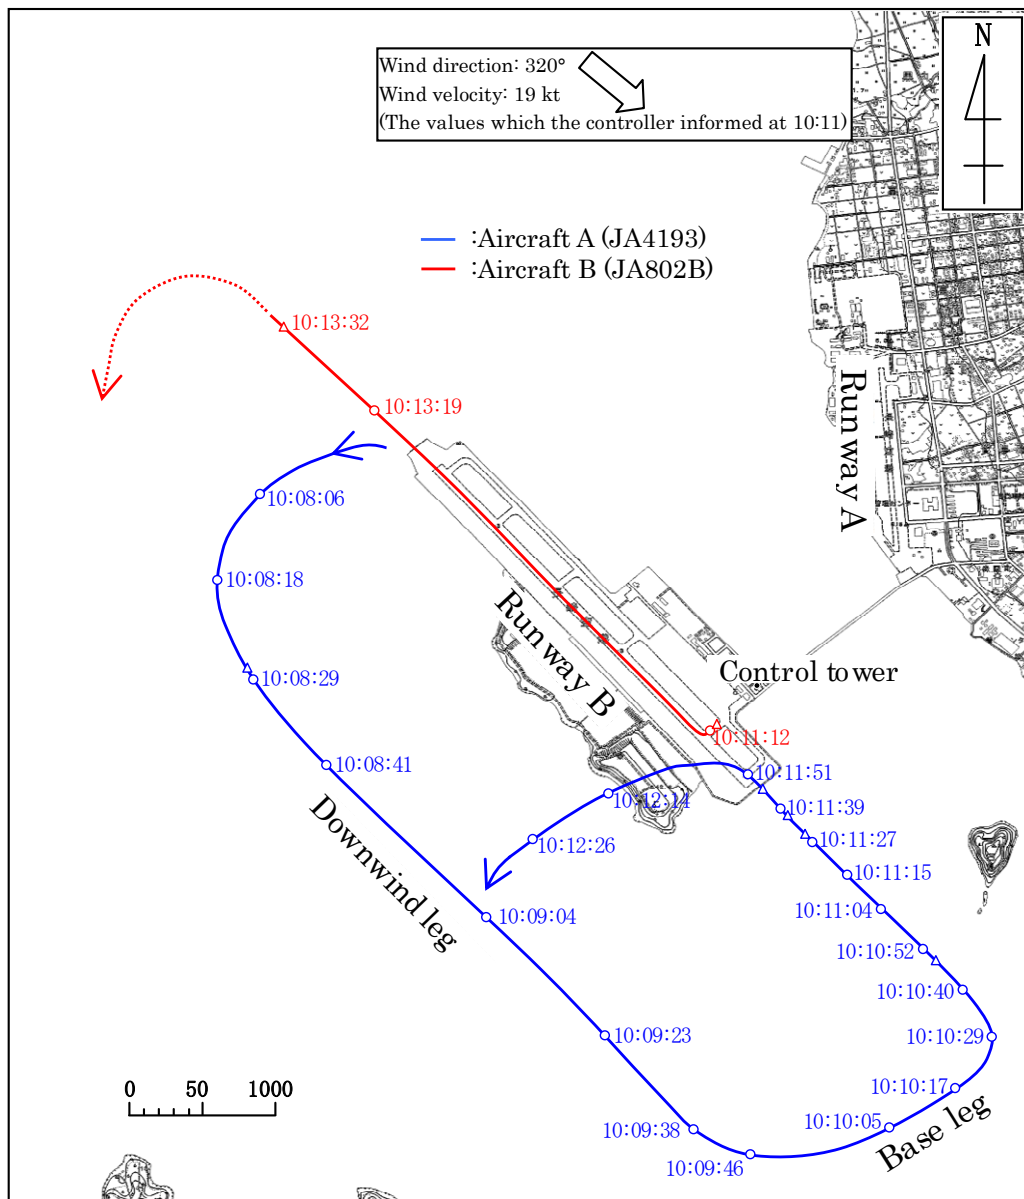
Estimated flight routes

A Piper PA-28R-201, registered JA4193 (the Aircraft A), operated by Air Flight Japan Co., Ltd. was approaching runway 32 (runway B) of Nagasaki Airport in Nagasaki

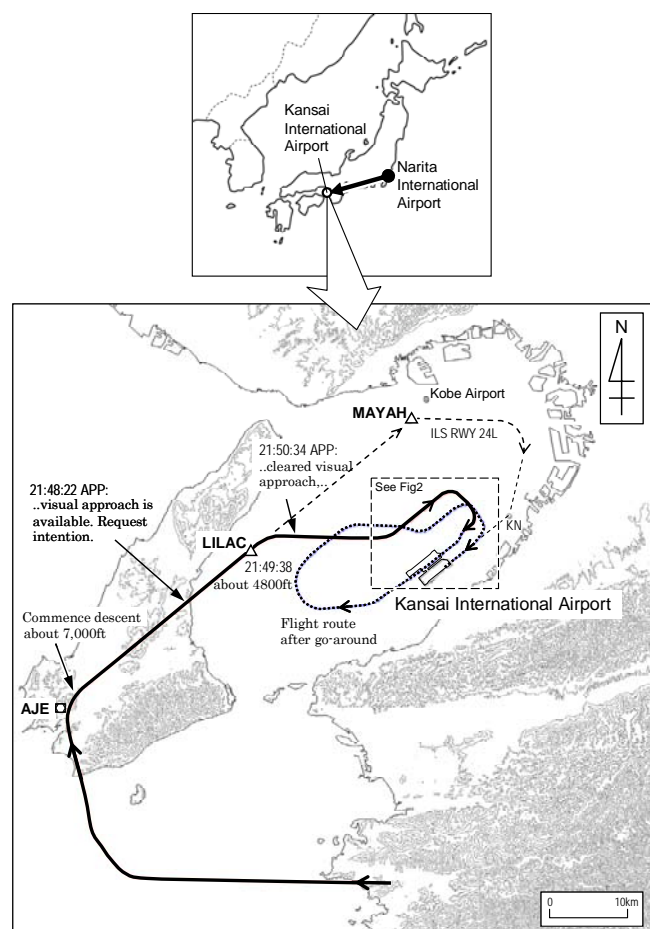
Estimated flight route

- 21:53:35: The autopilot of the Aircraft was set to vertical speed (V/S) mode with a descent rate of 200 ft/min (fpm) selected.
- 21:53:46: A descent rate of 500 fpm was selected.

- 21:55:11: The Tower pointed out that the Aircraft was approaching 24R, and asked whether it was possible to make a left turn to approach 24L. The Aircraft reported to the Tower that it would make a go-around because it was unable to approach 24L.
