# JAPAN TRANSPORT SAFETY BOARD ANNUAL REPORT 2012

Japan Transport Safety Board

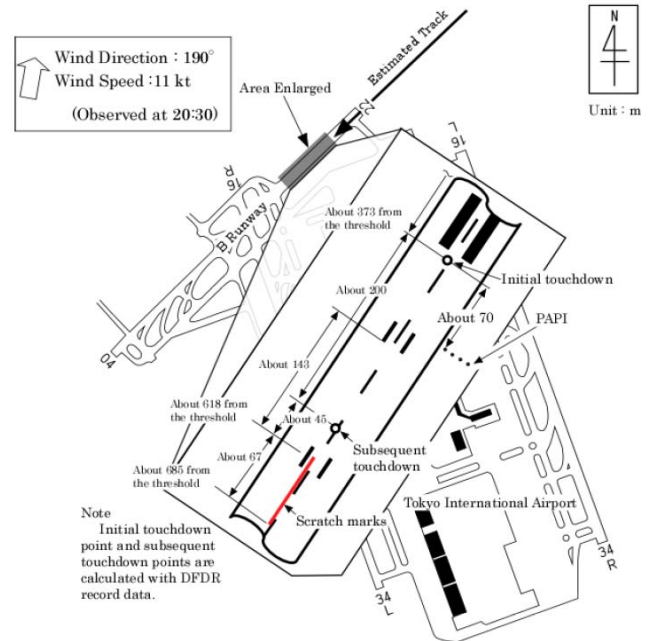
### Scratch marks on the runway 22

A total of 153 persons consisting of the pilot in command, five crewmembers and 147 passengers were on board the aircraft, but nobody sustained injuries. The aircraft was substantially damaged, but no fire broke out.

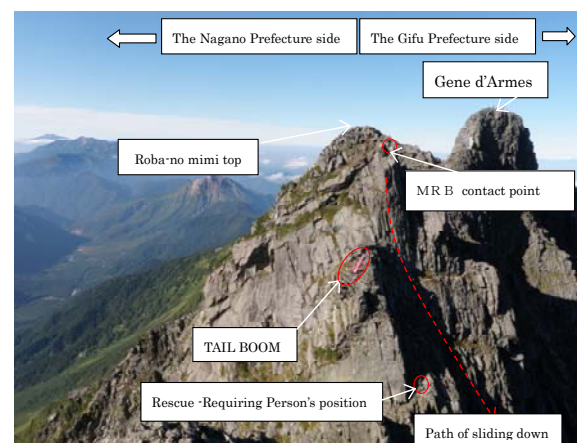
**Layout of accident site**

c. It is somewhat likely that the aircraft's altitude was suddenly lowered while it was hovering because of the influence of complex air currents typical of higher mountainous areas and when the aircraft moved backward with its altitude lowered, it became difficult for the captain to maintain the position of the aircraft relative to the mountain across the valley, which he had identified during the initial hovering, and that this made it difficult for him to precisely adjust the position and altitude of the aircraft and as a result, the aircraft moved backward and its main rotor blade (MRB) hit one of the rock walls.

- d. It is probable that the downwash generated by the aircraft converged toward the valley on the northern side to create an even stronger current without dispersing due to the geographical features around the accident site. It is probable that the hoist cable and the hook of the aircraft had been swayed toward the valley in the stream of the downwash. Because the aircraft raised its altitude, the length of the hoist cable wound out became about 48 m (including the surplus length), which was more than twice as long as the usual training length (about 21 m), it is probable that the cable started swinging even more erratically, requiring a longer time for rescue personnel on the ground to catch the hook.
- e. During the hovering, the captain raised the aircraft to an altitude around the top of Roba-no-mimi in order to avoid the rock wall running north and south and the rock wall

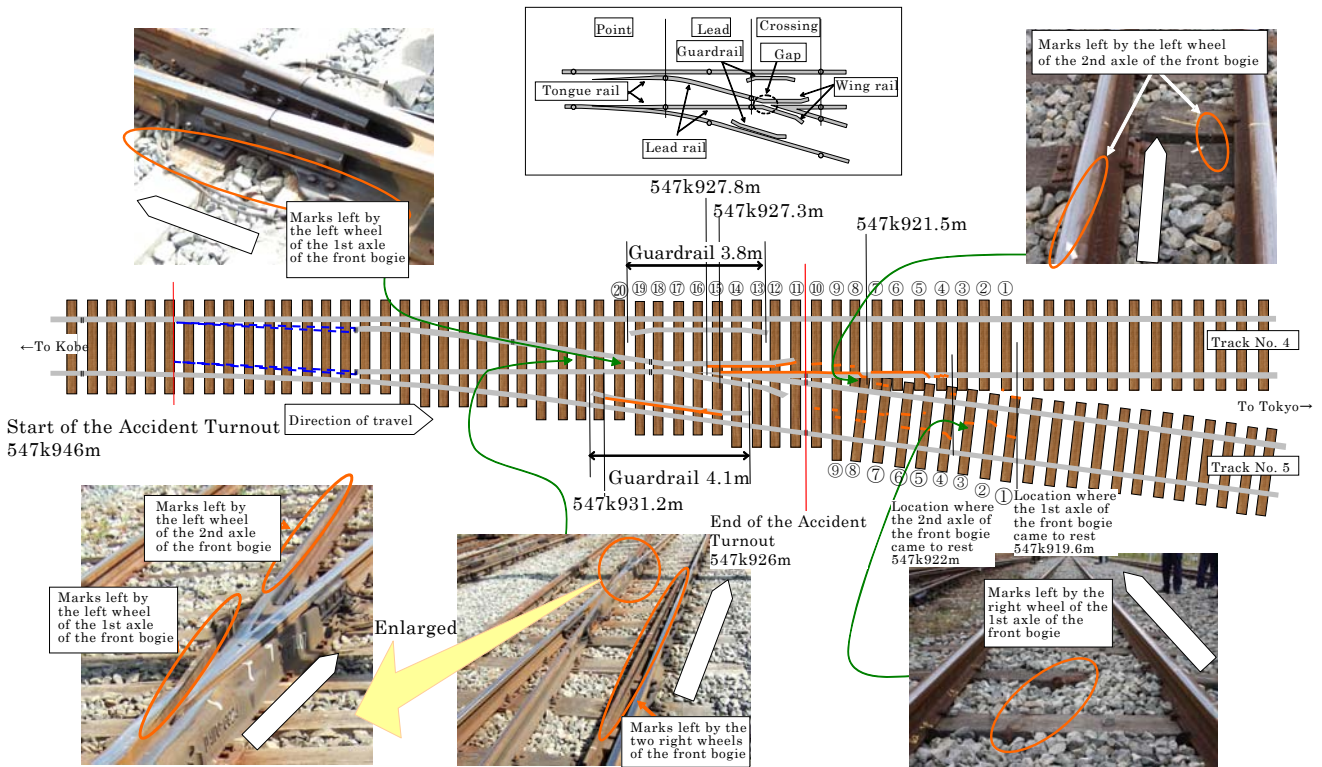
**Details of the derailment**

In addition, (a) the Accident (8th) Wagon and the 9th wagon were not carrying any containers or cargo and therefore were lighter than the leading wagons, (b) no marks were left on the rail immediately on the Kobe side from the gap at the crossing that would indicate the left wheels of the front bogie riding over the rail, and (c) the coupler had longitudinal and lateral dents on its right side. Considering these facts, it is probable that the Accident Wagon was about to enter the Accident Turnout when the driver took “acknowledgement action,” which resulted to trigger the emergency braking, causing the following wagons, which had not yet braked, to apply longitudinal force to the coupler of the leading two empty wagons and making the Accident Wagon sway laterally. As a result, it is probable that both axles of the front bogie of the Accident Wagon, which was lighter than the leading wagons, were lifted off the rails and that the coupler force, which was applied in the direction of Track No. 4 (the main line of the turnout), prevented the Accident Wagon from turning right onto Track No. 5 as had been intended, and caused the wagon instead to continue moving straight ahead (in the direction of the main line) as the inner sides of the right wheels of the front bogie slid over the guardrail.

As the train set length is about 507.8 m, it is probable that the 14th, 16th and 21st wagons, which were also empty loaded, were either at the exit of the 7407 turnout or on a straight line with no turnouts when the ATS operated, and that as a result, the longitudinal force from the trailing wagons acted to the leading wagons along the rail.

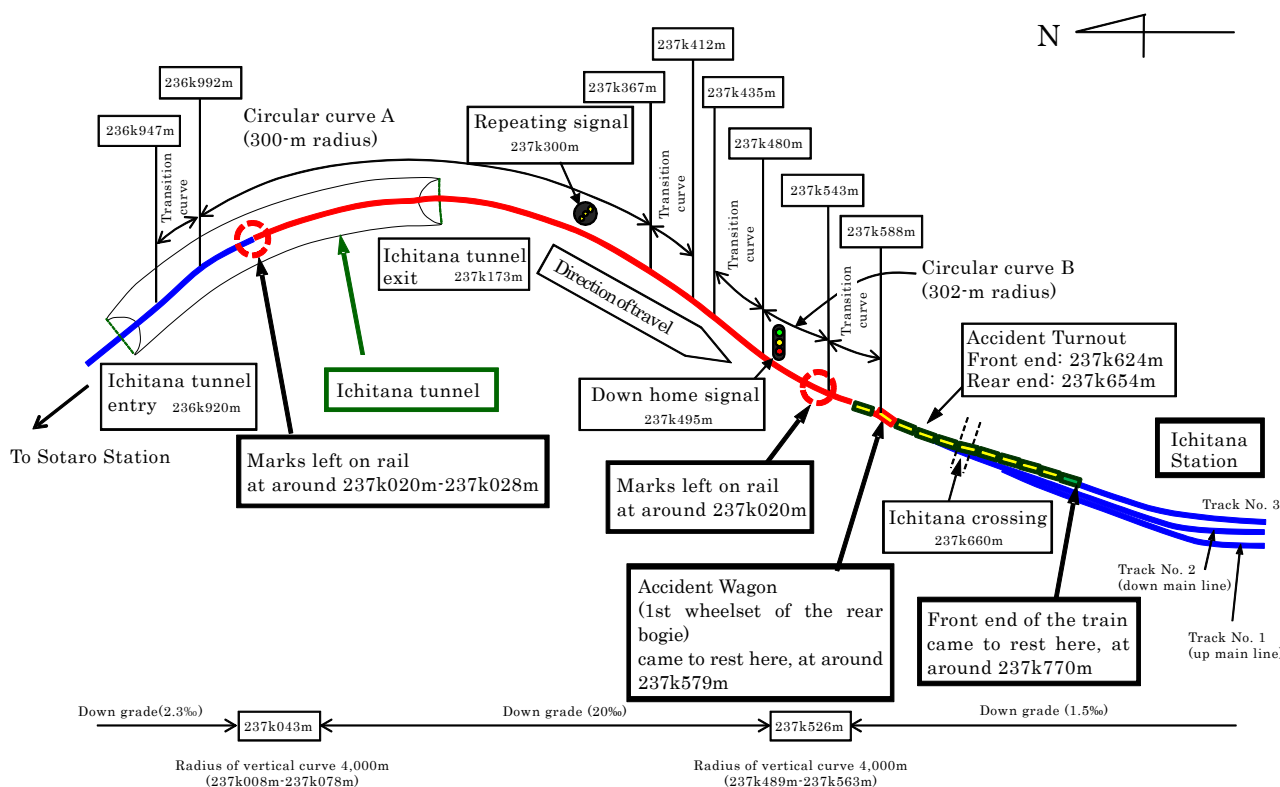
**Schematic of the accident site**

Considering the dents left on the underframe and cable conduit near the left wheel of the 2nd wheelset of the Accident Wagon's rear bogie that appeared to have been caused by

the wheel, it is somewhat likely that following the derailment of the 2nd wheelset of the rear bogie, the Accident Wagon sank deeply, allowing its rear coupler to slide down and come off the front coupler of the rearmost wagon. Considering that the damage on the right side of the rear coupler of the Accident Wagon extended upward while the damage on the left side of the front coupler of the rearmost wagon extended downward and that the top surface of the front coupler of the rearmost wagon had marks apparently caused during contact with the underframe, it is somewhat likely that the rear coupler of the Accident Wagon pushed up the front coupler of the rearmost wagon.

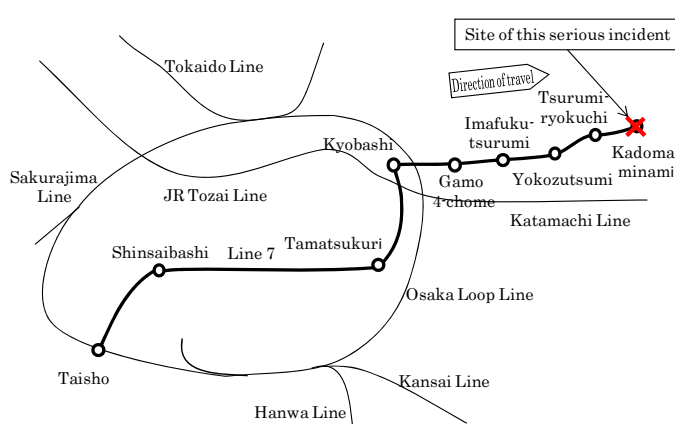
**Site of this serious incident**

The train “B0504” (Line 7), a 4-car train set, from Taisho Station to Kadoma-minami Station (the Train), operated by the Osaka Municipal Transportation Bureau (the Bureau), departed Kyobashi Station at 05:27. Soon after departure, the ATC\*<sup>1</sup> service brake operated, causing the train to stop at about 17 m from where it had started. The driver of the Train disengaged the ATC system as instructed by a train

dispatcher and resumed operation without changing the block system. At Kadoma-minami Station, the Train entered the route to Track No. 2 on which a substitute train, A0504 (the Substitute Train), had been stopped. The driver applied the emergency brake and the Train stopped about 60 m before the Substitute Train.

- f. It is probable that the cab signal failure of the Train was caused by damage due to aging of the electrolytic capacitor of the detector in the ATC receiver. Therefore, the Bureau must pay closer attention to aging when conducting future maintenance on its fleet.

In this serious incident, it is probable that the Train with a failed ATC system and without the substitute block system applied, was then allowed to enter Kadoma-minami Station without any check of the station's blocking status, so that the driver of the Train, on which the ATC system had been disengaged and the cab signal was showing an abnormal indication, did not check the point change to the correct route before entering the station, and that as a result, the Train was allowed to enter a course on which the Substitute Train had been stopped.

- a. Reeducation of train dispatchers and drivers on the rules and regulations regarding train operation and instructions during a failure in the onboard ATC system and have them strictly obey the rules and regulations.

- b. Improvement of the training programs for train dispatchers and drivers covering a range of abnormal cases including train failures requiring train replacement and failures from complex causes.

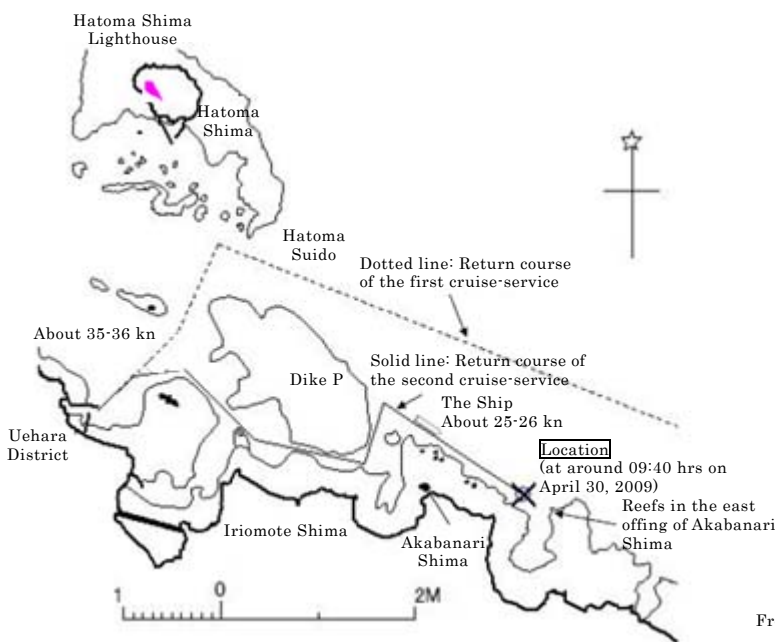
Plots of estimated positions of the Ship

(3) It is probable that the master, when approaching the point of turn near the reefs in the east of Akabanari Shima at the original speed, looking in the starboard bow direction in order to monitor the Ship's distance to the reefs in the bow and starboard side, failed to recognize the big wave approaching from the port bow direction.

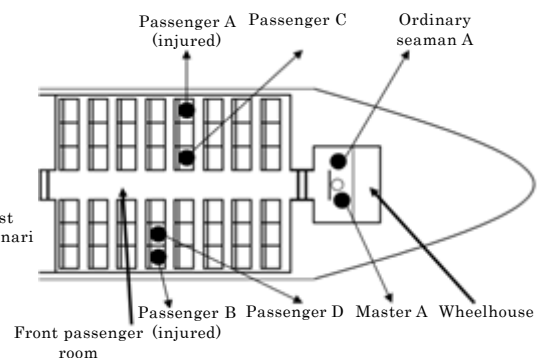
Seat positions in the front passenger room of the injured passengers, and other persons

It is probable that the accident occurred when the two passengers, sitting in the front passenger room, were lifted up and then dropped onto their seats, each suffering a compression fracture in the lumbar spine due to the free fall shock when the Ship's bow rode on the big wave crest and fell down to the wave bottom, because the master, proceeding east-southeast ward along the reefs in the north east offing of Iriomote Shima while hitting consecutive waves of about 1.5 to 2 meter high from east-northeast on the port bow and failing to recognize the big wave approaching until just before its arrival, kept the Ship proceeding at the original speed.

It is somewhat likely that the following facts contributed to the occurrence of the accident: the master and the ordinary seaman failed to provide passengers by public address system with directions or guidance to sit in the rear passenger room where hull motions are smaller; and the master failed to advise the passengers to wear seat belts.

The JTSC recommended Company A to provide safety education in accordance with their safety management regulations and so forth, prepare a safety operation manual in heavy weather applicable to the actual situation of their cruise services, and ensure compliance with the manual.

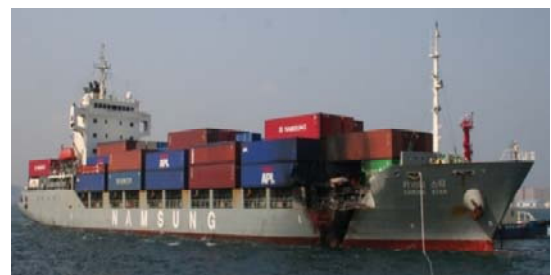
Container ship CARINA STAR (Ship A), boarded by a master (Master A) with 15 crew members, was proceeding eastward toward Hanshin Port through the Kanmon Passage in Kanmon Port. Destroyer of Japan Maritime Self-Defense Force (JMSDF) KURAMA (Ship B), boarded by a master (Master B) with 295 crew members, was proceeding westward through Kanmon Passage toward Sasebo Port, Sasebo City, Nagasaki Prefecture. The ships collided in the vicinity of Moji Saki, Kita-Kyushu City, Fukuoka Prefecture. Ship A sustained a fracture opening on the starboard bow outer-plate shell plate, and Ship B sustained substantial damage on the bow, which caused fire to break out on the damaged parts of both ships. Six crew members of Ship B suffered injuries during the fire-fighting operations; however, there were no injuries among the crew of Ship A.

Situation of Ship A

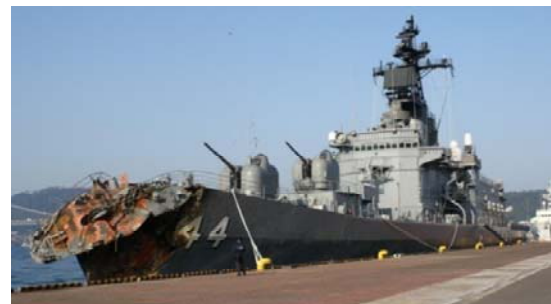
Situation of Ship B

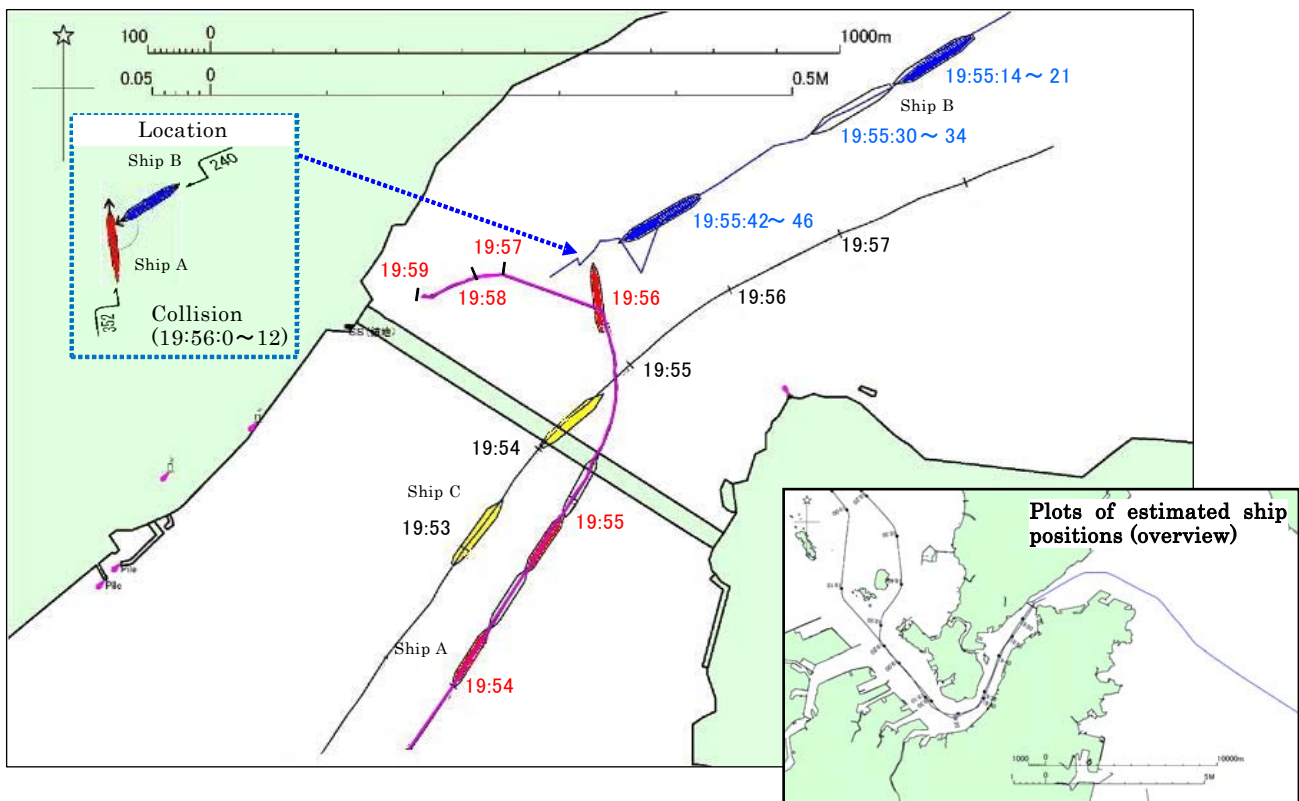
**Plots of estimated ship positions**

- d. It is probable that Ship A, due to the port-swinging inertia of the helm hard-a-port and the port-side rotational moment caused by the tidal stream, swung widely to port, advanced to the center of Kanmon Passage, and proceeded ahead of Ship B.

- a. It is probable that although Ship B’s navigation plan for the Kanmon Strait had prescribed the speed through the water at about 12 kn, Ship B, while navigating westward by Kanmon Passage, was navigating at a speed of about 17 kn at the Tanoura Offing due to the effects of the tidal stream, faster than the full speed through the water of about 15 kn, which had been set before entering Kanmon Passage based on the judgment on the situations where there were no vessels on the same course ahead except for a small vessel and also due to the intention to pass through the Kanmon Strait quickly so as to have sufficient time for scheduled work.

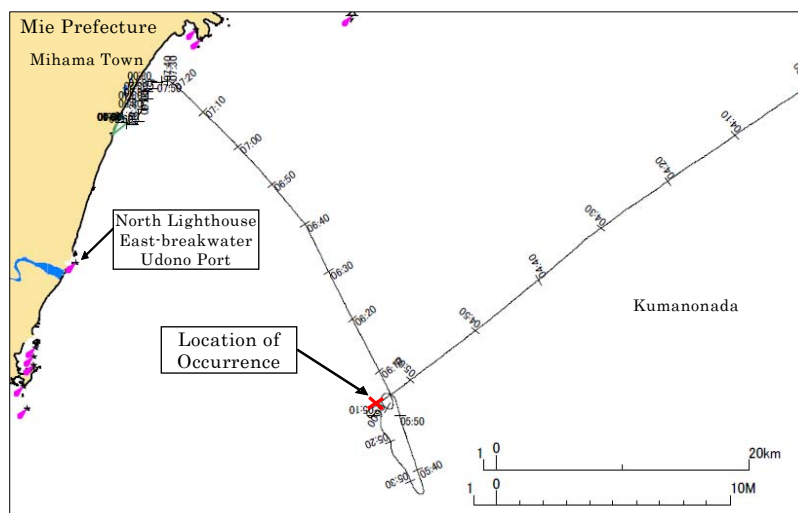
**Plots of estimated ship positions**

It is probable that: the ship, carrying 7 passengers, containers and trailers\*1, was sailing south-westward in Kumanonada with the waves on the port quarter; the ship encountered a wave (the first wave) and listed to starboard by about 25°, which triggered the cargo shifting; the ship, when encountered by the second wave, listed further.

In addition, it is probable that: the listing, although once reduced by shifting ballast waters, grew larger while the ship was sailing north-westward toward the shore; the ship grounded and fell on its side near the shore of Mihama Town; before the grounding, the

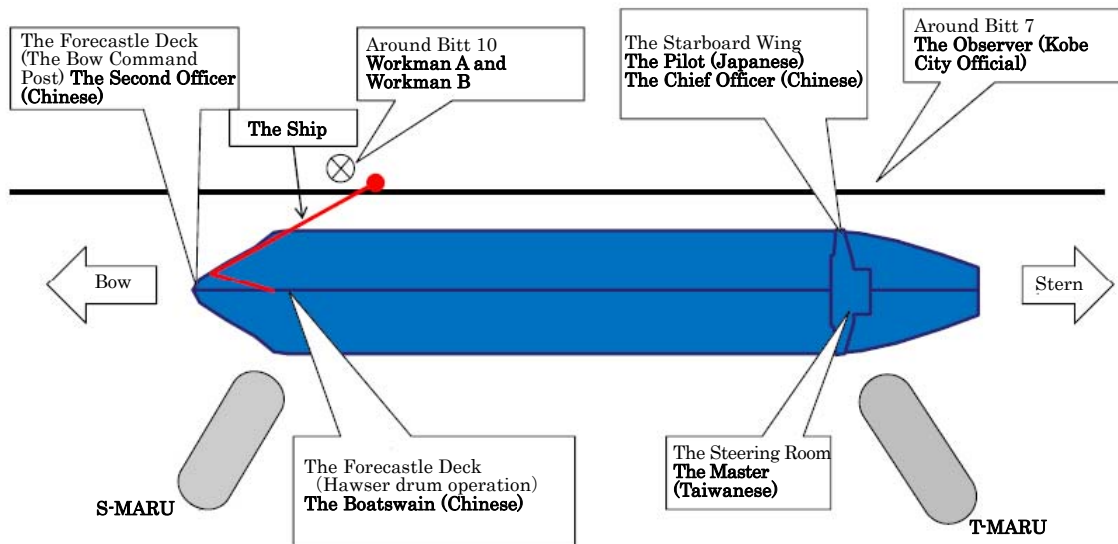
At about 07:36 hrs, while the container ship KUO CHANG (the Ship) was docking at Port Island Container Berth 18 (the Berth), a mooring rope moored onto a bitt on the Berth broke, snapped back and hit two workmen (Workman A and Workman B) who were engaged in mooring work. Both of the workmen died.

**Positions of the parties concerned at the time of the accident**

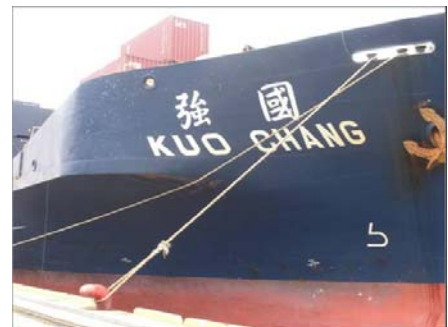
- (1) It is probable that, on docking at the Berth, the pilot was actually in command of the vessel and the master and the chief officer at the bridge gave order to the second officer on the bow and the third officer on the stern under the pilot's advice.
- (2) It is probable that the broken mooring line (the Line) was a synthetic fiber rope used for less than a year, but it was worn due to repetitive use while touching a bend point where the sheer strake and outside plating

**Forward spring line of the Ship**

touched at almost a right angle (the Bend Point).

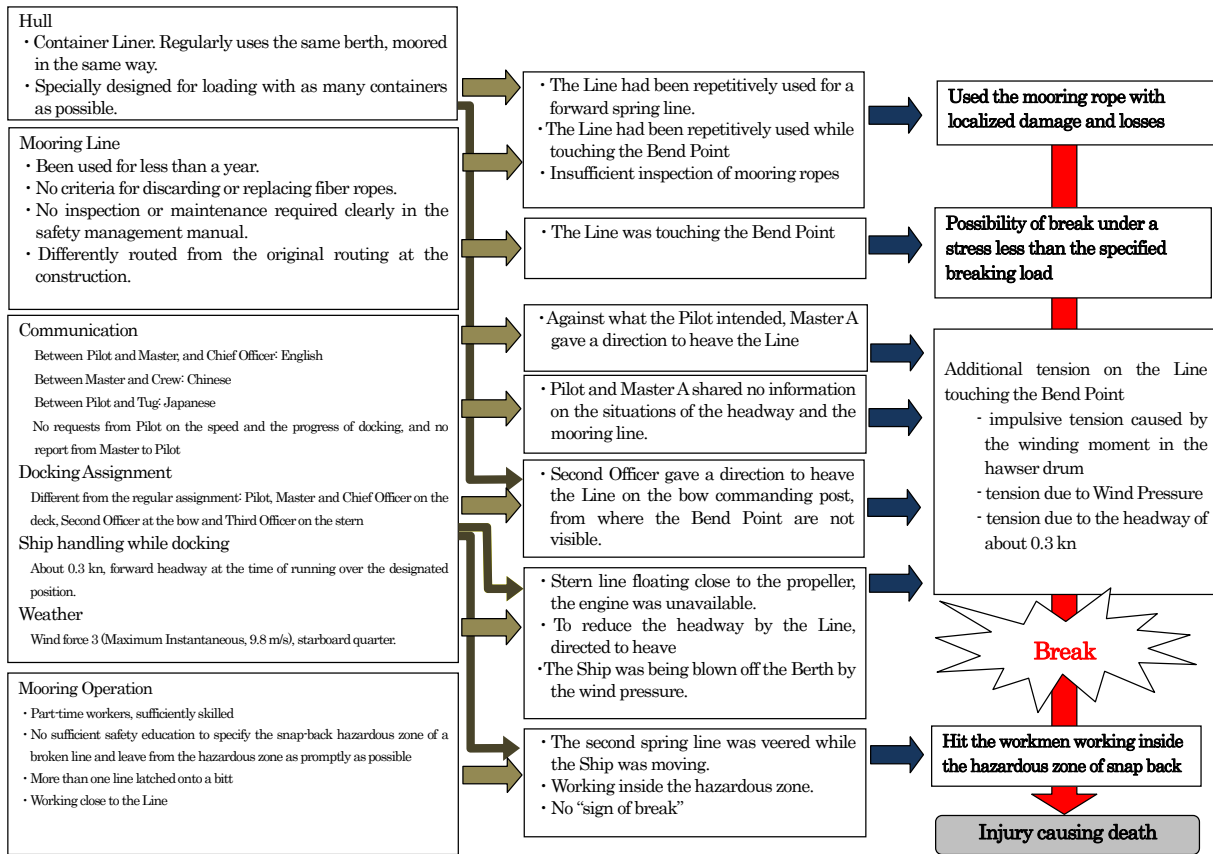
**Cause and effect relationship of causal factors**

(7) It is probable that the line handling service company had not provided the workman with safety instructions to complete the work swiftly and leave from the snap-back hazardous zone as promptly as possible in case of operations close to a mooring rope under tension, showing the extent of the snap-back hazardous zone of a broken rope under tension.

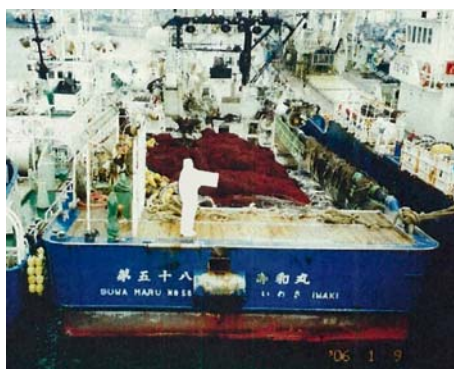
It is somewhat likely that the causes of the higher center of gravity than that in a normal state and the initial listing to starboard were as follows: the fishing nets gained weight because they had been soaked with water and been patched for repair; the fishing gear, ropes and other items were loaded on the wheelhouse's canopy; the imbalance in the transverse weight distribution was caused by the loading of the heavy chains, the fishing nets and the floats in that order from the starboard side; and, the fishing nets shifted toward the heavy chains as the boat rolled.

Loading situation of fishing nets

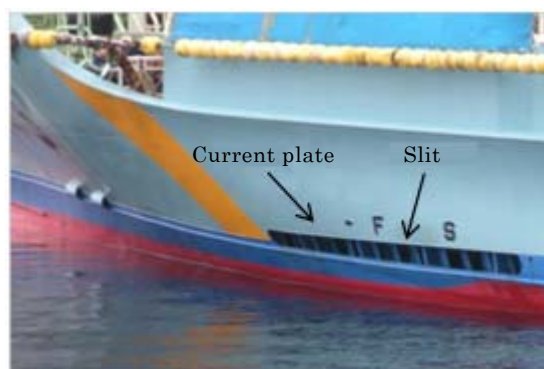
It is somewhat likely that the structure around the scupper contributed to hampering water drainage.

Structure of scupper  
(photo of similar type of boat)
