JAPAN TRANSPORT SAFETY BOARD ANNUAL REPORT 2013

ANNUAL
REPORT

2013

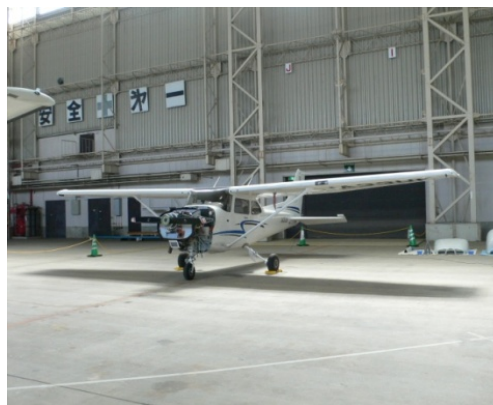
Second touchdown

As 70 mm inward bending of the blade tip needs at least 17.2° of pitch-down attitude, the student pilot had possibly pushed the control wheel or failed to apply back elevator pressure to hold the pitch-down attitude, resulting in the nose-low contact with the runway.

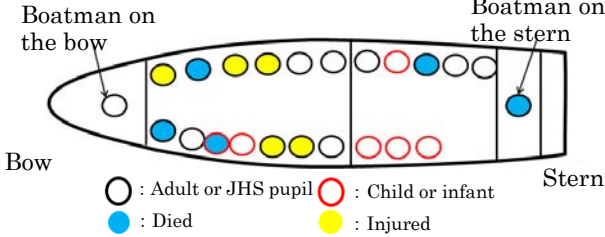
Summary: When cruising down the river Tenryugawa with 2 boatmen and 21 passengers aboard on August 17, 2011, this boat ran aground at around 14:17 on a rocky area on the left side of the bank of the Tenryugawa at Futamata, Tenryu Ward, Hamamatsu City, Shizuoka Prefecture, and was overturned, to take the life of four of the passengers and one of the boatmen and to injure five of the
