## Chapter 2 Aircraft accident and serious incident investigations

### 3 Statistics of investigations of aircraft accidents and serious incidents

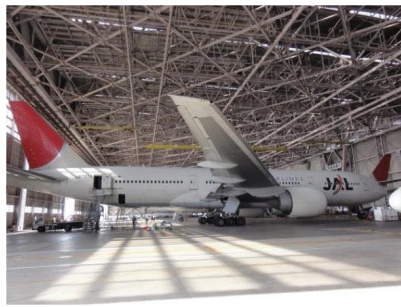
Probable Causes	<p>In this accident, it is highly probable that the aircraft continued rolling with the pitch-up attitude after touchdown, causing the aft fuselage to come into contact with the runway and be damaged.</p> <p>It is highly probable that the aircraft continued rolling with the pitch-up attitude due to the following reasons: after touchdown, the PIC had felt that the aircraft had bounced to the extent necessary for go-around, and judged to make go-around to avoid a hard landing, even after he became aware that the reverse thrust levers had been raised, he continued go-around; hence, it took time for the engine thrust to increase and he continued to pull his control column. Moreover, it is somewhat likely that, in a situation in which the PIC had been assisting the control of</p>

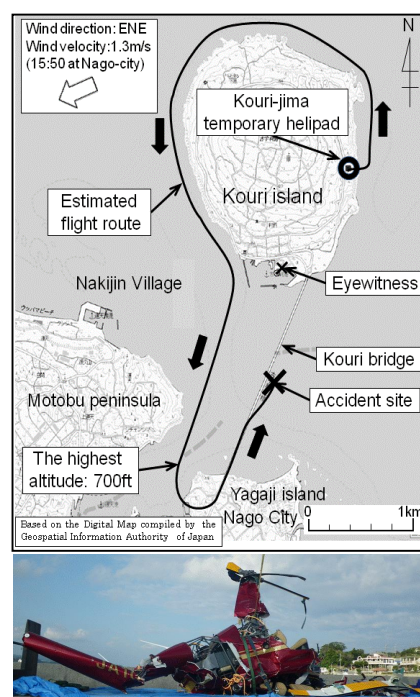
**Probable causes:** It is highly probable that the accident occurred as the helicopter during sightseeing flight descended at excessive speed and descent rate until close to sea surface, the captain misjudged the altitude over calm and high degree of transparency sea surface, delayed the transition from descent to climb, crashed into sea surface and the helicopter was destroyed.

Regarding the helicopter descended at excessive speed and descent rate until close to sea surface, it is highly probable that the Standard Operation Procedures which described detailed flight procedure were not provided in the Company and flight procedure of each flight operation was left to the captain's discretion. Moreover, the captain did not try to follow the laws and regulations and significantly lacked safety considerations.

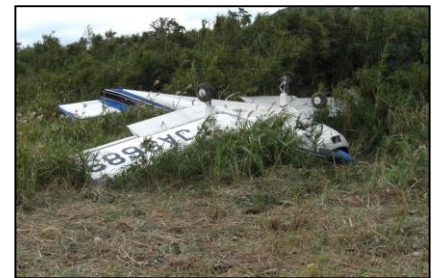
Serious incident aircraft

It is probable that the captain could not anticipate the left brake would become ineffective as he performed brake check during taxiing and found normal function before take-off and the left brake was effective just after touch-down. It is highly probable that the left brake became ineffective at the landing and the aircraft ran off the runway to the right as the captain intentionally applied the right brake hard, and then the nose wheel was tackled by the meadows and the aircraft came to a halt after tumble.

Since the wear of a rubber-made O-ring (mounted on the piston to prevent fluid leaks) in the left master cylinder of the brake system was confirmed, it is highly probable that the left brake system became ineffective because the master cylinder could not maintain sealing capability and brake fluid pressure could not be sufficiently transmitted to the brake linings.

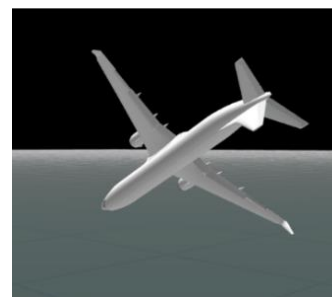
Unusual attitude (demonstration)

Rudder Trim SW operation

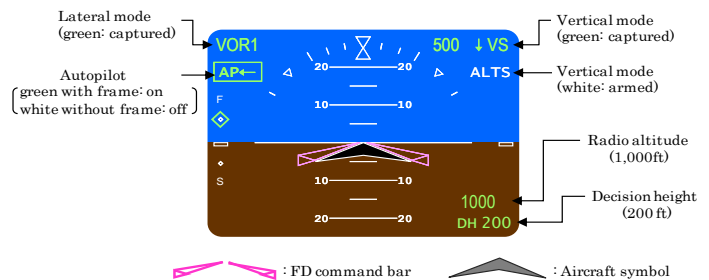
### EADI (Electronic Attitude Director Indicator)

It is possible that the PIC had to push the control column forward to control the nose up tendency accompanying engine power increase for go-around, and while feeling something uncomfortable about the FD command bar, he actually followed its directions. Therefore, it is highly probable that the PIC eventually made the Aircraft descend without his intention.

It is highly probable that the PIC could not perform a fundamental instrument flight at this time.

the attitude indication symbol of aircraft, the FD command bar to show pitch and roll command signals
