Chapter 3 Railway accident and serious incident investigations

3 Statistics for the investigations of railway accidents and serious incidents

List of published investigation reports on railway accidents (2014)

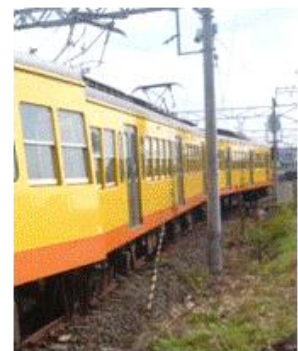
Probable Causes	<p>It is highly probable that this accident occurred as follows: The driver of the outbound train assumed that the starting signal of the down line was indicating the proceed signal as usual, due to the fact that the train did not pass the inbound train in Misato Station. The driver did not confirm the signal indication of the starting signal of the down line, which was supposed to be confirmed before closing passenger doors, and the driver also did not perform thorough finger-pointing and call prior to the departure. Due to this, the driver departed the train without noticing the stop signal indicated on the starting signal of the downline, and ATS emergency brake was activated. However, the train entered into the safety siding and stopped after destroying the car stop.</p> <p>It is highly probable that the stop signal was indicated on the starting signal of the</p>

down line due to the following reasons: The operation dispatcher of the CTC Center misread the train diagram, thought that trains were passing in Misato Station, and handled the train passing control button for the station by mistake. Due to this, the stop signal was indicated on the starting signal of the down line for the station.		
	Report	http://www.mlit.go.jp/jtsb/railway/rep-acci/RA2014-1-1.pdf		
2	Date of publication	Date and accident type	Railway operator	Line section (location)
	February 28, 2014	March 30, 2012 Train derailment	Toyama Chihou Tetsudou, Inc.	In the premises of Uchiyama Station, Main Line (Toyama Prefecture)
	Summary	<p>The driver of the deadheading train felt unusual sounds and shocks before entering Uchiyama Station. Then the driver applied the emergency brake and stopped the train, and confirmed that the wheels of the front axle had become derailed to the left. The driver notified to the dispatcher regarding the derailment.</p> <p>Out of the one driver and two railway workers on board, no one was injured.</p>

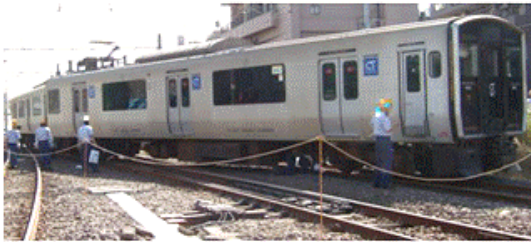
Probable Causes	<p>It is somewhat likely that the first axle in the rear bogie of the second vehicle of the train climbed up the outside rail, i.e., right rail, of the left curved track and derailed to the right of the outside rail, and the second axle dragged by the first axle derailed to the right, in this accident. It is probable that the train stopped after the first axle in the rear bogie of the second vehicle restored to the wrong track at the turnout.</p>

<p>It is probable that the first axle in the rear bogie of the second vehicle derailed to the outside rail of the left curved track due to the following reasons.</p> <p>(1) The lateral force of the outside rail had increased because the alignment of the left curved track had exceeded the maintenance standard and the alignment was increased toward the right, i.e., outside direction.</p> <p>(2) The wheel weight of the outside wheel had decreased because the twist in the left curved track had exceeded the maintenance standard and became large in the direction to decrease wheel load of the outside wheels. In addition, it is probable that the mud pumping in the ballast, the loosen spikes, partial corrosion in the sleepers and the gaps between rail and tie plates, observed around the start point of flange climbing, were related to climb up of the first axle in the rear bogie of the second vehicle. In addition, it is somewhat likely that the increased spring coefficient of the axle spring of the vehicle by aging was related to climb up of the first axle in the rear bogie of the second vehicle.</p> <p>It is somewhat likely that the rear bogie of the second vehicle derailed because the lateral force acting on the outside wheel due to larger static wheel loads in the inside wheels, i.e., left wheels, of the rear bogie, while the static wheel loads in the outside wheels, i.e., right wheels, were larger than in the inside wheels of the front bogie, although the ratio of wheel load unbalance were within the managed values in the regulations of the company.</p>

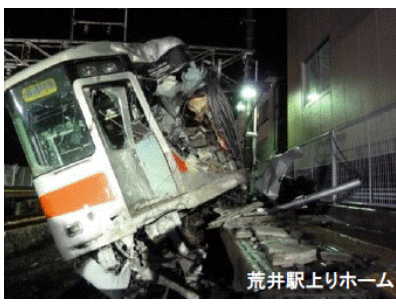
Report	http://www.mlit.go.jp/jtsb/eng-rail_report/English/RA2014-5-1e.pdf			
8	Date of publication	Date and accident type	Railway operator	Line section (Location)	
	June 27, 2014	February 12, 2013 Train derailment, accompanied with level crossing accident	Sanyo Electric Railway Co., Ltd.	Shinkomae level crossing, category one level crossing with automatic barrier machine and road warning device, between Iho station and Arai station, Main Line (Hyogo Prefecture)	
	Summary	<p>The train driver noticed the obstacle at Shinkomae level crossing while the train was coasting at about 95 km/h between Iho station and Arai station. Immediately, he sound a whistle and applied an emergency brake, but the train collided with the rear of the car carrier trailer truck and the stretch board for loading. After that, the train ran with destroying poles planted in the left side of the up track and the block fence along the track, and collided with the platform of Arai station and stopped.</p> <p>The front part of the train was completely demolished. The front bogie of the front vehicle was separated from the vehicle body and its first axle derailed to the left of the rail and the second axle derailed inside the track. The all axles in the rear bogie of the front vehicle and the all axles of the front bogie of the second vehicle derailed to the right of rail. The all axles of the rear bogie of the second vehicle derailed as the left wheels were raised up from the rail.</p> <p>There were about 60 passengers, a train driver and a conductor on board the train. The train diver was seriously injured and 15 passengers were slightly injured. In addition,</p>

the drivers of the freight truck and a taxi collided with the freight truck were slightly injured.		
	Probable Causes	<p>It is probable that the accident occurred by the inbound through limited express train derailed to the left of the up-track because the train collided with the load carrying platform of the freight truck and ran onto its stretch board for loading, which was lowered to cross the railway track, at the same time, when the train passed the Sinkomae level crossing, in this accident.</p> <p>It is probable that the rear portion of the freight truck had been staying inside the level crossing because the the truck driver drove the truck into the level crossing road, without noticing that the sedan ahead his truck might stopped at the road between the level crossing and the intersection ahead, and the truck was obliged to stop behind the sedan stopped at the intersection. It is probable that the stretch board for loading was lowered to cross the railway track because the truck driver had lowered them in the level crossing road to forward the truck without damaged the crossing rod because the truck driver had considered if the truck had forwarded with the stretch board for loading was set at vertical position, the stretch board would fell down in the level crossing and would contact with the train, furthermore, he judged that the truck could be forwarded because the sedan stopped at the intersection in front of the truck seemed to move forward.</p>

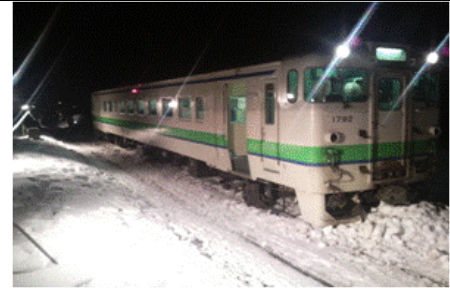
Report	http://www.mlit.go.jp/jtsb/eng-rail_report/English/RA2014-6-1e.pdf		
9	Date of publication	Date and accident type	Railway operator	Line section (Location)
	July 25, 2014	February 29, 2012 Train derailment	Hokkaido Railway Company	In the premises of Yakumo Station, Hakodate Line (Hokkaido)
	Summary	<p>The train driver left Yakumo station behind schedule after waited passing limited express operating behind schedule. After the train had departed, the train driver felt the swaying motion around the turnout, and he applied an emergence brake and stopped the train. After that, he checked the vehicle and found all two axles of the front bogie derailed to right of the turnout side track, after passed #10-Ro turnout located in the route to the up-track main line from the No.4 platform.</p> <p>There are 2 passengers and a train driver on board the train, but there is no casualty.</p>		
	Probable Causes	<p>It is probable that the wheels of the front bogie climbed up the right side lead rail and derailed because there were the hard frozen snow or ice were built up to the rail top in the flange way at the lead rail when the train ran into the branch line side route, in this accident.</p> <p>It is probable that there were the hard frozen snow or ice around the flange way because the snow removal work were insufficient.</p> <p>It is somewhat likely that the insufficient snow removal work was caused by the</p>

insufficient comprehension about the status of snow removal in the station, because the employees contracted in winter season did not understand the importance about the snow and ice removal work around flange way due to lack of description about it in the education material used in Yakumo station, and the company had not determined how to grasp the status of snow removal work by the contract employees and how to report about the snow removal work.		
	Report	http://www.mlit.go.jp/jtsb/eng-rail_report/English/RA2014-7-1e.pdf http://www.mlit.go.jp/jtsb/railway/p-pdf/RA2014-7-1-p.pdf (Explanatory material)		
10	Date of Publication	Date and accident type	Railway operator	Line section (Location)
	July 25, 2014	April 26, 2012 Train derailment	Japan Freight Railway Company	Between Izumisawa station and Kamaya station, Esashi Line (Hokkaido)
	Summary	<p>The train departed from Aomori signal station, and arrived at Goryokaku station.</p> <p>The transport staff waiting for the train at Goryokaku station found smoke rose from the freight wagon, 18th car of the arrived train, and notified to the station office. The rushed station staffs fought the fire of the freight wagon that the smoke rose from around the bogie. On the other hand, the switching malfunction of the turnout occurred in the premises of Kamaya station, Esashi Line, on the same day. The track maintenance staffs of Hokkaido Railway Company checked track condition in the premises of Kamaya station, and found that the turnout was damaged and there were traces of derailment on the sleepers around it. The freight wagon emitting smoke at Goryokaku station was not derailed but judged as it had derailed once, by the results of the inspection about status of the wheels of the freight wagon.</p> <p>A train driver was onboard the train, but there was no injury.</p>

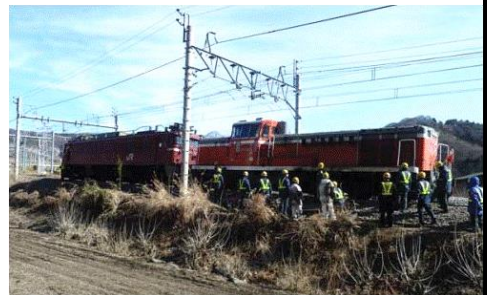
Probable Causes	<p>It is probable that the remaining converter oil in the torque converter was ignited by the high temperature fragments etc. of the converter which was broken and heated by missing cooling function of the converter because the coolant was drained, and the first stage converter rotated while the deadhead diesel locomotive were running, because the "neutral rock" of the forward/backward switching device was not correctly performed when a diesel locomotive was hauled as the deadhead operation without powering. It is probable that the reason why the neutral rock did not correctly performed was that the staff had set neutral rock without understanding the method to rock correctly and the staff in charge of checking also did not understand correctly the neutral rock.</p> <p>It is probable that the reason why the neutral rock operation had performed by the staff who did not understand the operation procedure and had been checked by the staff who did not understand correctly the neutral rock operation, was the poor recognition of the company about the importance of the neural rock operation, whose frequency is low because it was insufficient to prepare the operation manual and the prior education and training in advance were not performed or poor.</p> <p>Furthermore, it is probable that the automatic emergency brake did not operated when the velocity exceeded the permissible value, because the electric power of the speed detector was not supplied while the locomotive was in the deadhead operation without powering, due to the meter relay of the over speed detector was replaced to the new type which required power supply from independent batteries, was related to induce the accident.</p>

12	Date of publication	Date and accident type	Railway operator	Line section (Location)
	August 29, 2014	February 13, 2014 Train derailment	Kyushu Railway Co., Ltd.	Between Amagase station and Sugikawachi station, Kyudai Line (Oita Prefecture)
	Summary	<p>The train driver found the fallen tree about 50m ahead on the track while the train was in powering operation at about 70 km/h, and immediately applied an emergency brake, however, the train collided with the fallen tree and stopped after running about 60m.</p> <p>The train driver checked the train after it stopped, he found that all axles of the vehicle derailed and the vehicle leaned into the right.</p> <p>There were two passengers and a train driver on board the train, one passenger was injured.</p>		
	Probable Causes	<p>It is probable that because a cedar tree had fallen as to cross the track, the running train ran onto it and moved to the right and derailed, in this accident.</p> <p>It is probable that the cedar tree had fallen by the root considering the followings.</p> <p>(1) The position of the gravity center of the cedar tree became higher than as usual because the wet and adhesive snow stacked on the crown of the tree fallen on the accident day.</p> <p>(2) The suspension force of the root was considered weak compared to the relatively strong strength of the trunk, because the fallen cedar tree was the tree in its prime and its trunk had sufficient diameter against its height.</p> <p>In addition, it is somewhat likely that the tree had fallen by a little snowfall because the slope around the root of the tree had been in the water-rich state, because the landform of the slope around the fallen tree is ravine that the rainwater fell in the surrounded area will be concentrated, in addition, the water was leaking from the damaged sewerage system of the hot spring facility in the upper part of the slope.</p>

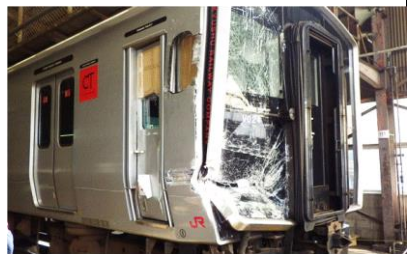
16	Date of publication	Date and accident type	Railway operator	Line section (Location)
	November 27, 2014	November 5, 2013 Level crossing accident	Kyushu Railway Co., Ltd.	Shinbori-Kendo level crossing, class one level crossing with automatic barrier machine and road warning device, in the premises of Takahashi station, Sasebo Line (Saga Prefecture)
	Summary	<p>The train driver noticed the obstacle at the Shinbori-Kendo level crossing in front of the train and applied an emergency brake immediately, but the train collided with the rear flap of the load carrying platform and the loaded iron plates of trailer truck, and the train stopped about 106m away from the level crossing.</p> <p>There were 65 passengers and the train driver on board the train, among them 10 passengers were injured. There was the truck driver on board the truck but he was not</p>

<p>injured. The iron plates loaded on the trailer truck were fell on the ground but there was no injury in the public.</p> <p>The front face and right side of the front vehicle were damaged, and a part of the load carrying platform of the trailer truck was damaged but the fire did not break out.</p>		
	Probable Causes	<p>It is highly probable that the train, when passed the Shinbori-Kendo level crossing, collided with the rear part of the load carrying platform and the loaded iron plates of the trailer truck, which stood for the stop signal at the intersection ahead of the level crossing, staying inside the level crossing disturbing the train route.</p> <p>It is probable that the trailer truck stood keeping the rear part of the load carrying platform and the loaded iron plates remained in the level crossing because the truck driver did not suspect that distance between the stop line of the intersection and the level crossing might be shorter than the length of the trailer truck, while the truck driver had missed his way and his consciousness was concentrated how to return to the scheduled route.</p> <p>In addition, it is probable that the collision of the train with the trailer truck was induced by the effect of the late emergency brake timing due to the thin thickness of the iron plate covered by the sheets disturbing the train route at the level crossing, which was difficult to recognize as the obstacles by the train driver, and the position of the load carrying platform and the loaded iron plates could not be detected by the obstruction detecting device for the level crossing because they were out of detecting area.</p>
