ANNUAL REPORT 2015

Japan Transport Safety Board

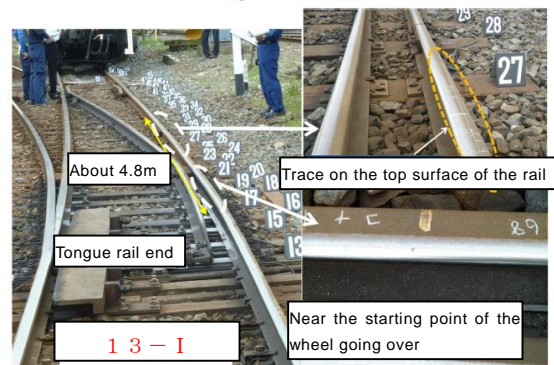
Derailement site

This serious incident occurred when the set of 18-car shunting train (two electric locomotives and 16 freight cars) was running along the section of the base line side of a turnout that goes in the same direction as the curve. The turnout was in a section that contained four consecutive curves. The situation was attributable to an increase in the derailment coefficient, which occurred at the same time as a decrease in the threshold derailment coefficient. As a result, the right wheel in the first axle of the second locomotive's front bogie subsequently ran up the outside rail and derailed to the right.

It is probable that the increase in the derailment coefficient is a result of the increase in lateral force, as well as a decrease in the wheel weight. This situation can be deduced from the following factors: the track was deformed in a direction that results in the reduction of the radius; the twist of the track increased so that the train leaned to the front right, and; it is probable that that the train was running with excess of cant, which was due to its low-speed. It is somewhat likely that the shift of the axle load due to the power running at an ascent was also a contributing factor.

It is probable that the decrease in the threshold derailment coefficient results from a shifting of track, which is associated with an excessive reduction of the radius, resulting in an increase in the angle of attack for the first axle of the front bogie.

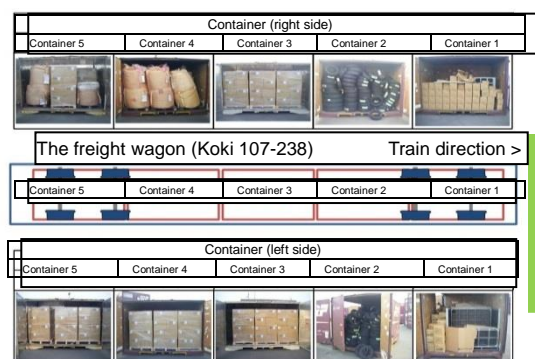
Loading situation in container

1. 48 cardboard boxes on the right side of the direction (about 540kg)
2. 16 cardboard boxes (about 180kg) and 3 flexible container bags (about 1,800kg) on the left side of the direction (1,980kg total)

*Left side had heavier loading than the right side's.

Due to the fact that there was a relatively large combination of track alignment and cross-level (*1) before the point where the wagon climbed over the rail, it is somewhat likely that the force to roll the wagon increased the decrease of the wheel load of the outside (right) wheel, resulting in a situation in which the wagon was prone to climbing over the right rail.

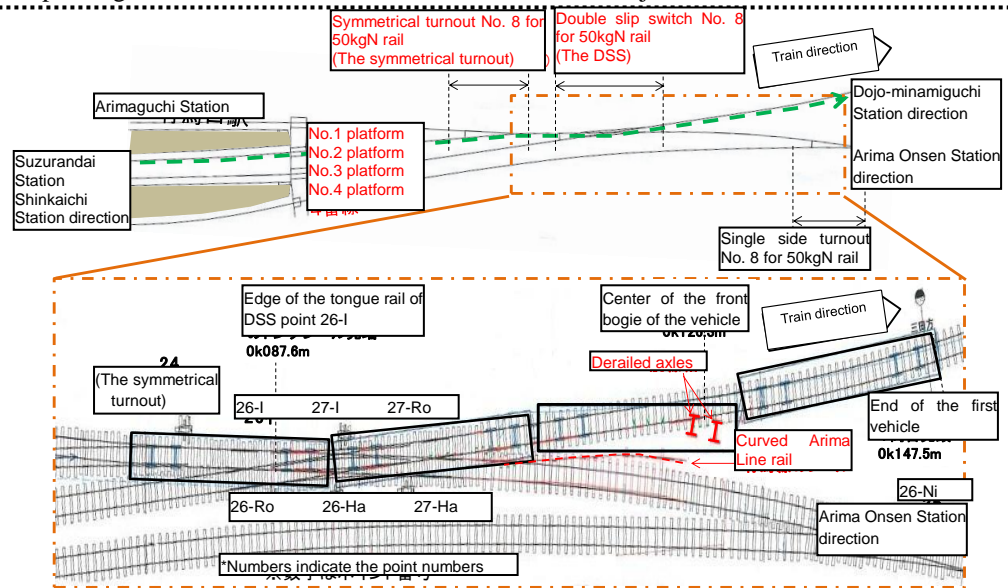
Lines and sketch of the accident site

There was wear of about 4-6mm in the thickness direction of the wheel flange and about 1-2mm in the height direction. Each of the flange part had been worn vertically compared to the designed cross sectional shapes, and the flange angle was larger than the designed cross sectional shapes of the wheels. Due to this, it is probable that the area near the edge of the flange of the right wheel was prone to be close to the right tongue rail of point 26-I of the double slip switch and climb over it.

Probable causes (excerpt): It is probable that the front bogie of the second vehicle of train started at No.2 platform of Arimaguchi station, Sanda line, had entered into the unexpected route to Arima-Onsen station and derailed, because the flange of the right wheel of the first axle in the front bogie of the second vehicle had climb over the tongue rail around edge of the right tongue rail of the point in the double slip switch, followed after passing the symmetrical turnout in the premises of Arimaguchi station, in this accident. And, it is probable that the second axle of the front bogie had derailed to the right in the double slip switch following to the first axle entered into the wrong route, although it had entered into the predetermined route at the point in the double slip switch.

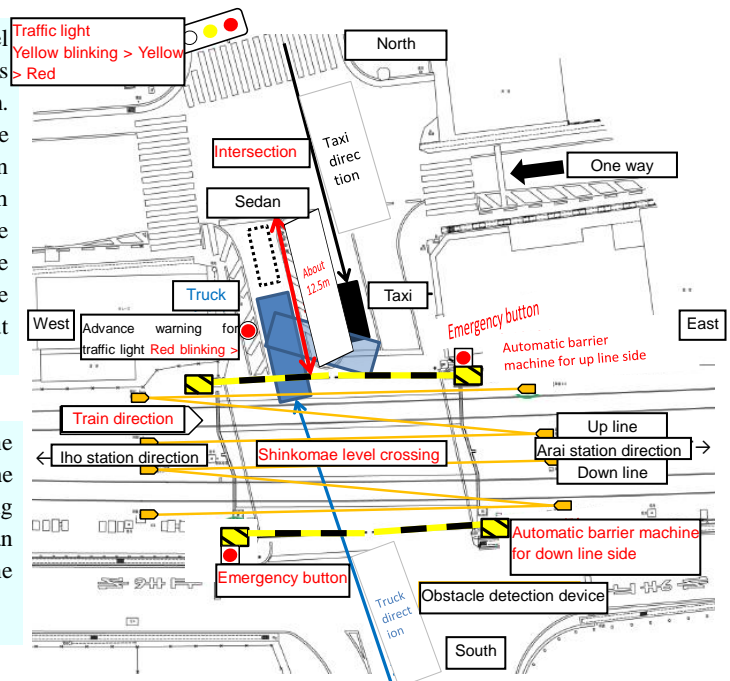
Sketch of the area near the level crossing

As for the road to the intersection ahead of the level crossing, the distance from where the crossing rod comes down to the stopping line of the intersection is about 12.5m. If the truck stops behind one sedan, which is stopped before the stopping line, it is probable that there was more than about 1.7m of the rear portion of the freight truck, which was stopped behind a sedan that had stopped before the stopping line of the intersection, on the inside of the crossing rod of the level crossing, due to the fact that the sedan length is about 4.6m and the truck length is about 9.6m.

It is probable that the truck driver left the rear portion of the truck inside of the level crossing due to the fact that he entered the truck inside of the level crossing without pausing before the level crossing, without thinking that the sedan ahead of his truck might stop at the intersection; because he was not familiar with the road circumstances.

It is probable that the truck driver was trying to move forward with the stretch board lowered in order to avoid colliding with the train. However, it is somewhat likely that the train became derailed because the wheels of the first axle of the front bogie of the train's first car climbed over the stretch board due to the fact that the stretch board was lowered.

Probable causes (excerpt): It is probable that the accident occurred by the inbound through limited express train derailed to the left of the up-track because the train collided with the load carrying platform of the freight truck and ran onto its stretch board for loading, which was lowered to cross the railway track, at the same time, when the train passed the Sinkomae level crossing, in this accident.

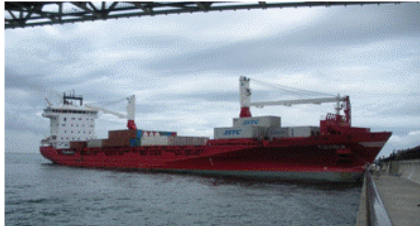
1	Date of Publication	Date and location	Vessel type and name, accident type
	January 31, 2014	August 19, 2011 The Sea Wall on the northern side of the Akashi Kaikyo Bridge, Kobe City, Hyogo Prefecture, Japan	Container ship FLEVODIJK (Netherlands) Collision (Sea Wall)
	Summary	<p>The container ship FLEVODIJK, with the master, the second officer and 13 other crew members on board, while she was proceeding north-eastward on the Harima Nada Sea off the western coast of the Awajishima Island, Hyogo Prefecture, collided with the Sea Wall on the northern side of the Akashi Kaikyo Bridge at around 0439 hrs. The FLEVODIJK was damaged on its bulbous bow and along with some recesses and broken holes, and she broke part of the Sea Wall at the same time, but there were no casualties.</p>

Probable Causes	<p>It is probable that the accident occurred because the second officer who was on the sole lookout on the bridge had fallen asleep, while the Ship was proceeding north-eastward through the Harima Nada Sea toward the west entrance of the Akashi Strait with the autopilot steering at night, and the Ship proceeded toward the Sea Wall and collided with it.</p> <p>As to why the second officer had fallen asleep, is probable that he was sitting on the Chair without his drowsiness relieved, even though he began to feel drowsy and walked around in the bridge to relieve his drowsiness.</p>

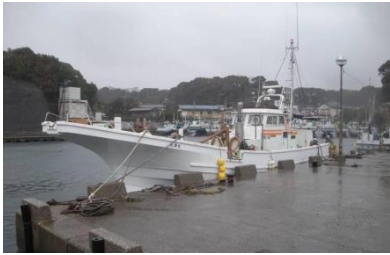
Summary	<p>Ship A, with the skipper and two crew members onboard, had departed from the fishing grounds off the southern coast of Sunosaki in Tateyama City, Chiba Prefecture, and was heading north to return to the port. Ship B, crewed by the skipper alone and carrying six fishing passengers, had been drifting and fishing off the northwestern coast of Sunosaki, when the two ships collided.</p> <p>On Ship B, one fishing passenger died, and the skipper sustained injuries. In addition, the stern on the starboard side sustained damage, while the toilet at the stern, the spanker mast, and the top part of the wheelhouse fell off.</p> <p>For Ship A, the handrails on the bow on the ports side were bent and damaged, the front part of the mast broke off, the bottom section of the ship was broken and sustained abrasions.</p>

Probable Causes	<p>It is somewhat likely that the two ships collided because the two skippers were not keeping a proper lookout while Ship A was proceeding north and Ship B was drifting and fishing off the northwestern coast of Sunosaki.</p> <p>It is probable that the skipper of Ship A was not keeping a proper lookout because the radar screen with a range scale of 1.5M did not show any ships that may hinder navigation and he thought that there were no ships that may hinder navigation as he was keeping a lookout by depending on the radar while sitting on a chair on the port side of the wheelhouse resulting in a blind spot on the bow side.</p>

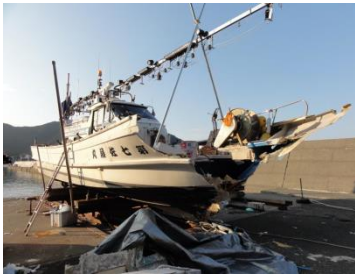
March 28, 2014	September 22, 2013 Rocky area off the coast of Yashiro Bay, Obama City, Fukui Prefecture	Recreational fishing vessel SATOMARU No. 7 Collision (Rocky area)	
	Summary	<p>The ship, crewed by the skipper alone and carrying six fishing passengers, had departed from the Inukuma district of the Uchitomi Port of Obama City, Fukui Prefecture, and was navigating along the coast of Yashiro Bay of Obama City when it collided into a rocky area of the same bay (Okinoishi).</p> <p>Six fishing passengers and the skipper sustained injuries, while the bow of the ship was severely damaged.</p>		
	Probable Causes	<p>It is probable that this accident occurred because the skipper was not able to keep a proper lookout, and did not realize that the ship was navigating toward a rocky area (Okinoishi), resulting in the collision into the rocky area (Okinoishi) while the ship was proceeding northwest off the coast of Yashiro Bay at night, deviating from its usual course.</p> <p>It is probable that the skipper was not able to keep a proper lookout because: the work lamps installed on the outer walls in front of the wheelhouse had been lit, resulting in high intensity brightness for a part of the field of view on the bow side; The glare arising from the light of these work lamps reduced visibility, making it difficult to see on the bow side of the ship; In addition, the yield of the fishing trip at midnight had been poor, giving rise to concerns about fishing grounds and fishing methods, reducing the number of times that the skipper looked at the radar and GPS plotter screens; At the same time, he had probably forgotten to switch the range scale of the radar and GPS plotter from a range scale used in the port, to a range scale for outside the port.</p>

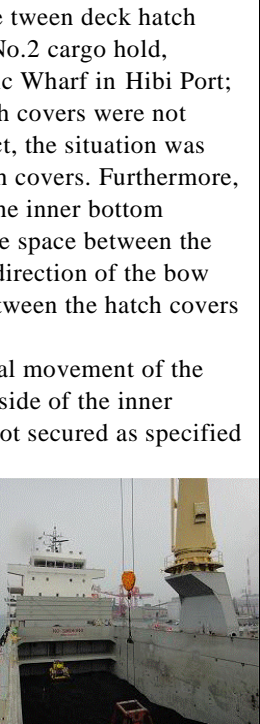
Report	http://www.mlit.go.jp/jtsb/ship/rep-acci/2014/MA2014-3-1_2014tk0002.pdf		
14	Date of Publication	Date and location	Vessel type and name, accident type	
April 25, 2014	May 10, 2011 Public Wharf, Hibi Port, Tamano City, Okayama Prefecture	Cargo ship SCSC WEALTH (Hong Kong) Fatality of a stevedore		
Summary	<p>While the cargo ship SCSC WEALTH was loading copper slag at the Public Wharf in Hibi Port, Tamano City, Okayama Prefecture, tween deck hatch covers that were placed on the inner bottom plating*2 in No.2 cargo hold moved, leading to a stevedore being caught between the hatch covers and a forward bulkhead, resulting in his death.</p>			
Probable Causes	<p>It is probable that this accident occurred for the following reasons: Five tween deck hatch covers were stacked up on the bow side of the inner bottom plating in No.2 cargo hold, during the loading of copper slag onto the SCSC WEALTH at the Public Wharf in Hibi Port; however, the safety bolts for the lowermost and second lowermost hatch covers were not inserted into the insertion holes in the inner hull plating. Due to this fact, the situation was such that it was impossible to prevent horizontal movement of the hatch covers. Furthermore, a driver entered No.2 cargo hold through a forward companionway to the inner bottom plating of No.2 cargo hold; and when the driver was passing through the space between the hatch covers and the forward bulkhead, the hatch covers moved in the direction of the bow after being pushed by the cargo, resulting in the driver being caught between the hatch covers and the forward bulkhead.</p> <p>It is probable that the reason why it was impossible to prevent horizontal movement of the hatch covers is that when the hatch covers were stacked up on the bow side of the inner bottom plating in No.2 cargo hold on the SCSC WEALTH, they were not secured as specified in the hatch cover operating manual.</p> <p>It is probable that the reason why the driver entered No.2 cargo hold through the forward companionway to the inner bottom plating of No.2 cargo hold is that the instructions to use the designated passage route were not heeded.</p>

Safety Recommendations	<p>Safety Recommendation to the SHANGHAI CSC Line Co., Ltd. (April 25, 2014)</p> <p>The company should provide instructions to crew members to ensure that they comply with the hatch cover operating manual and appropriate measures to prevent movement of open hatch covers are taken.</p>			
Report	<p>http://www.mlit.go.jp/jtsb/eng-mar_report/2014/2011tk0012e.pdf Refer to case studies (p. 142).</p>

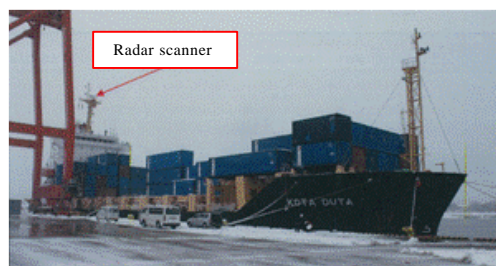
15	Date of Publication	Date and location	Vessel type and name, accident type
	May 30, 2014	February 7, 2012 Port of Niigata Higashi Ku, Niigata City, Niigata Prefecture	Container ship KOTA DUTA (Ship A Singapore) Cargo ship TANYA KARPINSKAYA (Ship B Russia) Collision
	Summary	<p>Ship A was leaving West Wharf No.3 Quay in Port of Niigata Higashi Ku, Niigata City, Niigata Prefecture with a master and 24 crew members onboard, while Ship B was navigating toward the South Wharf within the same section after leaving the Central Wharf East Quay within the same section with a master and 16 crew members onboard (Although there were 18 crew members total, one of the crew members was driving to the South Wharf with the personnel in charge of the ship's agent for handling lines), when Ship A's bow and Ship B's forward starboard side collided where the passages crossed.</p> <p>Although Ship B foundered, all of the crew members were rescued.</p> <p>Ship A suffered damage to the bow, but there were no casualties.</p>

Probable Causes	<p>It is probable that this accident occurred because the vessels collided with each other due to the facts that the master of Ship A and the master of Ship B agreed to the conduct of vessel for both vessels to alter to port to pass on the starboard side via VHF, that the vessels continued to navigate after the master of Ship A put the helm hard to port and the master of Ship B put the helm to port at 15° in an attempt to execute the agreement, and that they kept approaching each other in the situation that was different from the agreed conduct of vessel without being able to recognize any change in the heading when the vessels approached each other in the situation in which their courses would cross where the Dredged Passages crossed while Ship A was proceeding northeast after leaving the West Wharf No.3 Quay and while Ship B was proceeding south-southeast from the Central Wharf East Quay toward the South Wharf in Port of Niigata Higashi Ku.</p> <p>It is probable that the reason the master of Ship A agreed to the conduct of vessel for both vessels to turn to port to pass on the starboard side via VHF was that the master of Ship A was convinced that Ship B was going to pass on the starboard side due to the facts that the master of Ship B re-confirmed to pass on the starboard side, that Ship B was strongly stating "starboard to starboard" via VHF, that he felt that the report by the former master of Ship A had a strong tone, saying "starboard to starboard," and that the former master of Ship A, who was on board to hand over the master position, and the master of Ship B were stating "starboard to starboard."</p> <p>It is probable that the reason the master of Ship B agreed to the conduct of vessel for both vessels to alter to port to pass on the starboard side via VHF was that the master of Ship B offered the conduct of vessel to pass on the starboard side due to the facts that there was not enough distance and time to judge the conduct of vessel when they were called by Ship A via VHF to inquire about Ship B's name in Russian, that it was easy for Ship B to alter to port due to the large area of waters on the port side of Ship B, and that he believed it would be safer if the two vessels' courses did not cross in order to avoid collision because he could not anticipate where in the passage crossing Ship A would turn to port.</p> <p>It is somewhat likely that the fact it took approximately 20 seconds to agree on the conduct of vessel contributed to the occurrence of this accident due to the facts that the master of Ship A and the master of Ship B took approximately 20 seconds to agree on the conduct of vessel, that the vessels had approached each other to the distance of approximately 600m, and that they had no time to take actions to avoid collision when the vessels further approached each other in the situation that was different from the agreed conduct of vessel in which they could not recognize any change in the other vessel's heading when they tried to take actions to execute this agreement.</p>

Safety Recommendations	<p>Safety Recommendations for PACIFIC INTERNATIONAL LINES LIMITED (May 30, 2014)</p> <p>(1) Consider that supernumeraries are part of the bridge team if they are practically involved in maneuvering.</p> <p>(2) Instruct crew members of vessels belonging to PACIFIC INTERNATIONAL LINES</p>

<p>LIMITED and vessels under their management to conduct BRM education and training by learning from this accident case so that those on watch on the bridge can collect safety-related information on radar and other equipment and proactively provide it to the person conning the vessel.</p> <p>(3) Instruct officers of vessels belonging to PACIFIC INTERNATIONAL LINES LIMITED and vessels under their management to prepare for departure and keep look-out while correctly understanding items necessary to ensure safety navigation, such as detecting information on nearby vessels underway as early as possible by changing the radar range scale and conduct education by learning from this accident case when visiting the vessels.</p> <p>(4) Have masters of vessels belonging to PACIFIC INTERNATIONAL LINES LIMITED and vessels under their management re-acknowledge the following risks of using VHF by using this accident case and promote awareness by establishing items to reconfirm the risks of using VHF in a checklist to be used to navigate in narrow channels and congested waters.</p> <p>(i) It is possible that two vessels approach each other and have no time to take actions to avoid collision in case the agreement is not executed if those persons conning the two vessels take time to agree on the conduct of vessel and the vessels navigate in the original course at the original speed during that time.</p> <p>(ii) It is possible that those persons conning the vessels would believe that the other vessel would execute the contents to which they had agreed via VHF even if there is a difference between the anticipated actions of the other vessel according to the person conning the vessel and the actual actions after agreeing on the conduct of vessel and lose the opportunity to take actions to avoid collision.</p> <p>Safety Recommendation to the EAST WAY LLC. (May 30, 2014)</p> <p>(1) Instruct masters and deck officers of vessels belonging to EAST WAY LLC. and vessels under their management to carefully observe radar displays while underway to commence systematic analysis and conduct education by learning from this accident case when visiting the vessels.</p> <p>(2) Notify masters and deck officers of vessels belonging to EAST WAY LLC. and vessels under their management to recognize the following risks of using VHF by learning from this accident case. In addition, if they have checklists used to navigate in narrow channels and congested waters, promote awareness by establishing items to reconfirm the risks of using VHF.</p> <p>(i) It is possible that two vessels approach each other and have no time to take actions to avoid collision in case the agreement is not executed if those persons conning the two vessels take time to agree on the conduct of vessel and the vessels underway in the original course at the original speed during that time.</p> <p>(ii) It is possible that those persons conning the vessels would believe that the other vessel would execute the contents to which they had agreed via VHF even if there is a difference between the anticipated actions of the other vessel according to the person conning the vessel and the actual actions after agreeing on the conduct of vessel and lose the opportunity to take actions to avoid collision.</p>

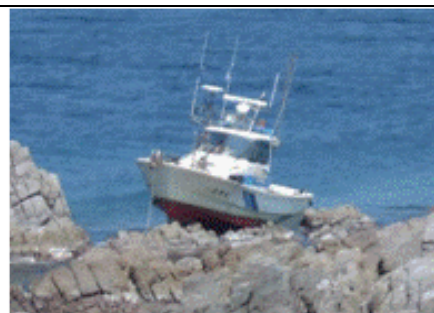
Grounding accident that occurred on August 14, 2013

In August and September 2013, three cases of recreational fishing vessels grounding on rocky areas, colliding into breakwaters, and other such serious marine accidents occurred one after another, and 15 people including passengers sustained minor to serious injuries. Furthermore, after October the same year, three cases of similar accidents continued to occur.

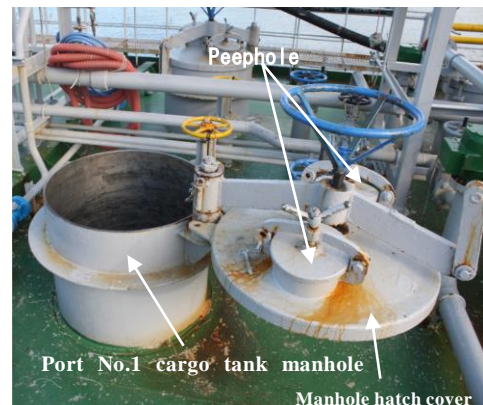
Cargo tank manhole hatch

It is probable that this accident occurred as the second officer entered the port No.1 cargo tank, where the wash water had remained with a smell of gas, and inhaled the chloroform gas when checking the inside of the tanks while the chemical tanker was heading north to the Umemachi Terminal, because AST Inc. had not made the crew well accustomed to taking careful actions when entering the cargo tank, including measurement of oxygen and other gas concentration, and also because the company had not manifestly established tank cleaning procedures in case of wash water found remaining in the cargo tank.

- 1) give their tanker crew instructions in the measurement of oxygen and other gas concentration when entering in enclosed spaces so as to make sure they implement it, and regularly visit their tankers to check that the measurement of oxygen and other gas concentration is carried out without fail;

- 2) instruct their masters to keep record of the measurement of oxygen and other gas concentration and, if a gas detector is used in the gas measurement, also keep record of the number of detector tubes purchased, used, and remaining, and regularly visit their tankers to check the record of gas concentration measurement and the detector tubes to ensure that the measurement and the recording are carried out without fail;

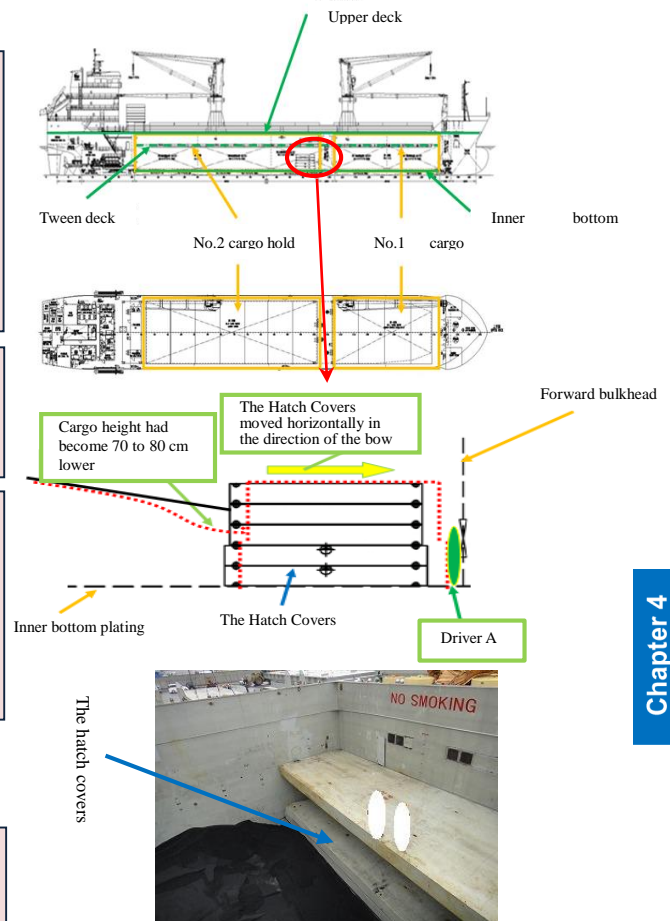
At about 14:20 on May 10, the hatch covers were pushed by cargo, and Driver A was caught between the hatch covers and the forward bulkhead.

Probable Causes: It is probable that this accident occurred for the following reasons: Five tween deck hatch covers were stacked up on the bow side of the inner bottom plating in No.2 cargo hold, during the loading of copper slag onto the ship at the Public Wharf in Hibi Port; however, the safety bolts for the lowermost and second lowermost hatch covers were not inserted into the insertion holes in the inner hull plating. Due to this fact, the situation was such that it was impossible to prevent horizontal movement of the hatch covers. Furthermore, a driver entered No.2 cargo hold through a forward companionway to the inner bottom plating of No.2 cargo hold; and when the driver was passing through the space between the hatch covers and the forward bulkhead, the hatch covers moved in the direction of the bow after being pushed by the cargo, resulting in the driver being caught between the hatch covers and the forward bulkhead.

It is probable that the reason why it was impossible to prevent horizontal movement of the hatch covers is that when the hatch covers were stacked up on the bow side of the inner bottom plating in No.2 cargo hold on the ship, they were not secured as specified in the hatch cover operating manual.

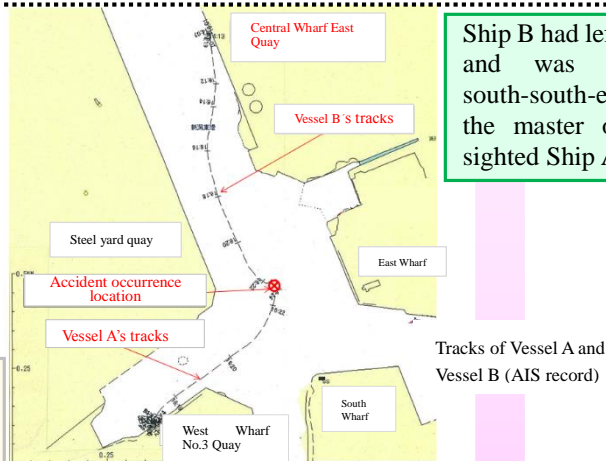
The master of Ship A felt that there was a danger of colliding, and ordered to put the bow thruster full to port at 16:20:42, stop the engine at 16:20:45, and put the engine full astern at 16:21:07.

Ship B had left the wharf and was proceeding south-south-east, when the master of Ship B sighted Ship A.

At **16:19:35**, the master of Ship B **offered** the conduct of vessel to pass on the starboard side via VHF to Ship A. (Speed at the time was 4kn)

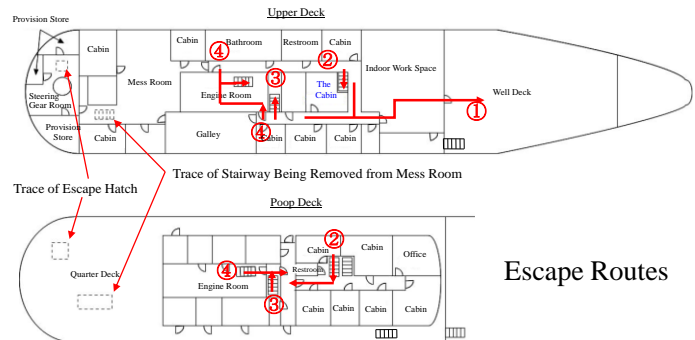
Escape Routes

Spread of fire from bedding in the cabin, believed to be caused by smoking

Ordinary Seaman A and some others heard the fire alarm go off past 01:30 on May 16, and Ordinary Seaman B notified the person-in-charge at the shipping agent of the fire via the shipper on mobile phone at about 01:40.

Some of the crew members took action to put out the fire, but it was not successful. The fire was eventually put out at about 13:00 on May 16 by firemen who had been activated after receiving a report from the shipping agent.

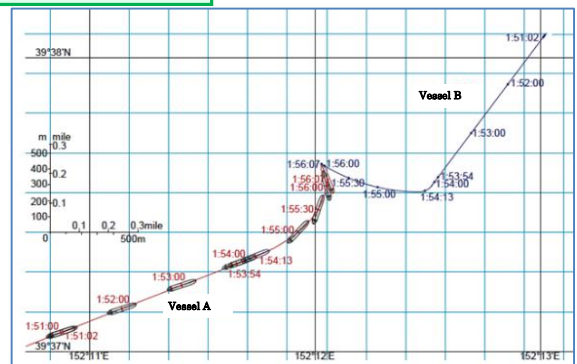
Estimates of ship tracks

The helmsman sighted the mast lights of Ship B at 01:51:02 on the port bow, and reported to the officer. The officer attempted to obtain information and images of Ship B on the radar and AIS (Automatic Identification System), but could not find it.

Contributing factors: no AIS installed on Ship B; rain, waves; and Ship B's size.
