Japan Transport Safety Board

Annual Report

2020

July, 2020

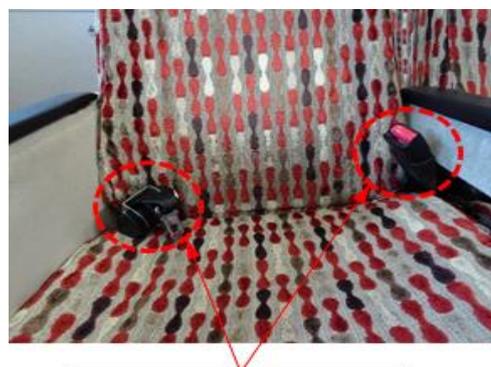
Automatic two point seat belt for the passenger ship GINGA

(hydrofoil) of the ship, and the recommendation, which recommends the Minister of Land, Infrastructure, Transport and Tourism, which is to instruct the owner of the ship to "take measures such as providing seats and seat cushions which are considered to absorb the impact force sufficiently" and "take measures such as attaching cushioning materials to the back of the seats", and the operator to "guide the elderly people to the seats where the impact of the front part of the cabin is relatively small" and "carry out regular training in case of a large number of injured persons", and the JTSB published the Accident Investigation Report on March 26, 2020.

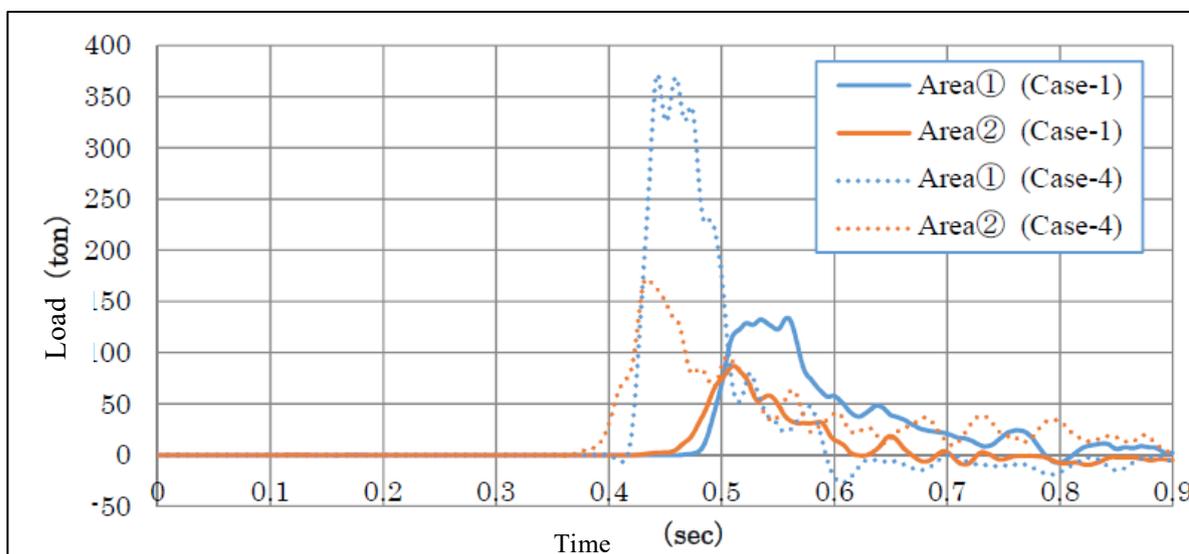
Besides from the viewpoint of confirming the soundness of fuse pins, which are part of the safety devices of the hydrofoil, we commissioned the National Institute for Materials Science (NIMS) to conduct an analysis survey on the fracture surfaces and mutation spots of fuse pins. As a result of the analysis, it was found that the fuse pins were considered to have undergone ductile fracture due to shearing in a sound condition as designed.

Analysis of Time Series of Vertical Impact Force on the bottom of the ship

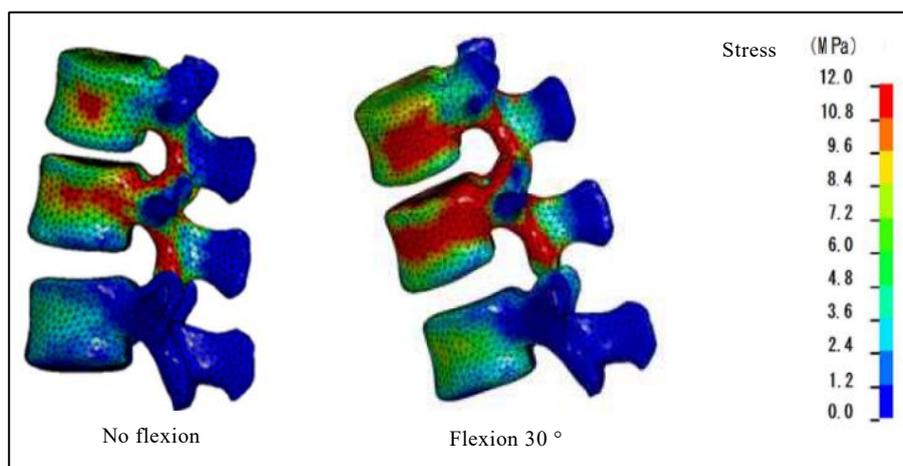
Moreover, in order to analyze the mechanism leading to lumbar vertebral fracture, Dr. Kei Watanabe, a lecturer at the Department of Orthopedic Surgery, Niigata University Medical & Dental Hospital, participated in the survey as an Expert Adviser, and worked on the analysis of how the load on the lumbar spine differs depending on the posture of passengers.

Stresses in the vertebral

In response to these analyses, the JTSB collated the cause of the accident, which is probable to be caused by a large number of passengers suffering from lumbar vertebral fracture, etc., due to the collision between the floating objects in the water and the aft foil

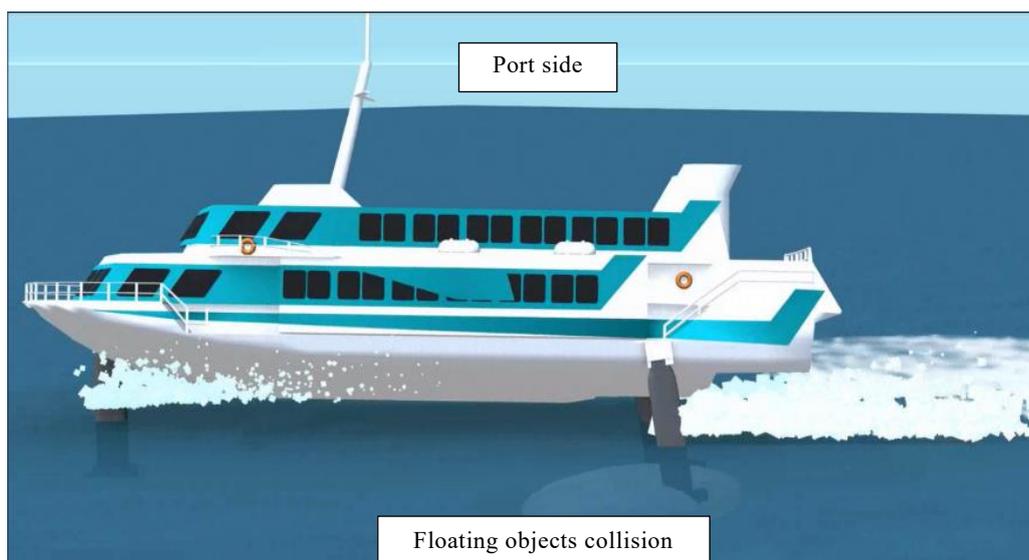
Computer graphic reproduction of ship behavior at the time of accident
(URL: <http://www.mlit.go.jp/jtsb/video/ship/2019tk0008-movie.wmv>)

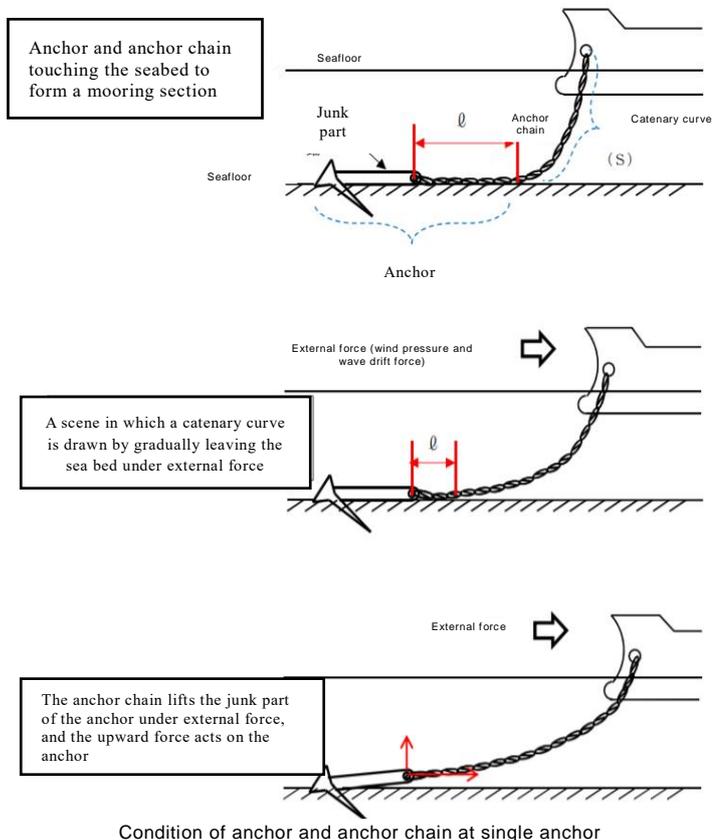
In the accident investigation (see page 2 of "Major Activities in the Past Year") in which the oil tanker collided with Kansai International Airport Access Bridge, which was published on April 25, 2019, the National Maritime Research Institute (NMRI) of the National Institute of Maritime, Port and Aviation Technology analyzed the mooring power of the concerned oil tanker and the ship anchored in Osaka Bay, as well as the wind pressure during the anchoring, by our request.

As a result of this analysis, the mechanism of anchor dragging (that the ship is carried away with the anchor thrown) was explained in an easy-to-understand manner. It also led to recommendations for safety measures (see page 21), such as ensuring sufficient mooring power with anchors and anchor chains and using the main engine on a continuous basis, in order to prevent recurrence of similar

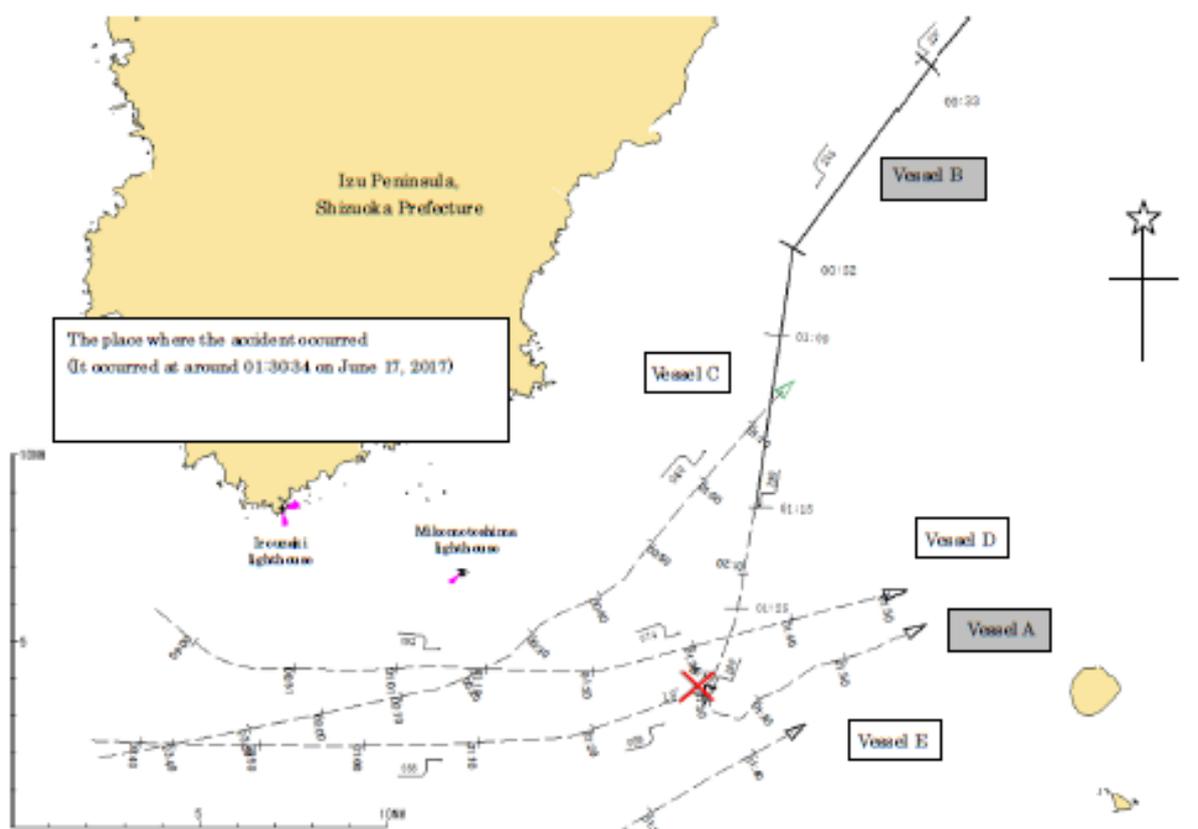
The United States Coast Guard, which was commissioned by the Maritime Safety Investigation Authority (NTSB) of the United States of America, provided investigation data for the collision accident investigation of the container ship ACX CRYSTAL (Vessel A) and the missile destroyer USS FITZGERALD (Vessel B), for which the report was published on August 29, 2019. Along with various information collected by the marine accident investigators of the Japan Transport Safety Board and technical advice from research institutes in Japan, the JTSB has been able to organize and analyze factual information and put together the causes and preventive measures. It was the first time the Japan Transport Safety Board had obtained and reflected detailed information on accidents involving U.S. Navy vessels in its report.

Estimated Route Chart of Vessel A and Vessel B

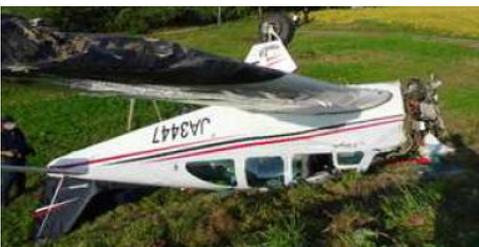
1	Date of Publication	Date and location	Operator	Aircraft registration number and aircraft type
	January 31, 2019	October 8, 2017 Semine Temporary Airfield in Kurihara City, Miyagi Prefecture.	Privately Owned	JA3447 BEEHCRAFT E33 (Small aeroplane)
	Summary	<p>The aircraft overran the runway after rejecting the take-off at Semine Temporary Airfield in Kurihara City, Miyagi Prefecture. It rolled over to a paddy field and suffered damage to its airframe. One passenger was seriously injured.</p>

Probable Causes	<p>It is highly probable that in this accident, the aircraft overran the runway after rejecting the take-off, rolled over to a paddy field, and suffered damage to its airframe.</p> <p>It is also highly probable that the reason why the aircraft overran the runway was because the weight of the aircraft exceeded the weight with which the aircraft would be able to safely take off within the range of the runway length at the airfield, and the remained distance to the runway end was reduced, leading to a delay in making a decision of rejecting the take-off.</p>

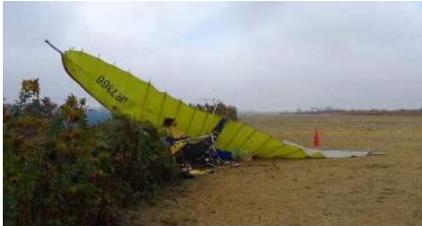
Summary	<p>The aircraft crashed while flying near the Ubuyama temporary airfield in Ubuyama Village, Aso-gun, Kumamoto Prefecture after taking off from Ubuyama temporary airfield for leisure. The aircraft was destroyed and a pilot died.</p>		
	Probable Causes	<p>In this accident, it is somewhat likely that the aircraft stalled while it was repeatedly going up, down and turning at a low AGL altitude, and it could not recover, so it collided with the ground with the nose down attitude and crashed.</p>

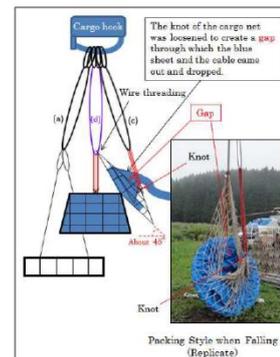
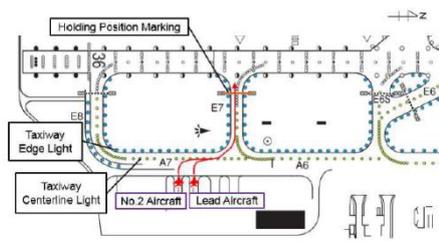
Report	https://www.mlit.go.jp/jtsb/eng-air_report/52-8850_32-8818_JA84RC.pdf		
8	Date of Publication	Date and location	Operator	Aircraft registration number and aircraft type
	September 26, 2019	June 29, 2018 Narita international airport	Korean Airlines Co., Ltd.	HL7573 Boeing 777-300 (Large aeroplane)
	Summary	The aircraft had the right main landing gear aft axle fractured when landing at Narita international airport. Consequently, the aircraft was forced to halt and was unable to continue taxiing on the taxiway.

Probable Causes	<p>It is certain that the aircraft had the right main landing gear aft axle fractured when landing in the serious incident, and subsequently, it was forced to halt on taxiway and could not continue taxiing.</p> <p>It is highly probable that the fractured axle was attributed to the SCC originated from the corrosion generating on the pivot bore and ongoing operations of the aircraft thereafter with cracking occurred.</p> <p>It is highly probable that the corrosion generated on the pivot bore was contributed by water penetration caused by the torn fillet seal due to rotation of the bushings and corrosion inhibitor that was not applied.</p>		
	Report	<p>https://www.mlit.go.jp/jtsb/eng-air_report/HL7573.pdf https://www.mlit.go.jp/jtsb/aircraft/p-pdf/AI2019-6-1-p.pdf (Explanatory Materials)</p>		
	Reference	Case Studies (page 70)		
9	Date of Publication	Date and location	Operator	Aircraft registration number and aircraft type

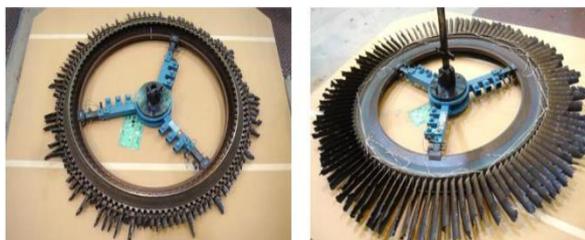
October 31, 2019	September 5, 2017 Tokyo International Airport	Japan Airlines Co., Ltd	JA743J Boeing 777-300 ER (Large aeroplane)
	Summary	<p>On Tuesday, September 5, 2017, a Boeing 777-300 ER, registered JA743J, operated by Japan Airlines Co., Ltd., had noise generating from the No. 1 engine (the left engine) along with indication of occurrence of engine failure illuminated on instruments immediately after take-off from runway 34R at Tokyo International Airport, and consequently, shut down the engine and returned to the airport for landing after obtaining a priority from air traffic control.</p> <p>The inspection conducted after landing revealed that multiple stages of stator vanes and turbine blades in low pressure turbine (LPT) of the engine were damaged and a hole was confirmed to have been generated in turbine rear frame.</p>		
	Probable Causes	<p>It is highly probable that the serious incident was caused by collisions of some of fragments with turbine rear frame (TRF), which led to generating the hole due to damage to multiple stages of stator vanes and turbine blades of low pressure turbine (LPT) of No. 1 (left side) engine immediately after take-off.</p> <p>It is highly probable that damage to multiple stages of stator vanes and turbine blades of low pressure turbine was contributed by the fracture of one of LPT fifth stage stator vanes.</p> <p>It is highly probable that the fracture of one of LPT fifth stage stator vanes was contributed by the crack generated by stress concentration caused by arch-binding, which progressed to the fracture by repetitive stress associated with engine operation.</p>

Damaged condition of LPT fifth stage disk and blades (left) and sixth stage disk and blades (right)

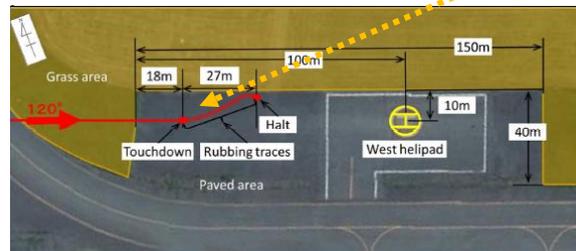
Damaged antenna mounting

Probable causes: In this accident, it is highly probable that the helicopter experienced hard landing without stopping its descent speed and damaged the air frame, when the helicopter was executing autorotation Full Landing, because of the delayed commencement of deceleration and improperly subsequent maneuvering.

The instructor should cancel the autorotation when the instructor recognized the deceleration could not be commenced at an altitude according to the prescribed procedure.

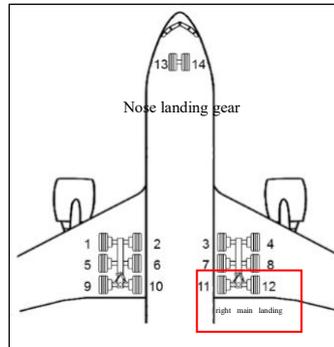
Damage to Aircraft

(Slightly damage) •The R-MLG AFT Axle was fractured. •The R-MLG Truck beam was damaged. •The R-MLG Steering system was damaged. •Hydraulic hoses of Brake and the Steering system were cut. •Hydraulic system fluid leaked. •Brake components were damaged. •Electric cables and junction box of the R-MLG were damaged.

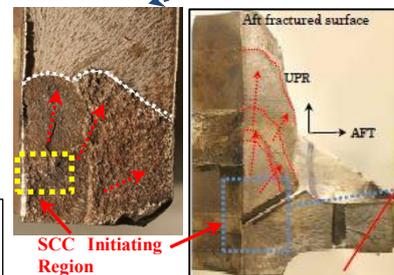
Situation of main damages to aircraft (The R-MLG AFT Axle was fractured)

- The entire fractured surface of the front side of the pivot discolored black due to the corrosion.
- It was confirmed that a partially black-discolored portion due to corrosion and a grey new metal surface were confirmed on the fractured surface of the aft side of the pivot.

The forward fractured surface had an initiating region of corrosion on the lower side of the pivot bore, then was generating SCC and finally was fractured due to repetitively imposed loads.

The fillet seal was damaged due to the rotation of the bushings, which allowed water to penetrate between the pivot bore and the bushings.

The aft fractured surface was caused by SCC initiated by the corrosion generated on the lubrication passage, which then led to progressing cracking due to repetitively imposed loads.

It is highly probable that the fractured axle was attributed to the SCC originated from the corrosion generating on the pivot bore and ongoing operations of the aircraft thereafter with cracking occurred.

It is highly probable that the corrosion generated on the pivot bore was contributed by water penetration caused by the torn fillet seal due to rotation of the bushings and corrosion inhibitor that was not applied.

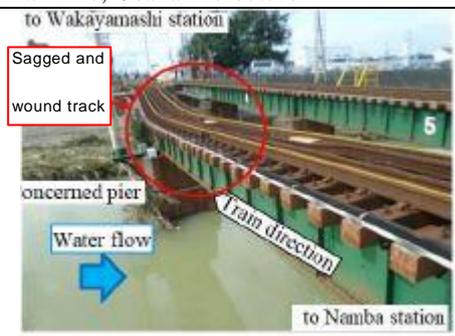
1	Date of Publication	Date & Accident type	Railway operator	Line section (location)
	January 31, 2019	October 22, 2018 Train derailment	Nankai Electric Railway Co., Ltd	Between Tarui station and Ozaki station, Nankai Line, Osaka Prefecture
	Summary	<p>October 22, 2017, the outbound Local 6867 train, composed of 4 vehicles started from Namba station bound for Wakayamashi station, Nankai Line of Nankai Electric Railway Co.Ltd., departed from Tarui station on schedule at 16:38. While the train was operated in coasting at about 70 km/h on Onosatogawa bridge, the driver of the train noticed that the track about 50 m ahead had sagged, and applied the brake immediately but the train passed the sagged track and stopped after running for about 250 m.</p> <p>It was found in the investigation implemented after the occurrence of the accident, that the 2nd axle in the rear bogie of the 3rd vehicle of the train derailed to right on Onosatogawa bridge, and had restored after that. Hereinafter, the words "front", "rear", "left" and "right" are used based on the running direction of the train.</p> <p>In addition, the pier No.5 of the down track of Onosatogawa bridge had been subsided and tilted, and the track had been sagged and wound.</p> <p>There were about 250 passengers and 2 train crews, i.e., the driver and the conductor, onboard the train, among them 5 passengers were injured.</p> <p>Here, it had been raining in wide area in the southern area of Osaka Prefecture including the accident site, as the front crossed the southern coast of the main island of Japan was activated by the Heisei 29th year Typhoon No.21 which was moving northward in south of Japan, on the day of the occurrence of the accident.</p>

Probable Causes	<p>It is highly probable that the accident occurred as the 2nd axle in the rear bogie of the 3rd vehicle had derailed to right because the train was running on the track on the bridge significantly deformed by the subsided and tilted pier, after that, the derailed axle restored in the level crossing while passed as being derailed.</p> <p>It is probable that the pier had subsided and tilted because the ground in around the pier was scoured in wide area by the swollen river water at the time of the occurrence of the accident, while the function to protect the piers from scouring had already been deteriorated before the occurrence of the accident, such as the subsided riverbed in around the pier caused by the concentration of the river water due to the change of the water route, damages of the foot protection as the scour protection work, etc.</p> <p>It is probable that the deterioration of the function to protect scouring was related with that the measures such as the repair, reinforcement, etc., of the foot protection were not implemented, because the evaluation for the unusual status were not implemented sufficiently, even though the unusual status of the foot protection of the pier was recognized in the inspection of the piers.</p>

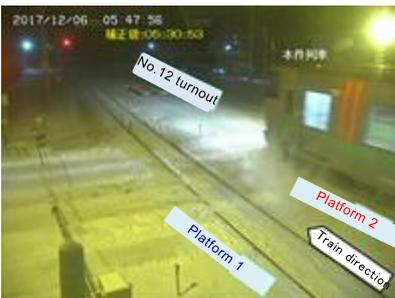
Probable Causes	<p>It is probable that the accident occurred as the left wheel of the 1st axle in the front bogie of the 1st vehicle climbed up the left rail, i.e., the outer rail, and derailed to left, while the train Japan Transport Safety Board was passing the level crossing in the premises of the station, located in the right curved track in the refuge track for inbound and outbound trains where the frequency of train operation was low.</p> <p>It is somewhat likely that the derailment was caused as the wheel flange climbed up the compacted snow which had existed on the rail and the flangeway in the level crossing.</p> <p>It is somewhat likely that the compacted snow had been formed as it snowed hard in the previous day of the accident in the situation that the temperature around 0 °C had been continued, and the snow had been trodden hard by the automobiles passing the level crossing road in the long interval between the concerned train and the train operated just before the concerned train. In addition, it is somewhat likely that the compacted snow formed on the rail and the flangeway had been remaining without removed, because the snow removal works had not been implemented before the concerned train passed.</p> <p>It is somewhat likely that the snow removal works had not been implemented related with that the accident occurred before the period to prepare the snow removal formation in winter, that the status check of the level crossing had been implemented by the simple inspection such as the visual inspection, etc., and that the interval of the train operation was not considered well in the onsite confirmation and in the judgement to implement the snow removal work.</p>

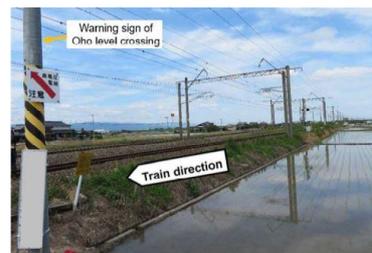
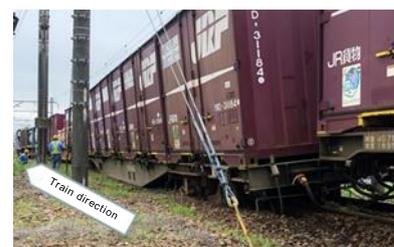
Probable Causes	<p>It is probable that the accident occurred as all four axles of the wagon, the 4th vehicle from the front, derailed because the gauge widened while the freight train composed of 19 vehicles</p>

<p>was running in around the 106-B turnout in the premises of Soga station.</p> <p>It is probable that the gauge in around the 106-B turnout widened due to the decreased rail fastening force caused as the Japan Freight Railway Company, who was in charge of the management of track maintenance, had not implemented the measures such as the replacement of sleepers or the repairing work, etc., although the sleepers, which had been judged as inferior in the periodic inspection, existed continuously.</p> <p>It is somewhat likely that Japan Freight Railway Company had not implement the measures such as the replacement of the sleepers or the repairing work, etc., because it had not recognized the dangerous situation against the gauge widening well, as the irregularity of gauge measured under unloaded condition in the periodic inspection was within the maintenance standard value.</p>		
	Report	<p>http://www.mlit.go.jp/jtsb/eng-rail_report/English/RA2019-4-1e.pdf http://www.mlit.go.jp/jtsb/railway/p-pdf/RA2019-4-1-p.pdf (Explanatory materials)</p>

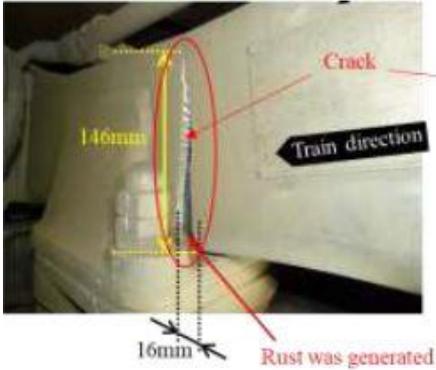
<p>Probable Causes</p>	<p>It is highly probable that the concerned serious incident occurred because the gear type flexible shaft coupling displaced exceeding the allowable range and damaged due to deformation of the bogie frame caused by the crack which had generated in the side beam of the bogie frame of the vehicle and had expanded by fatigue. The crack had generated in the side beam of the bogie frame of the vehicle because it is somewhat likely that the split had generated in around the back boundary of the slot welded part where the crack had originated when the welding work had implemented. In addition, it is highly probable that the crack had generated related with the followings.</p> <p>(1) The residual stress was generated in around the slot welded part due to the implementation of the overlay welding on the bottom surface of the axle spring seat after annealed.</p> <p>(2) The thickness of the bottom plate of the side beam had become thinner than the designed standard value, because the bottom surface of the side beam had been grinded excessively when attached the axle spring seat to the bottom plate of the side beam.</p> <p>In addition, it is highly probable that the crack had expanded in the period shorter than the vehicle life, i.e., the usable period of the bogie, because the expanding speed of the crack became faster as the thickness of the bottom plate of the side beam became thinner due to the excessive grinding works implemented in the bottom plate of the side beam.</p> <p>Here, it is highly probable that the bottom plate of the side beam was grinded excessively related with that the problem, that the machining work was required to attach the axle spring seat due to the swell in the bottom surface of the side beam generated in the manufacturing process of the bogie frame, was dealt without studying the essential causes and counter measures, and the manufacturing works had implemented without well understandings on the instructions for the work related to the strength of the bogie frame.</p>

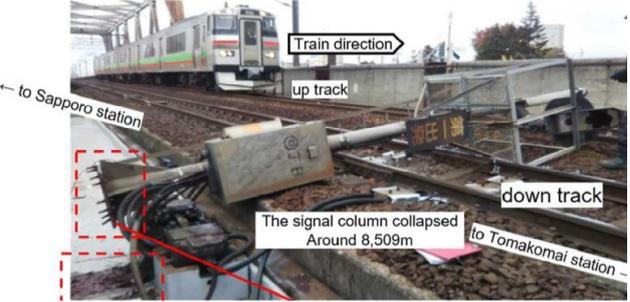
<p>Probable Causes</p>	<p>It is probable that the concerned serious incident had occurred because there was the inferior construction work as the insufficient cleaning in the hole after drilled into concrete body in the construction work of the metal extension anchor based on the "after constructing anchor method", in the planting work of the down line No.1 starting signal column.</p> <p>It is probable that the metal extension anchor was in the status as insufficient tolerance against tensile force because the cone of the metal extension anchor had not expanded the swelling part of the anchor due to the inferior construction work when the signal column had been planted.</p> <p>Therefore, it is somewhat likely that the signal column had collapsed because the external force exceeded the tolerance of the metal extension anchor fixing the signal column of the home signal, as the anchor of the metal extension anchor was loosening gradually, caused by vibration due to running trains on the viaduct in addition to the effects of the external force such as windstorm, earthquake, etc., in the period of about 38 years from planting, in the status that the metal extension anchor supporting the signal column had been insufficient endurance against tensile force, in cooperation with the wind pressure of about 20 m/s instantaneous wind speed on the collapsed day.</p>

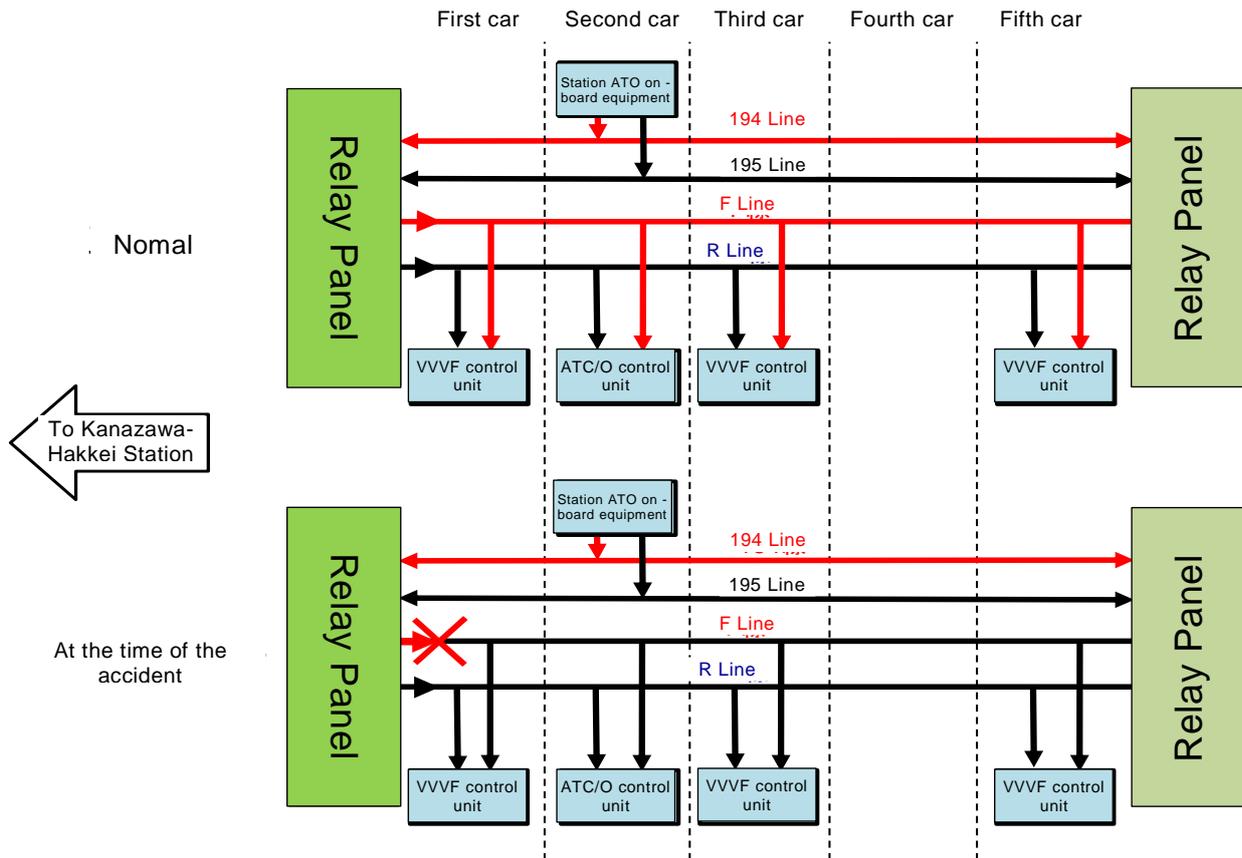
Figure 3 : Schematic diagram of vehicle related wiring (red line indicates pressurization when traveling direction is down)

(2) Lines F and R were routed through the entire 5 - car train, and the disconnection of Line F was found near the rear end of the first car (on the connecting side with the second car), and one of the disconnection parts was welded to the member on the car body side.

(4) The traveling direction is set by the on-board equipment of the station ATO, and a voltage (100 V) is applied to the F line or R line through a relay to transmit the traveling direction to the VVVF controller. However, the condition of the F line was not transmitted to all the VVVF controllers due to the disconnection of the F line.

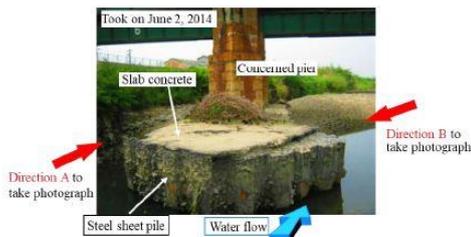
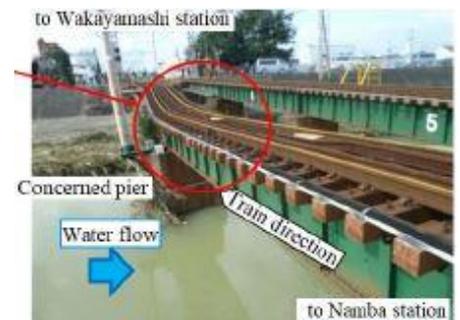
The damages had started from the part of the soldier beams and lagging structure using the log piles and the wooden plates, where it was fragile compared to the steel sheet piles, as the riverbed had been subsided and the foot protection had been exposed due to the erosion by the flowing water after 2008.

The side surface of the footing had been exposed by the deterioration of the washed away cobble stones, etc., between 2012 and 2014.

Probable causes : It is highly probable that the accident occurred as the 2nd axle in the rear bogie of the 3rd vehicle had derailed to right because the train was running on the track on the bridge significantly deformed by the subsided and tilted pier, after that, the derailed axle restored in the level crossing while passed as being derailed.

It is probable that the pier had subsided and tilted because the ground in around the pier was scoured in wide area by the swollen river water at the time of the occurrence of the accident, while the function to protect the piers from scouring had already been deteriorated before the occurrence of the accident, such as the subsided riverbed in around the pier caused by the concentration of the river water due to the change of the water route, damages of the foot protection as the scour protection work, etc.

It is probable that the deterioration of the function to protect scouring was related with that the measures such as the repair, reinforcement, etc., of the foot protection were not implemented, because the evaluation for the unusual status were not implemented sufficiently, even though the unusual status of the foot protection of the pier was recognized in the inspection of the piers.

It is required to judge the healthiness by comprehending the unusual status of the scour protection works such as the status of the riverbed and the foot protection, etc., from the viewpoints to maintain the function of the scour protection works against the swollen water, for the piers which the significant reduction of the natural frequency was not found at that time.

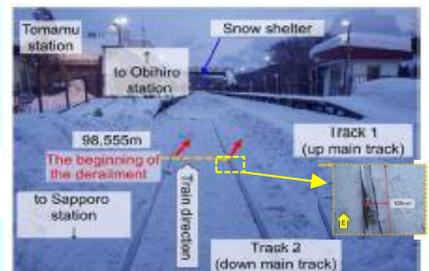
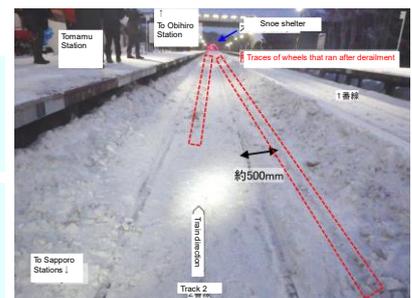
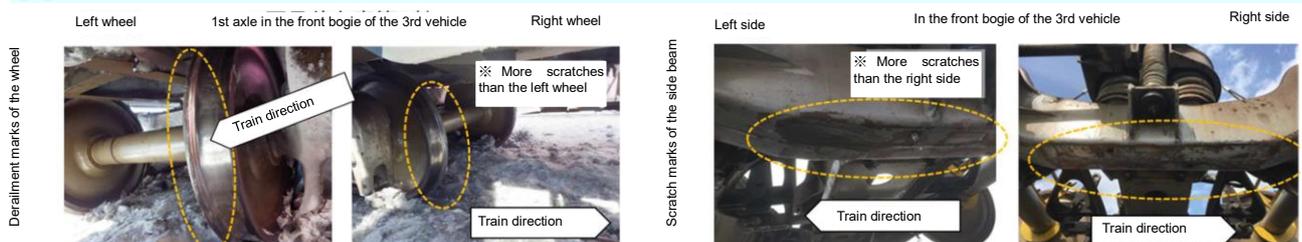
Probable cause: It is probable that the accident occurred as the flange of the right wheel of the 1st axle in the front bogie of the 3rd vehicle climbed over the right rail and derailed at the place where large amount of ice and snow were stacked on the track, while the train was passing the straight track section in the premises of the station, and after that the train restored in the turnout while passing in the status as derailed. It is somewhat likely that the 1st axle in the front bogie of the 3rd vehicle of the train derailed because the side beam of the front bogie of the 3rd vehicle was pushed up over the ice and snow stacked on the railway track, at the same time, the wheel flange was raised up by the hard ice and snow which had existed in around the flangeway. It is somewhat likely that large amount of ice and snow had been stacked on the railway track in around the place where the derailment accident occurred, related with a large amount of snow fall and stacked snow in the previous day of the concerned accident, and that the snow removal works had not been implemented for 6 days before the occurrence of the accident.

It is considered necessary to remove snow from railway tracks at a higher frequency in consideration of the conditions of snowfall, snow accumulation, and accumulated snow on the site, and to judge the appropriate timing, scope and method.

When removing snow, it is especially necessary to pay attention to the ice and snow formed higher than the rail surface on the outside of the track gauge in the railroad section where freight trains run, considering the side beam position of freight cars.

Since it is necessary for the driver to take corrective action immediately after detecting a derailment, it is desirable to develop and popularize a device that can notify the driver of the occurrence of a train derailment.

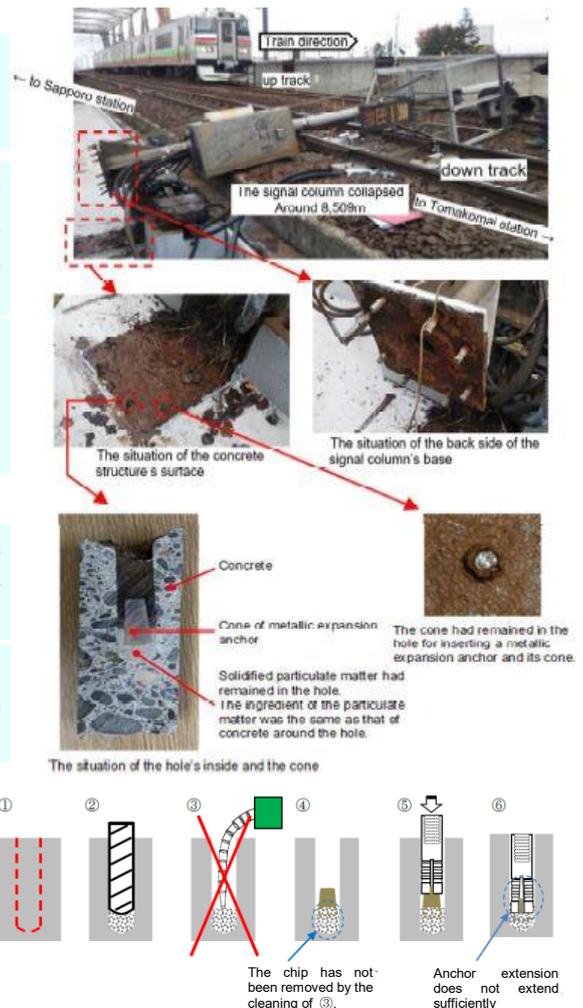
As all eight of the metal expansion anchors to which the traffic signal pole was fixed were removed from the concrete body, and the cone remained in the perforation of the concrete body, it is probable that all eight anchors had the same construction conditions.

Judging from the condition of the cone inside the perforation of the concrete body, it is highly probable that the worker cast the anchor of the metal expansion anchor in the condition that chips, etc. remained at the bottom because the cleaning inside the perforation was insufficient.

Probable Causes: It is probable that the concerned serious incident had occurred because there was the inferior construction work as the insufficient cleaning in the hole after drilled into concrete body in the construction work of the metal extension anchor based on the "after constructing anchor method", in the planting work of the down line No.1 starting signal column.

It is probable that the metal extension anchor was in the status as insufficient tolerance against tensile force because the cone of the metal extension anchor had not expanded the swelling part of the anchor due to the inferior construction work when the signal column had been planted.

Therefore, it is somewhat likely that the signal column had collapsed because the external force exceeded the tolerance of the metal extension anchor fixing the signal column of the home signal, as the anchor of the metal extension anchor was loosening gradually, caused by vibration due to running trains on the viaduct in addition to the effects of the external force such as windstorm, earthquake, etc., in the period of about 38 years from planting, in the status that the metal extension anchor supporting the signal column had been insufficient endurance against tensile force, in cooperation with the wind pressure of about 20 m/s instantaneous wind speed on the collapsed day.

Since it is difficult to find out any problems after construction, it is desirable to carry out the construction surely after satisfying the conditions described in the guide, etc., and it is desirable that the construction is carried out by the worker with the work qualification, and that the record of the construction content, etc. is left.

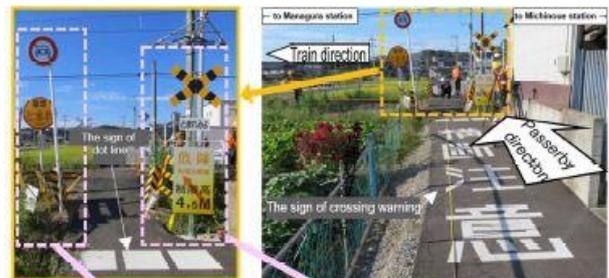
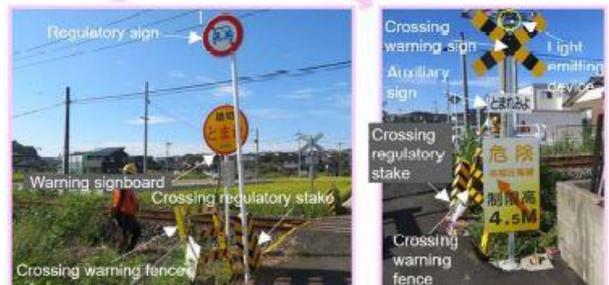
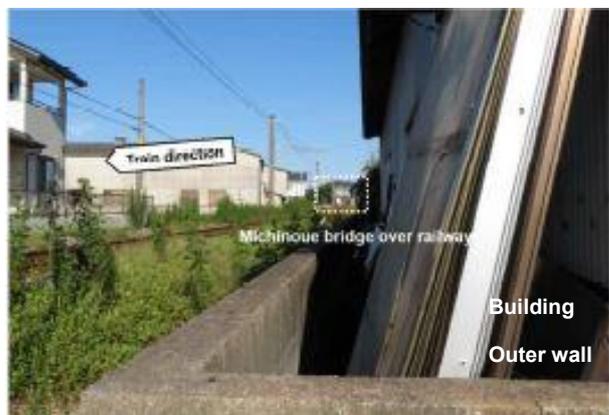
After the previous accident, the level crossing warning signs were replaced, color plates were attached to the level crossing warning fence, and road markings were carried out. Therefore, it is probable that the level crossing had been maintained so that passers by could easily notice the existence of the level crossing.

In the traffic safety education at the elementary school where the passers - by went, it is somewhat likely that there were some children who did not know the existence of the level crossing, there was no instruction that there was a class 4 level crossing in the school district and it was necessary to cross carefully.

It is somewhat likely that, from the child's point of view, it was not possible to easily recognize that "the warning sound did not sound and the crossing gate did not descend, but the train might be dangerous if it approaches and crosses over." Therefore, it is considered probable that sufficient measures were not taken in terms of facilities in consideration of the child's point of view and in terms of education concerning the existence of the class 4 level crossing.

Probable Causes: It is certain that the accident occurred as the train collided with a bicycle because the passerby riding bicycle entered Iwasakinoichi level crossing, class 4 level crossing without automatic barrier machine nor road warning device, in the situation that the train was approaching. It could not be determined why the passerby riding bicycle entered the level crossing in the situation that the train was approaching, because the passerby was dead in the accident, although it is somewhat likely that the passerby did not recognize the approaching train.

Expected Measures to Prevent the Recurrence:

- Necessity of the traffic safety education on the class 4 level crossing based on the viewpoint of the children.
- Necessity of the measures in the region where the population is increasing.

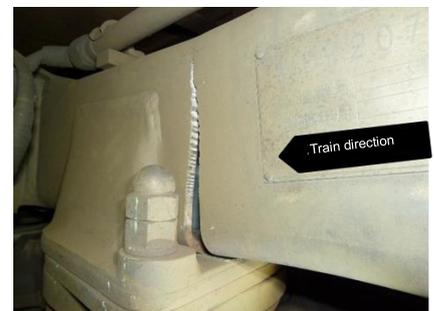
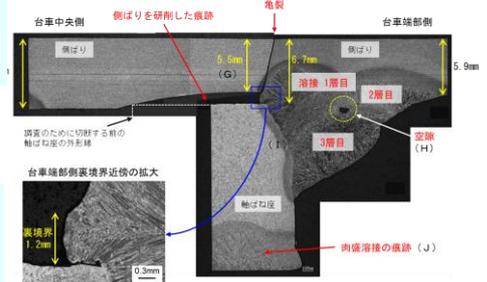
It is highly probable that the crack, the broken surface in around the slot, was not expanded in a short period.

It is considered somewhat likely that the crack was not detected because the crack was not opened because the inspection was carried out in a non-loaded condition with the bogie frame as a single unit during the general inspection and no abnormality was found in the dimensional inspection.

It is probable that on the previous day, the crack had developed to the extent that it affected the rigidity of the side beam, and that the crack had further expanded to the extent that the side beam was deformed during the operation on the day and affected the bogie components.

Probable Causes: It is highly probable that the concerned serious incident occurred because the gear type flexible shaft coupling displaced exceeding the allowable range and damaged due to deformation of the bogie frame caused by the crack which had generated in the side beam of the bogie frame of the vehicle and had expanded by fatigue.

The crack had generated in the side beam of the bogie frame of the vehicle because it is somewhat likely that the split had generated in around the back boundary of the slot welded part where the crack had originated when the welding work had implemented. In addition, it is highly probable that the crack had generated related with the followings.

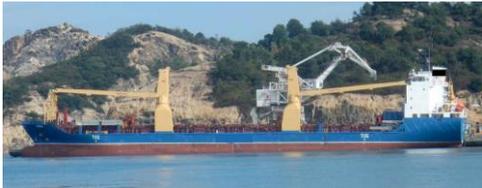
Summary	<p>While the vessel was moored at the Mitsubishi Naoshima wharf, with the master and 14 crew members on board, 4 crew members were performing the cleaning work of the upper hatch coaming of the cargo holds after unloading cargo, and an able seaman fell from the upper deck to the bottom floor of the cargo hold and dead.</p>

Probable Causes	<p>It is considered probable that this accident occurred because Crew Member A who was working while being in an unstable posture on the Ladder fell forward and fell from the upper deck to the bottom of the cargo hold bottom when he doing the cleaning work while the vessel was moored at Mitsubishi Naoshima wharf.</p> <p>It is considered probable that the vessel carried out the cleaning work by the methods that differed from the Ladder guidelines of the CSWP, and that because there was nothing to support his upper body on the Ladder, Crew Member A was performing the cleaning work while being in an unstable posture on the Ladder.</p> <p>It is somewhat likely that Company A was insufficient in monitoring that the crew members clearly understood the Ladder guidelines of the CSWP and then applied and performed the Ladder guidelines in the cleaning work, because the vessel carried out the working methods being different from the Ladder guidelines in everyday work.</p>

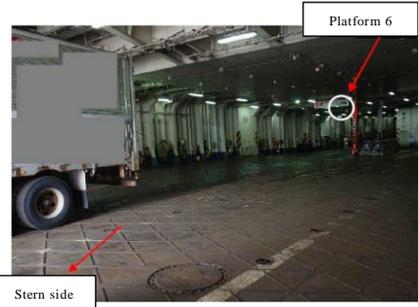
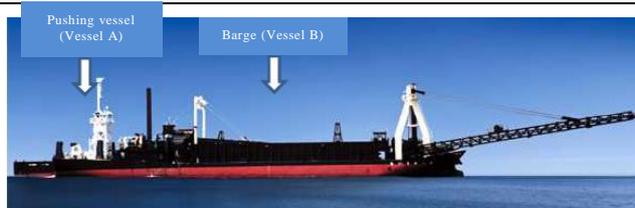
Summary	<p>Vessel A was drifting off the south-southwest of Cape Ashizuri, Tosashimizu City, Kochi Prefecture, with the master, the officer and 16 crew members on board. Vessel B, on the other hand, was proceeding east-northeast toward Tokyo Area, Keihin Port, with the master B and 4 crew members on board. Vessel B collided with Vessel A off the south-southwest of Cape Ashizuri.</p> <p>Vessel A had a hole, etc. on the port side rear hull and Vessel B suffered a collapse on the bow.</p> <p>There were no casualties on both ships.</p>	
	Probable Causes	<p>It is probable that in this accident, while Vessel A was drifting off the south-southwest of Cape Ashizuri for the purpose of time adjustment and Vessel B was proceeding east-northeast by autopilot, Master B, who was on the bridge watch alone, fell asleep Vessel B collided with Vessel A.</p> <p>It is probable that the reason why the Master B fell asleep was that the level of awareness was lowered because he had accumulated fatigue during the long-term boarding, because there were few ships around the Vessel, because he sat on a chair and was on duty with autopilot, and because he thought that the alarm would be activated even if he fell asleep.</p> <p>It is somewhat likely that the Bridge Navigational Watch Warning System of Vessel B detected the movement of the body and legs of Master B, who fell asleep, and therefore the alarm did not work. It is probable that this fact contributed to the occurrence of the accident.</p>

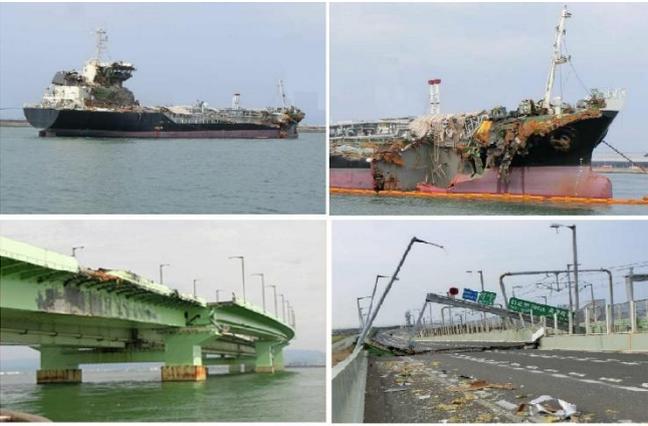
<p>Probable Causes</p>	<p>In this accident, the Vessel continued single anchoring at the east side of the Oil Tanker Berth (hereinafter referred to as "the Anchorage") located on the southwest side of the Senshu Port in Osaka Prefecture, where Kansai International Airport Access Bridge is located about one nautical miles north of the southeast of the 'Kansai International Airport First Stage Airport Island' (hereinafter referred to as "the Kanku Island") for the purpose of typhoon evacuation, under the condition that the Typhoon No. 21 was approaching and the maritime typhoon warning was issued in the Seto Inland Sea including Osaka Bay. In addition, the Vessel continued to anchor at the Anchorage due to the strong wind and waves caused by the approaching typhoon. Besides, once the drifting stopped by using the main engine so the master continued to hold the joystick in</p>

<p>the HOVER position as a result the Vessel was forced to drift down again and collided with Kansai International Airport Access Bridge under the condition that there was no sufficient distance to control the Vessel.</p> <p>It is probable that the reason why the Vessel anchored at the Anchorage, which is located about one nautical miles north of the southeast of the Kanku Island, was that the master thought that Typhoon No. 21 would pass the east side of the Anchorage and the left semicircle of the typhoon would enter the Anchorage, that the typhoon was traveling at a high speed and that strong wind would not blow for a long time, that the area was surrounded by the shore, that the seabed material was mud and the anchor would be highly effective, that other vessels were anchoring at the time of typhoon evacuation, that the next loading was planned to be carried out in the Sakai-Senboku Area of the Hanshin Port, and that he did not know the 2011 leaflet "Let's Prevent Anchor Dragging Maritime Accident ." and did not recognize to anchor avoiding the sea area within three nautical miles from the Kanku Island.</p> <p>It is probable that the reason why the Vessel kept single anchoring at the Anchorage was that the master thought that the double anchoring would be entangled when the wind direction changed and the mooring force would decrease, and that the master had the experience of using the main engine to cope with the typhoon wind.</p> <p>It is probable that the master set the joystick in the HOVER position because he thought that the anchor was stopped when the GPS speed over the ground indicated on the radar became zero, and that the Vessel would move forward if the joystick was in the forward position.</p> <p>It is probable that the reason why the Vessel was drifted down again that, under the situation where the forward thrust was lost due to the dispersion of the propeller thrust while the joystick was kept in the HOVER position, the anchor chain left the seabed with the increase of the water depth due to the high tide, the mooring force decreased, and the wind pressure on the hull and the wave drifting force increased.</p> <p>It is somewhat likely that Hinode Shipping Co., Ltd. and Tsurumi Sunmarine Co., Ltd. were involved in the occurrence of this accident because they did not provide the master with confirmation of the rough anchoring, information on the typhoon and information on the anchorage, and did not discuss the safe operation.</p>

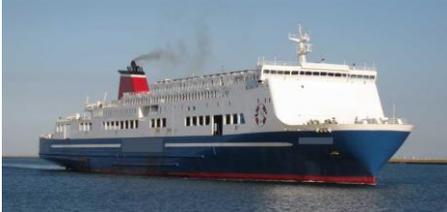
Probable Causes	<p>In this accident, it is probable that the Vessel, in the sea area west of the west exit of the Akashi Strait Passage, drifted to carry out the work of passing over the one passenger (hereinafter referred to as "the Patient"), who were lying in a state of stupor due to convulsions, to the Japan Coast Guard Patrol Craft NUNOBIKI (hereinafter referred to as "the Passing Work") at night, and while the Japan Coast Guard Patrol Craft NUNOBIKI was trying to go to the portside, the Vessel was drifted to the vicinity of the Kantama South Light Buoy due to the current, and collided with the Light Buoy because the Vessel could not secure a safe distance to pass the</p>

<p>Light Buoy.</p> <p>It is probable that the reason why the Vessel could not secure the distance to safely pass the Kantama South Light Buoy when the Vessel was pushed down toward the vicinity of the buoy by the tidal current was as follows :</p> <p>(1) The master of the Vessel was not able to continuously confirm the relative position between the Vessel and the Kantama South Light Buoy, and he did not notice the change in the direction in which the Vessel was being drifted, because he paid attention to the Passing Work. Therefore, he thought that the Vessel might pass through the south side of the Light Buoy, although he was concerned about the proximity to the Light Buoy.</p> <p>(2) The master of the Vessel had been anxious to disembark the Patient as soon as possible because the time had passed since the occurrence of the sudden illness patient, and he was thinking of continuing the Passing Work as much as possible.</p> <p>(3) When the master of the Vessel decided to operate the wing angle in order to obtain forward thrust in order to secure the distance from the Kantama South Light Buoy, he operated the wing angle step by step, because he had concerned about the influence of the rapid operation of the wing angle on the Japan Coast Guard Patrol Craft NUNOBIKI.</p>

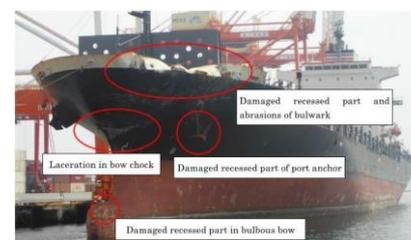
Probable Causes	It is probable that in this accident, at night, in the southeast off Irouzaki, while the Ship A was navigating for the northeast and the Vessel B was navigating for the south, the Vessel B navigated while keeping the course and speed without proper lookout for the Vessel A because the attention was paid to an ocean-going container ship, which navigated parallel in the north of the Vessel A, and the Vessel A navigated while keeping the course and speed, and therefore this accident was caused by the collision of the both vessels. It is somewhat likely that Vessel B, because the fact that the ocean-going container ship approached the starboard bow side of the Vessel B and Radar information of the Vessel A were not surely obtained, paid attention to the ocean-going container ship, which navigated parallel in the north of the Vessel A, and was not properly on the lookout for the Vessel A. It is probable that the Vessel A, because daylight signalling lamp were emitted to the Vessel B and it was expected that the Vessel B would recognize them and avoid the Vessel A, navigated

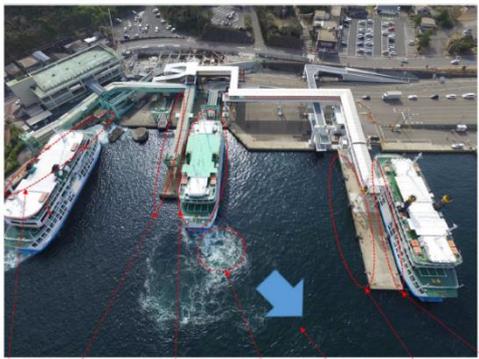
Probable Causes	<p>In this accident, it is probable that, while the Vessel was approaching Berth No.4 of the Sakurajima Port Ferry Terminal under the circumstance where discharging flow caused by propellers of the Consort Vessel at the Berth No.3, flowed from left to right on the course of the Vessel, the bow of the Vessel was pushed to the right by the water flow therefore the master set the propellers on both sides fully astern, but the starboard bow collided with the northeast end of Berth No.4 because he could not stop the coasting of Vessel.</p>

<p>It is probable that the reason why the bow of the Vessel was pushed to the right was that the Consort Vessel was pushing herself against the Berth No.3 by running the propellers on both sides, and the strength of the discharging flow generated from the propellers on the Consort Vessel was stronger than the discharging flow generated only from the propeller on one side, which is the usual way.</p> <p>It is probable that the reason why the Vessel could not stop the force to move her forward was that the master kept the Vessel close to Berth No.4 at a speed faster than the standard speed.</p> <p>It is somewhat likely that the reason why the master kept the Vessel close to Berth No.4 at a speed faster than the standard speed was that the master was accustomed to maneuvering the Vessel to approach Berth No.4 at a speed faster than the standard speed.</p>

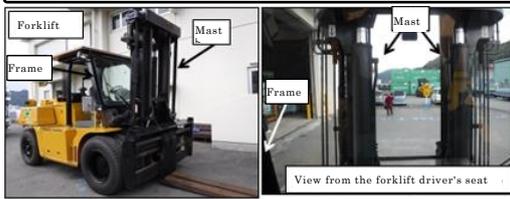
Ship Particulars : Gross Tonnage 2,502 tons, Length Over All × Width 121.00m × 16.50m
 Summary of the accident : While the cargo ferry was unloading at the quay, Officer B jumped out of the sidewalk area near the air blower and contacted the moving forklift.
 Damage : Officer B died of severe chest trauma.

Officer B did not understand that the movement of the forklift and existence of the blind spot from the driver's seat because he was about one month after he got on board.
 The vessel borrower did not provide appropriate education as stipulated in the regulations.
 Officer B did not notice that the forklift was approaching due to the noise from the air blower and other equipment.

Although Worker B noticed that Officer B was near the air blower, Officer B entered the blind spot of the forklift and was traveling at a speed of about 17km/h. He did not notice that Officer B had jumped out of the sidewalk area, and the brake operation was delayed.

- The crew members shall, in principle, walk on the sidewalk area of the vehicle deck during the loading and unloading work using the forklift. They shall also accurately grasp the surrounding conditions and shall not protrude from the shadows of the cargo. [Safety check]
- The forklift operator shall operate the forklift at a speed at which it can be stopped immediately when the forklift operator is travelling on the vehicle deck where a person is present. [Safety check]
