Japan Transport Safety Board

Annual Report

2020

July, 2020

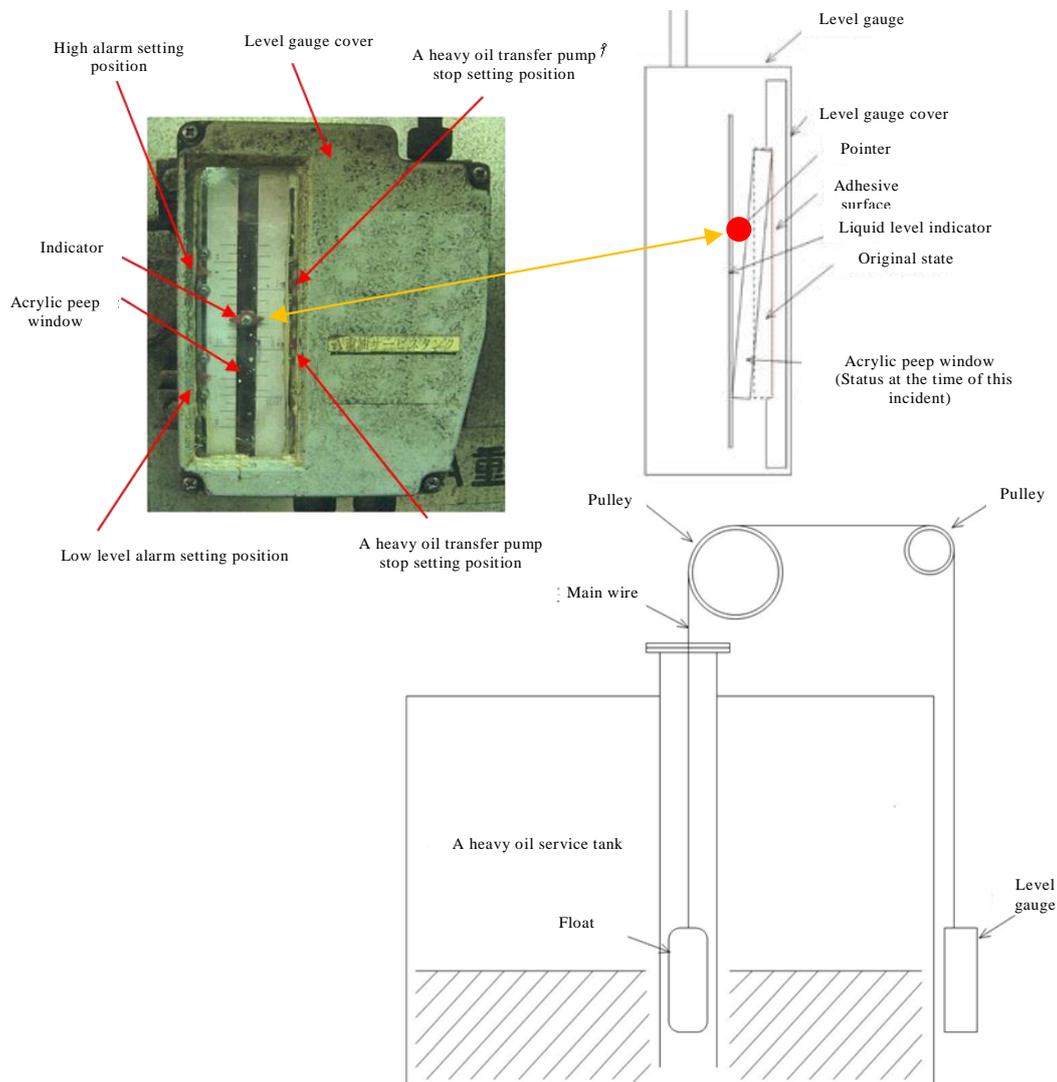
③ Cause of shutdown of the generator

- Acrylic cover installed outside
- level indicator installed independently of pump and alarm

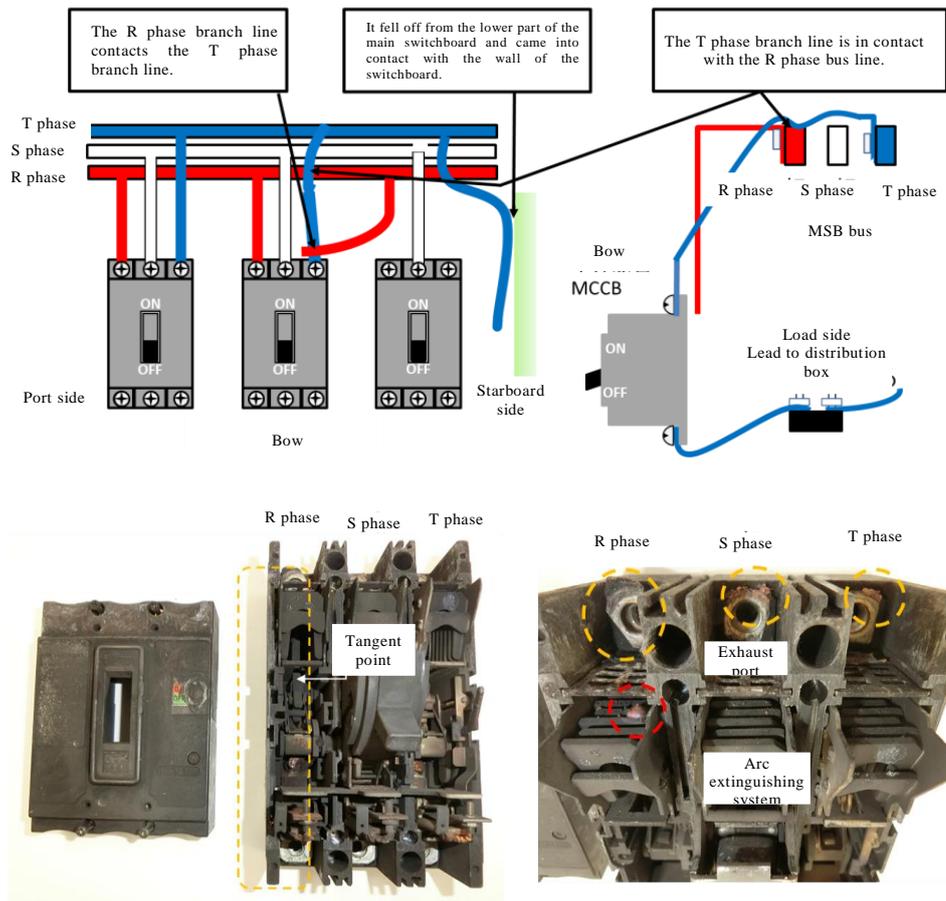
Arc gas was discharged from the molded case circuit breaker for wiring of the main switchboard which had a history that short - circuit current flowed several times due to failure on the load side and short - circuit of the electric circuit, and the bus copper band branch line was blown and jumped off, and the branch line was short - circuited to a branch line of different phase and grounded to the hull.

- MCCB Update
- Review of insulation resistance measurement methods for electric circuit

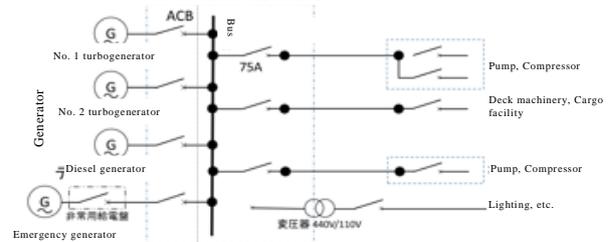
The turbine generator was unable to continue operation due to an misfire in the main boiler, the performance of the diesel generator was degraded due to contamination of the air cooler, and the emergency generator was unable to supply ACB due to an electrical system failure.

The flame of the gas - fired burner of the main boiler is extinguished.

- ✓ Turbo generator cannot be used due to reduced steam pressure
- ✓ Performance degradation of the auxiliary diesel generator
- ✓ Inability to back up emergency generators

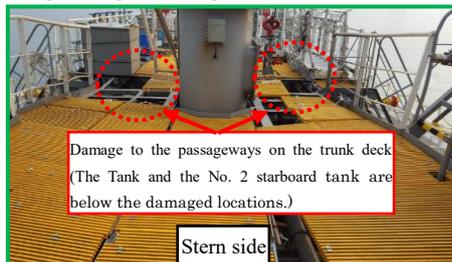
Two of GOLDEN SUNNY HANA's ordinary seamen were injured and her cargo oil tanks had holes and other damage.

(Damage looking from the top of No. 3 tank toward the bow)

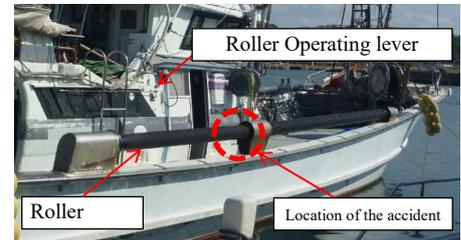
(Roller Position)

The fingertip part of the rubber glove of the chief fisherman was caught between the net during hauling and the rotating stern side roller, and then the left hand and the left arm was caught and injured (around 04:30.)

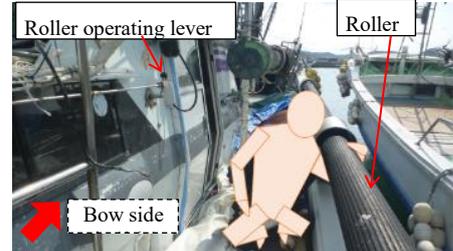
(Situation when injured)

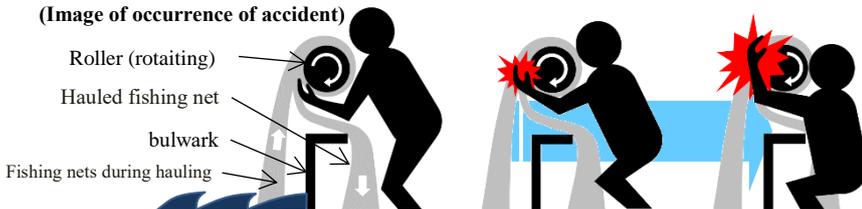
(Image of occurrence of accident)

A school of fish was unevenly distributed on the bow side, requiring manpower for hauling with the bow side roller, and the chief fisherman independently fixed the net to the stern side roller.

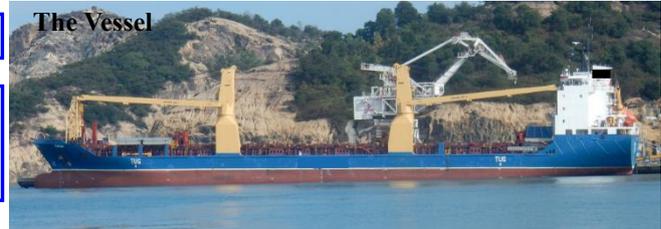
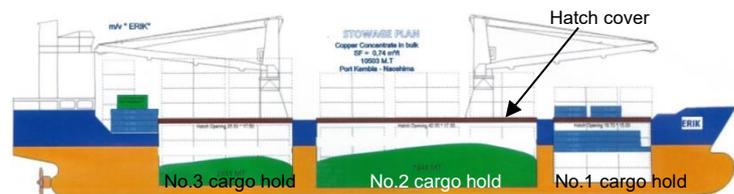
Crew Member D looked at Crew Member A, who came to be in an unstable posture and fell forward, then twisted his body and tried to clutch at the upper hatch coaming of the No. 2 cargo hold with his left hand. However, he fell head-first with his back facing downward to the bottom of the No. 2 cargo hold at around 17:26.

Fell to the bottom of the cargo hold (at around 17: 26)
