Chapter 3 Aircraft accident and serious incident investigations

9 Summaries of major aircraft accident and serious incident investigation reports (case studies)

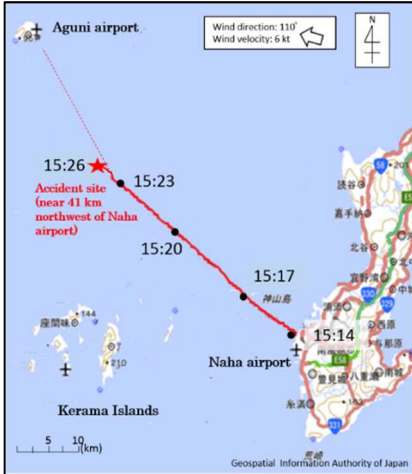
JA350D parking on the ground (right)

- It is likely that, during the flight, a GOV warning went off, the nose of the helicopter veered rightward, the rpm of the main rotor decreased and the output of the engine dropped.

- The engine’s failure to recover from its low output state was likely due to the manual throttle control (for increasing output) failed, or because adequate fuel flow could not be achieved. In the end, the helicopter subsequently sank into the water and therefore further physical investigations into the causes of the malfunction were not possible.

- It is highly probable that the captain elected to attempt an emergency water landing and therefore performed emergency operations, (i.e., sending out a mayday call and readying his emergency floatation equipment) but failed to decelerate in time and ditched the helicopter into the sea at an excessive descent rate, resulting in damage to the emergency floatation equipment and subsequent sinking of the helicopter.

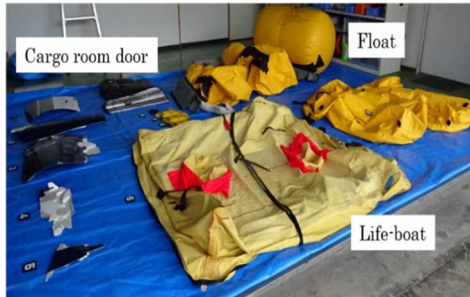
- Estimated flight route (Upper left)
- From GOV warning activation to ditching of JA350D (Upper right)
- Floating wreckage gathered (Right)
- ※ “GOV (governor)” denotes a sensing device that senses the rpm of main rotor and engine and automatically controls fuel flow in order to keep main rotor rpm constant

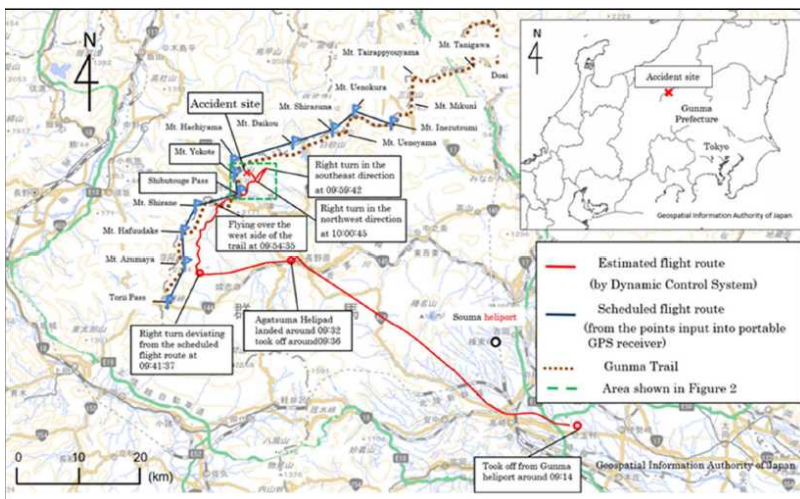
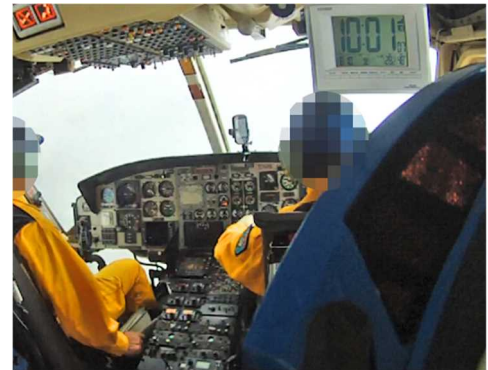
Photo taken at 10:01:07, five seconds before the crash landing (Flight controller mode change was attempted.)

- It is probable that the helicopter was heading toward mountain path Shibutoge, but due to poor forward horizontal visibility, the pilot adjusted his route toward northwest. However, he still could not maintain VMC (Visual Meteorological Condition).
- It is highly probable that, during the northwestern flight, the craft accelerated, made turns and descended beneath the clouds. The captain attempted a recovery operation, but by then the altitude was too low to recover and the helicopter crash-landed.
- It is probable that, after the linear and angular accelerations and turns of the helicopter, the captain lapsed into spatial disorientation.

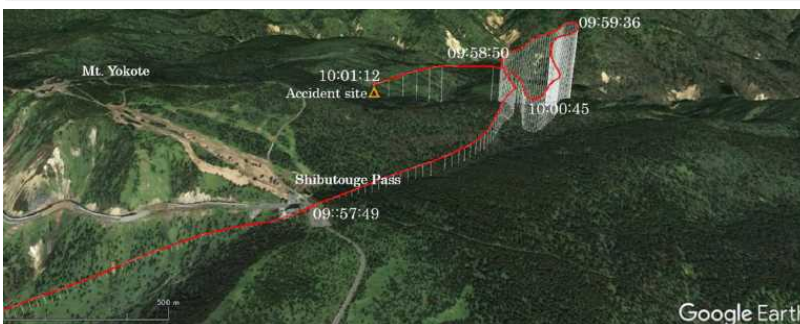
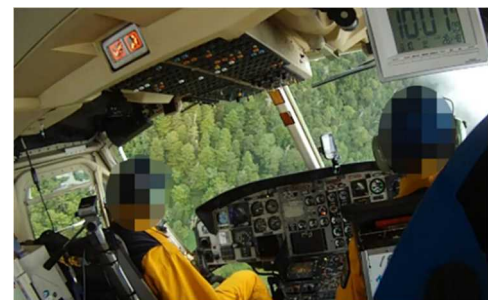
Photo taken at 10:01:09, three seconds before the crash landing (descending past the cloud)

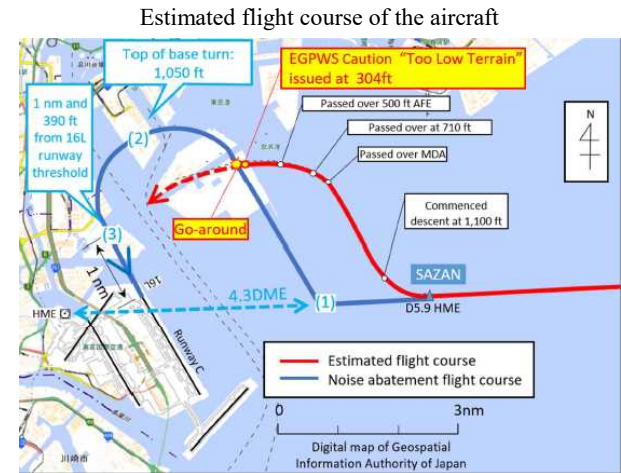
- After passing an altitude of 500 ft, the PIC kept a constant visual confirmation of the runway and continued the approach.
- Tokyo Tower advised the PIC, “Your altitude is too low, confirm that you have 16L insight,” but the PIC could not visually recognize the approach light beacon and also lost sight of 16L.

- When the pilot answered “Negative”, EGPWS warnings “TERRAIN!” went off, so he judged that the aircraft's approach was too low and executed a go-around to avoid collision with the ground.

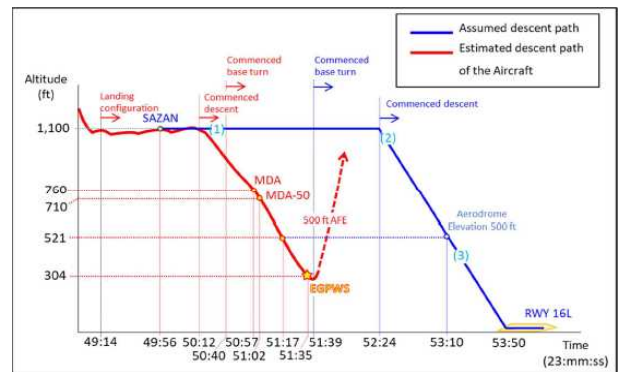
Assumed descent path and estimated descent path of the aircraft

Supplementary note: Landing at 16L via VOR-A approach is very rare—accounting for about 0.04% of the total number of landings in FY2018. Both the PIC and FO never attempted this approach at that time. Neither one had any simulator training for it. An “assumed descent route” means a descending flight route on the assumption of “after flying horizontally along the noise abatement flight course, descending at a normal descent of 3° and then landing on Runway 16L.”
