Chapter 4 Railway accident and serious incident investigations

Railway accident investigation reports published in 2021

Railway serious incident investigation reports published in 2021

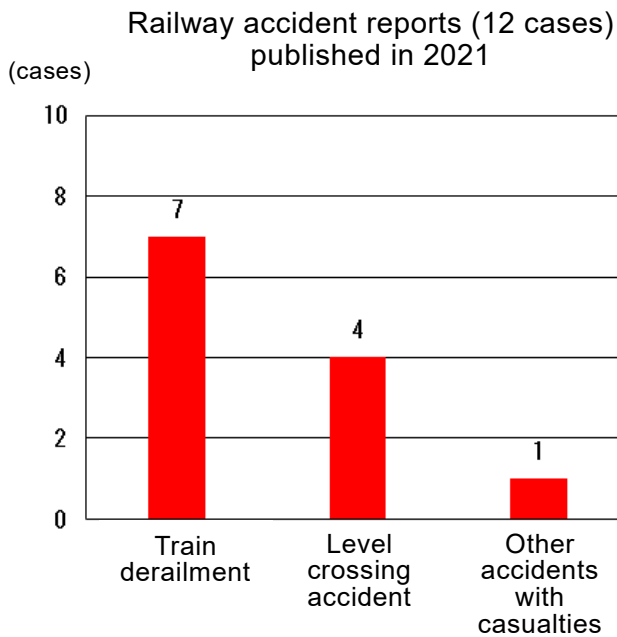
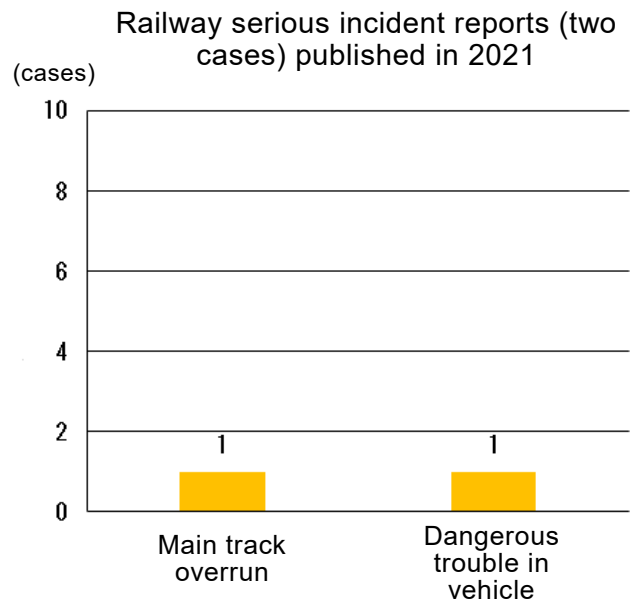
1	Date of publication	Date and accident type	Railway operator	Line section (location)	
	February 18, 2021	June 1, 2019 Other accidents with casualties	Yokohama Seaside Line Co., Ltd.	In the Shin-Sugita Station yard on the Kanazawa Seaside Line, Kanagawa Prefecture	
	Summary	<p>The train departed from the starting station, Shin-Sugita station, on schedule, by the unmanned automatic operation. However, the train moved to the inbound direction opposite to the direction of travel i.e., the outbound direction, and collided with the car stop at the end terminal of the track.</p> <p>There were 25 passengers boarded on the train, the 17 passengers among them were injured.</p>

Probable causes	<p>The JTSB concludes that the probable cause of this accident was certain that this accident occurred because the Train started to run in the inbound direction, i.e., the outbound direction opposite to the direction of travel, when turned back in Shin-Sugita station, and collided with the car stop at the end terminal of the track.</p> <p>It is highly probable that the Train started to move by the power running in the direction opposite to the designated running direction without intention, because the motor control device of the 2000 series vehicle drove the motors in the inbound direction that had been preserved in the memory function, as the F cable, which is the command cable to transmit the signal on the running direction of the train to the motor control device, became in the de-energized status due to be broken in the 1st vehicle. Furthermore, it is probable that the measures such as the emergency stop procedures could not be implemented, because the station ATO ground unit recognized that the running direction of the train had been set normally, as the station ATO onboard unit had transmitted the status of the running direction based on the energized status of the command line to select the driving desk, which is different to the input signal to the motor control device, and also there was no function to detect the backward running or the function to detect by the other methods backward moving such as in this accident.</p> <p>It is probable that the F cable had broken as that the insulator of the F cable wore gradually by the friction with the upper surface of the end panel due to the vibration while the vehicle was running, and fault grounded to the end panel, as the results of that the bundle of cables including the F cable in the device room were wired without attaching the protecting materials for the electric wires sufficiently, and had been contacted with the end panel made of the stainless steel, but the inspection had not been implemented after finished the wiring works.</p> <p>It is likely that the existence of the latent causes for such dangerous incident and the insufficient security of the safety against the abnormal status such as the backward running, etc., were not noticed, because the confirmation and the arrangement on the understandings for the designing organization, the basic concept, and the specifications, etc., among the Company, the vehicle manufacturer and the device manufacturer, and the extraction of the safety factors before designing were not implemented sufficiently, in the designing and manufacturing process of the 2000 series vehicle, the latent causes of the dangerous incident for the occurrence of the backward running was generated, in addition, also the verification of the safety was insufficient, in the back ground of this accident.</p>

Safety actions	<p>Measures taken by the Company</p> <p>Safety actions of the running in wrong direction implemented by the Company after this accident were as follows.</p> <p>[1] Changed the electric circuit to add the contact terminal of the relay to detect the energized status of the F cable and the R cable, in the condition of the operation of the departure condition relay in the ATO*¹ onboard unit.</p> <p>In addition, for the purpose that the ground units comprehend correctly the recognition on the running direction of the vehicle, changed the command cable, which return the information on the status of running direction to the ground units via the station ATO onboard unit, from the conventional command cables to select the</p>
