ANNUAL REPORT 2023

Japan Transport Safety Board
Annual Report 2023
[March 2023]

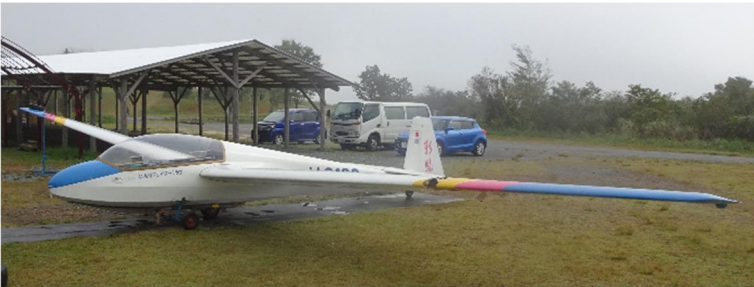
Probable causes	<p>When the aircraft attempted the crosswind landing, the attitude was disturbed due to the wind just before the touchdown, the probable cause of the accident was the trainee could not correct appropriately. Therefore the aircraft touched down with the nose facing the leeward left direction deviated the runway, collided with shrub and sustained damage.</p>

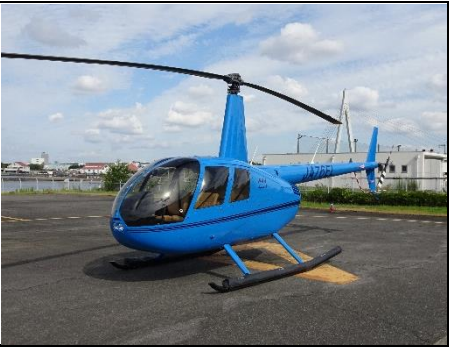
Summary	When taking off from Nagasaki Airport, the aircraft was cleared for take-off from the runway by the air traffic controller, but took off from a taxiway.

Probable causes	The probable cause of this serious incident was more likely the captain's misinterpretation that, when cleared by the Tower for take-off from T2 intersection at Runway 32, the aircraft was cleared for take-off from Taxiway T2 that led to the take-off from the Taxiway T2.		
	Safety Actions	Recurrence prevention measures taken by the company On the day of the serious incident, the company reminded all employees for their thorough understanding that take-off from any area other than runway or helipad is not authorized.		
	Report	https://www.mlit.go.jp/jtsb/eng-air_report/JA76EL.pdf		
7	Date of publication	Date and location	Operator	Aircraft registration number and aircraft type
	April 28, 2022	November 27, 2021 Menuuma Gliding Field (temporary operation site), Kumagaya City, Saitama Prefecture	Privately owned	JA4083 Cristen Industries A-1 (Small aeroplane)

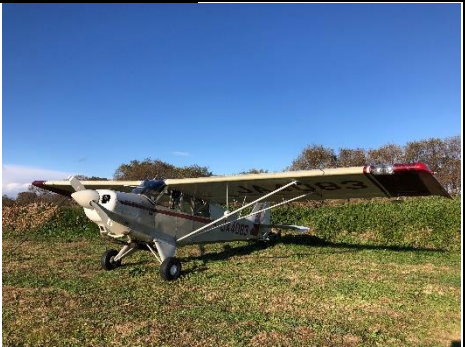
Summary	The airframe leaned to the left during landing roll, and the left wingtip contacted with the ground surface. The pilot alone was onboard, and did not sustain injury.

Probable causes	The probable cause of this serious incident was likely that the aircraft was shaken by the gusty wind from the right direction during landing roll that caused the right wing to float and the aircraft to lean to the left, and the left wingtip contacted with the ground surface.		
	Report	https://www.mlit.go.jp/jtsb/eng-air_report/JA4083.pdf		
8	Date of publication	Date and location	Operator	Aircraft registration number and aircraft type
	June 30, 2022	September 16, 2019 In the sky over near the Komatsu Airfield, at an altitude of about 150 m	Japan Students Aviation League (the League) (Aircraft A)	JA01KY Diamond aircraft HK36TTC Super Dimona (Power glider)
			Japan Students Aviation League (the League) (Aircraft B)	JA2471 Alexander Schleicher ASK21 (Glider)

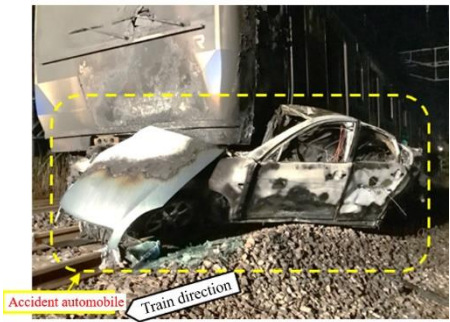
Probable causes	<p>It is highly probable that the running train collided with the automobile which entered the track and was stopping on the railway track, and right wheels of all two axles of the front bogie of the first vehicle ran onto the rail and derailed to right side of the track, because the automobile got into the space between lower left part of the front surface of the first vehicle and the railway track.</p> <p>It is probable that the automobile had been enter the railway track because the automobile broke through the net fence and enter the railway track and became stuck, because the driver of the automobile mishandled the steering wheel in the situation that the driver could not drive calmly in order to escape from the pursuit by the police.</p>		
	Safety actions	<p>Measures taken by Road Administrator</p> <p>After the accident, at the request of the company, the road administrator who has jurisdiction over the net fence took the following measures before June 3, 2021 at the location where the automobile entered.</p> <p>(1) The damaged net fence was repaired.</p> <p>(2) A guardrail was installed on the net fence side of the prefectural road 141.</p>

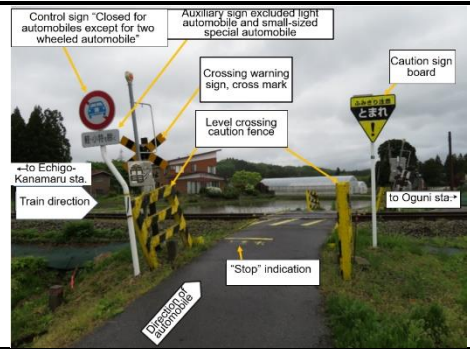
Probable causes	<p>It is probable that this accident was caused by the collision of the train and the pedestrian who entered Naito level crossing, the class 4 level crossing where crossing gate and road warning device were not equipped, in the status that the train was approaching.</p> <p>It could not be revealed the reason why the pedestrian entered the level crossing and continued to walk in the status that the train was approaching because the pedestrian was dead.</p>

Safety actions	<p>(1) Measures Taken by the Company</p> <p>1. A discussion on the abolition was held with the landowner on October 12, 2021. However, the landowner rejected the idea because of its actual status of usage and no agreement on the abolition was reached.</p> <p>2. Leaflets to call attention to the use of the level crossing was provided. On October 19, 2021, warning signs “Accident occurred here. Check left and right” were installed at the level crossing. (See Fig.1)</p> <p>(2) Measures taken by the Landowner</p> <p>On August 12, 2021, the landowner installed colored cones and a safety bar in front of this level crossing to remind people to stop before it. (See Fig. 2)</p> <div style="display: flex; justify-content: space-around;"> <div style="text-align: center;">   <p>Installed warning signs</p> </div> <div style="text-align: center;">   <p>Installed colored cones and safety bar</p> </div> </div> <p>Fig. 1 Implementation status of the safety measures taken by the company</p> <p>Fig. 2 Implementation status of the safety measures taken by the landowner</p>

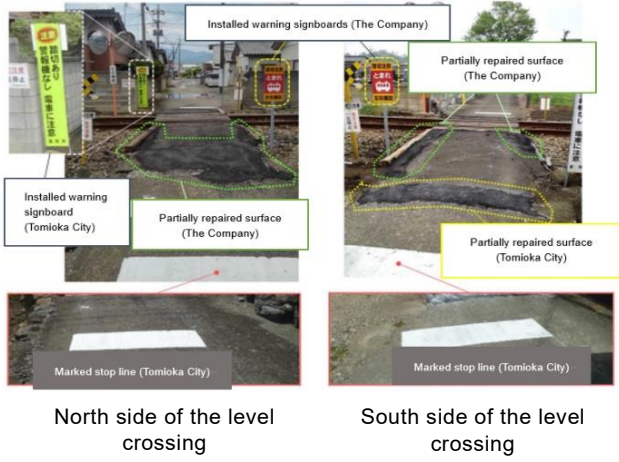
Fig. Measures taken by the company and government of Tomioka City for this level crossing

<p>the passerby. The passerby was dead in this accident.</p>
<p>Probable causes</p>	<p>It is certain that this accident was caused because the train collided with the passerby and the bicycle who entered and staying in Seiunji level crossing, the class 4 level crossing without crossing gate nor road warning device.</p> <p>It could not be revealed the detailed reason the passerby was staying in the level crossing because the passerby was dead, although it is likely that the passerby did not notice the approaching train due to be concentrated the consciousness to some actions as the bicycle fell down in the accident level crossing, or the passerby could not move the body due to some causes.</p>
<p>Safety actions</p>	<p>(1) Measures taken by the Company</p> <p>As shown in the figure, warning signboards were installed on both sides of the level crossing, and some grooves and holes in joints in the asphalt pavement were repaired.</p> <p>In addition, in the wake of this accident, the company together with the Gunma Prefecture conducted a survey on the pros and cons of abolishing the class 4 level crossing to each municipality along Joshin Line (on February 10, 2022) and decided to proceed with the discussion with the road administrator to abolish 7 level crossings which had been confirmed to be abolished (this level crossing is not included because it is installed in a private land only accessible to a municipal road) in future. Furthermore, the company abolished one of the class 4 level crossings “Under the up line signal level crossing” which had been determined to be abolished in March 2022.</p> <p>(2) Measures taken by the Road Administrator</p> <p>As shown in the figure, the Tomioka City, as the road administrator, marked stop lines on both sides of the level crossing, partially repaired the road surface on the south side, and added warning signs.</p>

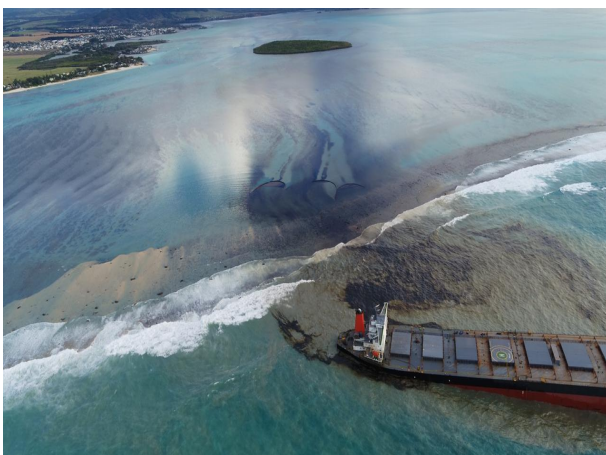
On July 25, 2020, an accident occurred in which a Panamanian-flagged cargo ship operated by a Japanese shipping company grounded on a shallow on the southeastern of Mauritius Island. After the accident, the vessel was buckled and the fuel oil spilled out and was contaminated ashore on the coast of the southeastern of the island, causing oil pollution damage in a wide range of area.

Oil spilling out from the grounded vessel

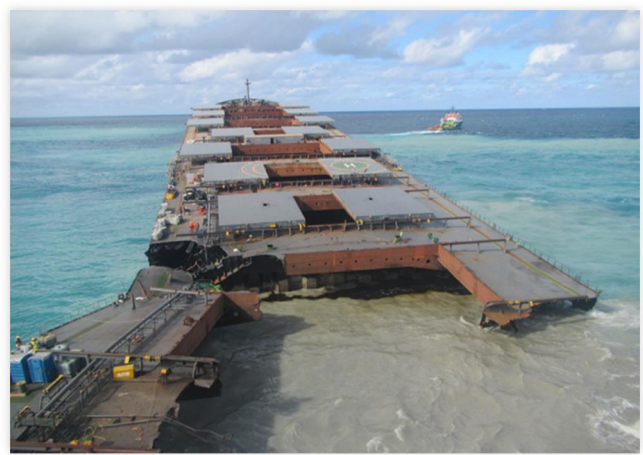
The severed vessel
