Major activities in the past year

1 Accident Investigation Regarding a Collision between Aircraft on the Runway at Haneda International Airport in Tokyo

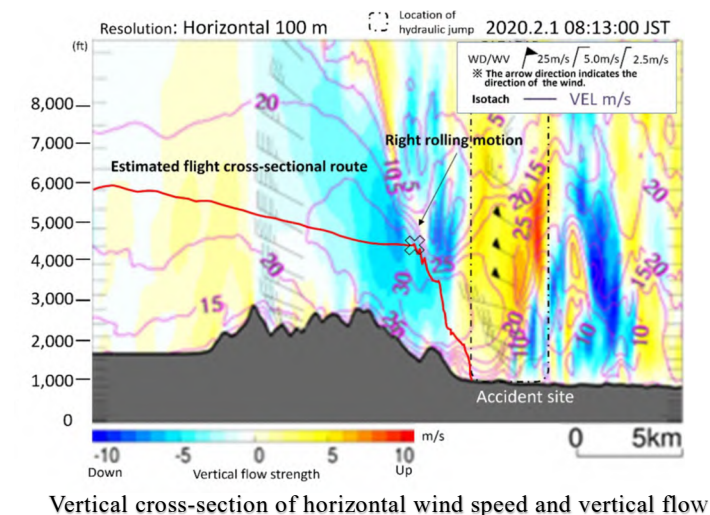
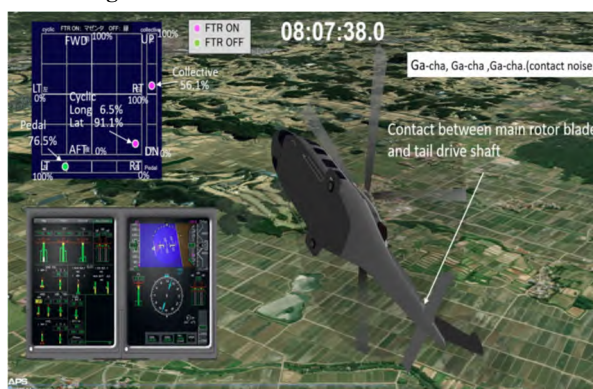
As a result, when the helicopter encountered a localized strong downdraft and the horizontal wind speed decreased while flying at high speed with a tailwind over the Mountain Range, the airspeed rapidly increased. In response to the attitude change when the airspeed increased, part of the attitude retention function was released and the cyclic stick was moved to the right rear in an

attempt to maintain attitude, resulting in a right rolling motion exceeding 360°. The JTSCB concluded that the main rotor blades most likely severed the tail drive shaft during this motion, making the helicopter difficult to control.

Based on the results of this investigation, the JTSCB recommended, as safety actions, that when flying over mountainous regions in strong winds where mountain waves are expected to occur, pilots need to slow down in advance and select appropriate flight control modes to respond to sudden weather changes. The JTSCB also recommended that to fully understand and properly use flight control modes during flight, pilots should carefully read the relevant documents and, whenever possible, conduct training using Full Flight Simulator and others corresponding to each aircraft type, including coordination between two pilots to enable quick and calm responses during emergency operations.

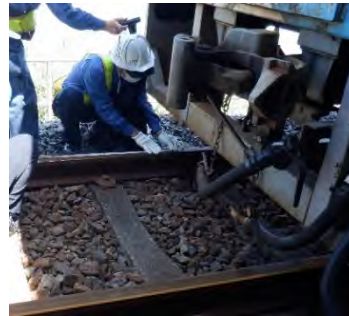
Fig. 2: Investigation status

On June 2, 2023, a single-car train bound for Kubokawa Station from Sukumo Station derailed after running over earth and sand between Ariigawa Station and Tosa-Shirahama Station (see Figs. 1 and 2). There were no passengers on board, only one train driver and one maintenance worker, but no injuries were reported.

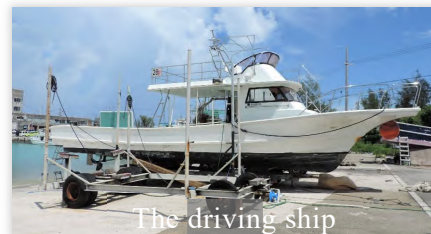
The driving ship

This accident occurred when the ship experienced severe wind, rain, and high waves while passengers were diving. Since the ship continued to anchor by letting go anchor from the stern, waves crashed onto the upper deck, seawater and other substances flowed into the engine room from the stern storage, etc. Furthermore, as the Master continued to sail with more passengers on board and the stern lowered, it is probable that the crashing waves caused the ship to flood and capsize.

- By changing the stern shape (removal of the partition plate), the structure became more vulnerable to crashing waves.
- After repairing the hydraulic piping, the penetration was left open without being closed.
- The Master did not obtain information on weather and sea conditions after departure and could not make decisions such as evacuation.
- It was possible that the stern part of the ship sank easily, which affected the deterioration of stability, as approximately 1,000 kg of diving equipment was loaded mainly on the stern deck.

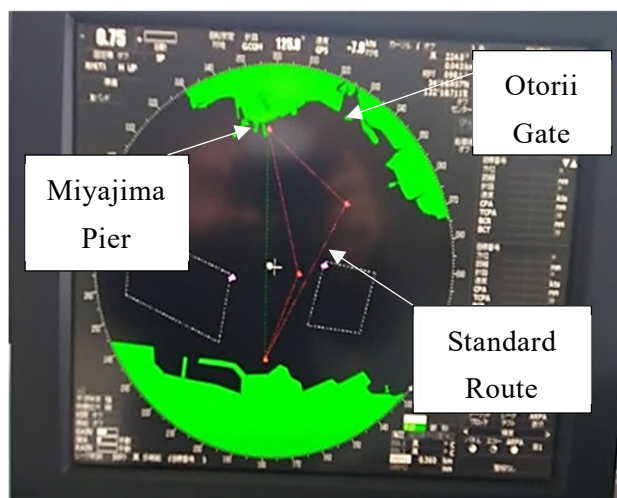
Additionally, after the ship was stranded in February 2020, the passenger ferry operation company displayed the standard route on the passenger ferry's radar and instructed passenger ferries not to navigate in the waters near the Otorii Gate of the standard route when visibility was restricted, such as during fog, but allowed them to drift in the same area. However, the operation company had not considered the precautions to take when drifting in the area.

factors, a Master must not be optimistic based on his/her experience or other factors, thinking that the ship will not be swept away, but must check the ship's position visually and by radar, etc. Furthermore, to improve navigation safety, passenger ship operators are required to investigate the risks of grounding and other hazards in the waters they navigate, consider safety measures, including prohibiting entry, and have crew members implement these safety measures.
