## Chapter 4 Railway accident and serious incident investigations

### 3 Statistics of investigations of railway accidents and serious incidents

### Railway accident investigation reports published in 2024

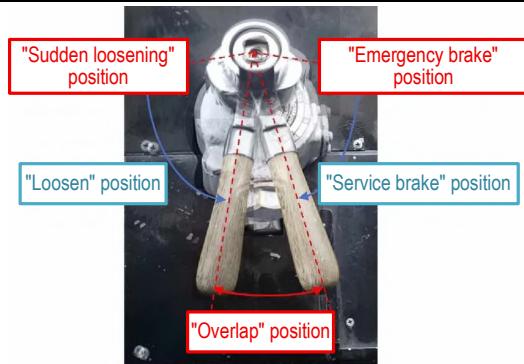
<p><sup>*1</sup> The term "overcoat" here refers to the cold-weather clothing provided to the driver by the Public Corporation.</p>		
	Safety actions	<p>(1) Safety Actions considered necessary for the Public Corporation</p> <ol style="list-style-type: none"> <li>① It is necessary to establish handling procedures for when the driver leaves the vehicle.</li> <li>② It is necessary to thoroughly instruct the drivers to handle operations as specified.</li> <li>③ Regarding the means of communication between the drivers and the operations control room, it is desirable to establish the priority of the equipment to be used.</li> </ol> <p>(2) Safety Actions considered necessary for Sapporo City Transportation Bureau<sup>*2</sup></p> <p>It is desirable to install devices on all vehicles owned that automatically activate the brakes when the driver leaves the driver's seat.</p>		
		<p><sup>*2</sup> "Sapporo City Transportation Bureau" was separated into upper and lower sections in April 2020, with the Bureau owning the vehicles and facilities, and the Public Corporation managing the operation of trams and the maintenance of vehicles and facilities.</p>

\*This figure is a composite of multiple photographs.
